# TOWN OF ORLEANS

# FIRE STATION FEASIBILITY STUDY

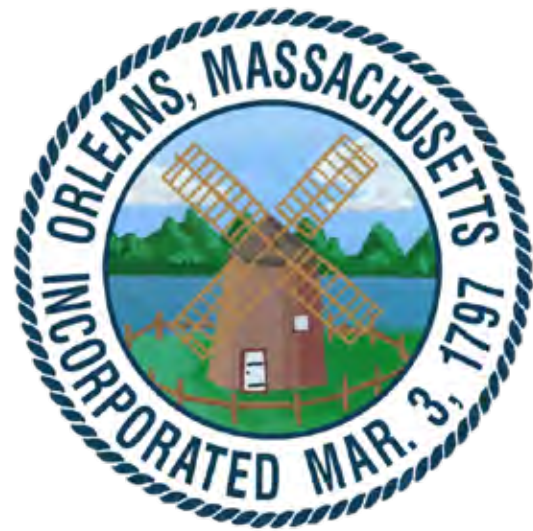
## TABLE OF CONTENTS

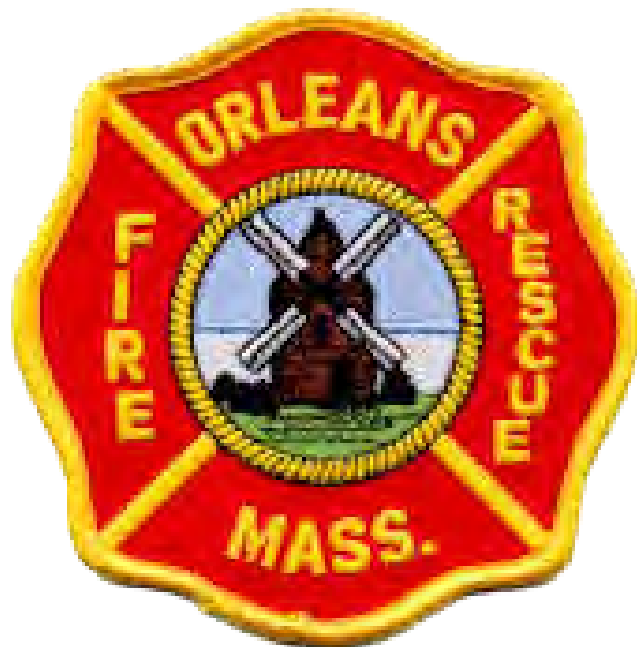
The Orleans Fire Department aims high with their mission statement, vision statement, and core values. Further, professional agencies in 911 dispatch centers and surrounding communities providing mutual aid require a professional level of services be available.

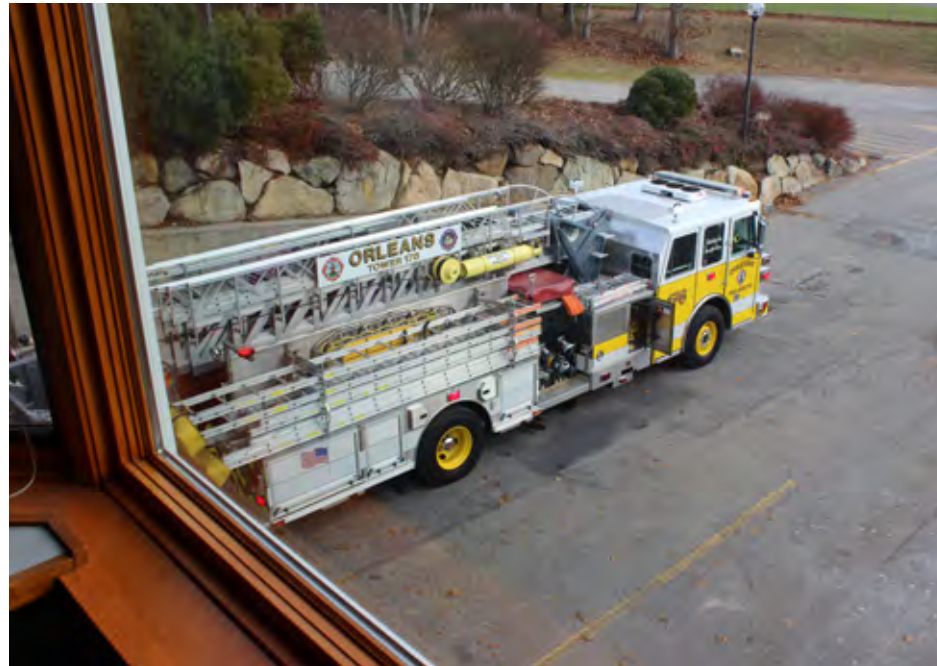
The “tri-level” nature of the building imposes a constant obstacle of traversing stairs to initiate almost every first responder task

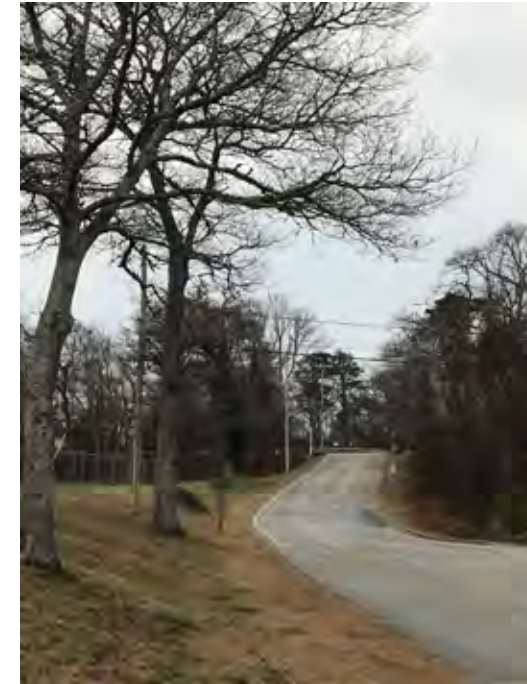
**It is highly recommended to locate public safety facilities on relatively flat sites, as close to the street as possible.**

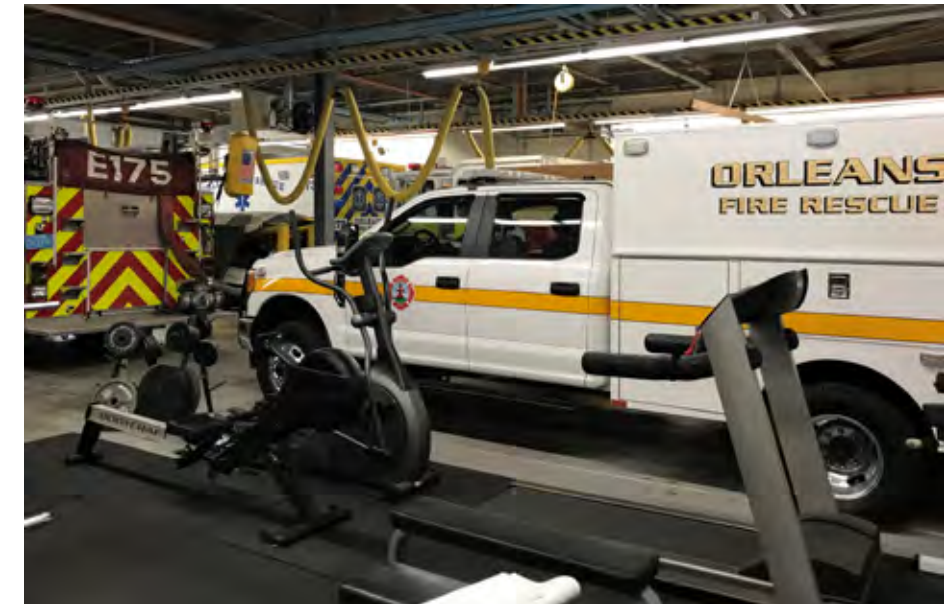
In Orleans, the fitness equipment is located directly on the apparatus floor – the biggest Hot Zone in a fire station – and the worst possible place for deep breathing caused by exercise. Anyone working out on an apparatus floor is breathing in the history of soot, but also potentially any current day carcinogens that return with the trucks and / or the diesel exhaust the trucks emit as they enter the building – even with the Plymovent system. This is a very big hazard and needs to be corrected.

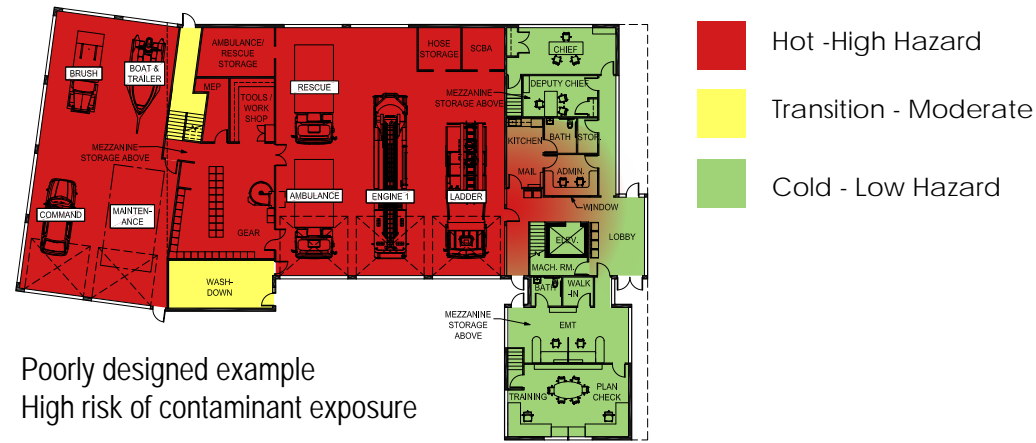
Poorly designed example  
High risk of contaminant exposure

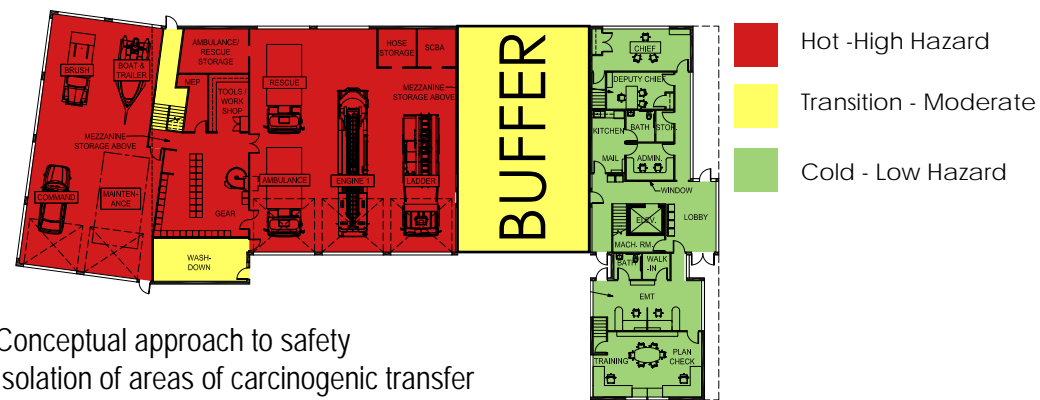
Conceptual approach to safety  
Isolation of areas of carcinogenic transfer  
\*Diagrammatic only, not representative of actual size

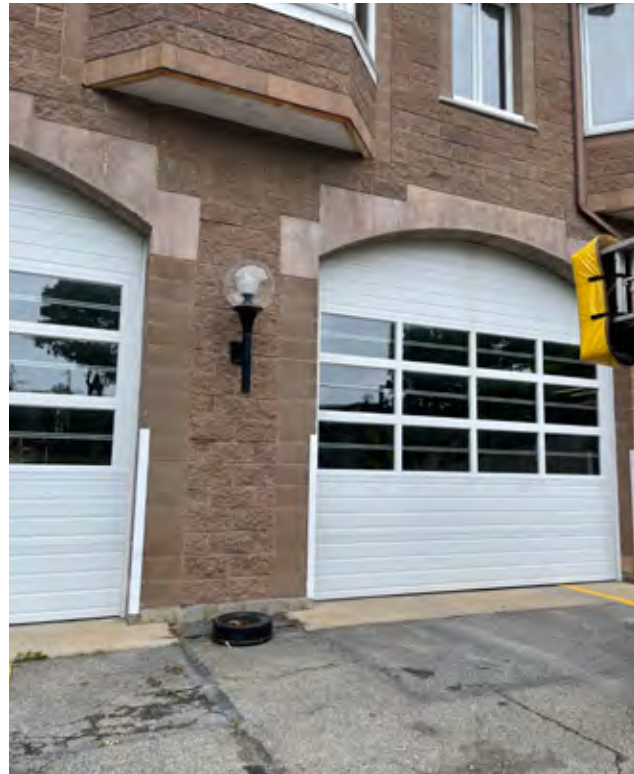
The aprons in place at the existing station are made of asphalt. Today this material would NOT be used for the reasons above and more. Asphalt settles, cracks, and moves radically with temperature changes. It is slippery when wet and builds ice easily. It is a more dangerous material to first responders for this reason, and much more abusive to the Town’s trucks and property leading to long-term expensive truck repair or replacement. Further, it does NOT last as long as concrete, which can be designed specifically for these areas. The current aprons are outdated, failing, cracked, not draining properly, and are a general safety hazard and nuisance to the fire department. Repairing them would require extensive reworking and we suggest this would be a poor use of tax dollars.

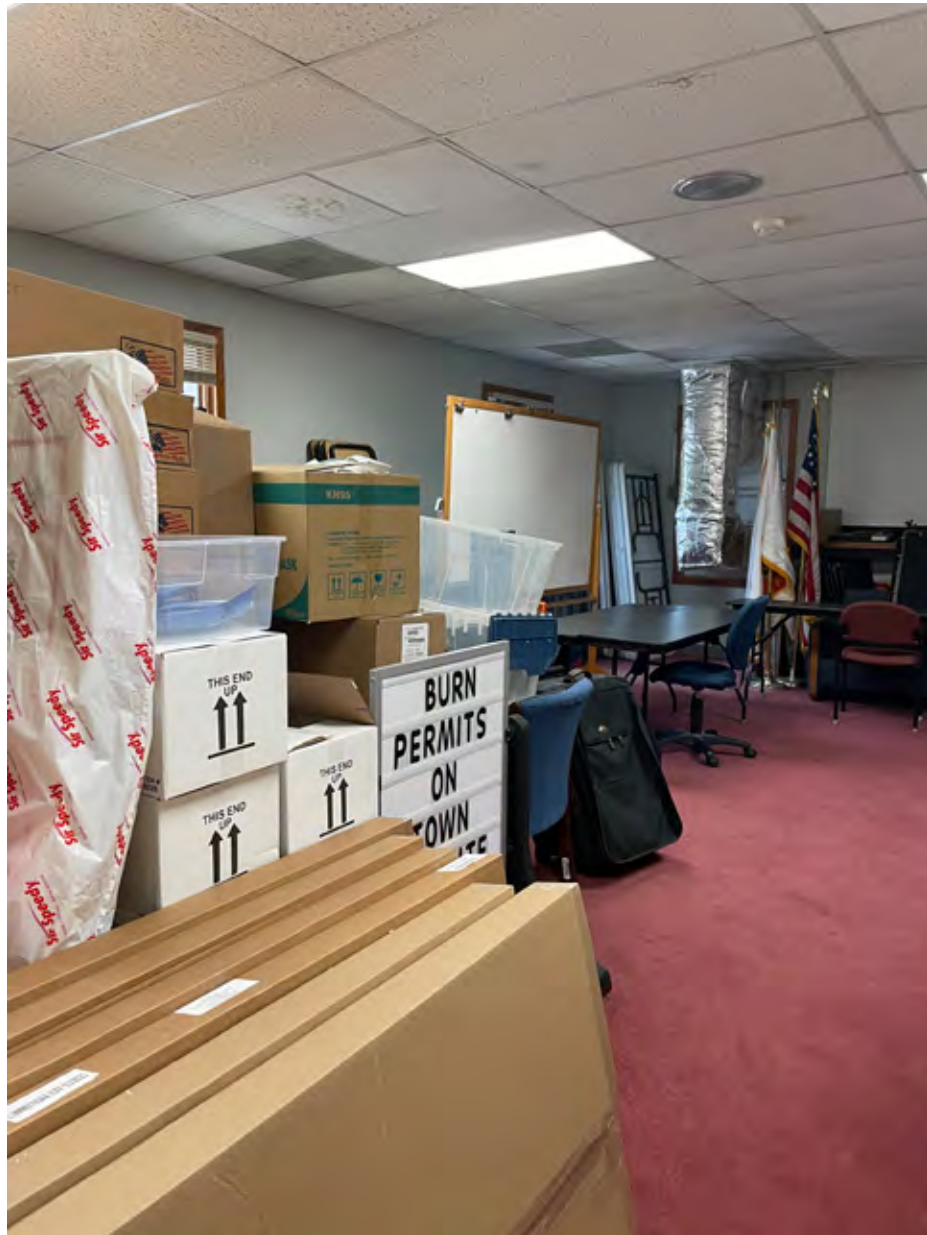
The kitchen is far too small for current staff needs. It does not have emergency shutdown switches needed for when the department is cooking but then needs to rush out to a fire. Systems like these provide safe places for fire fighters to live and work. The kitchen is NOT accessible to those in wheelchairs or others with physical impairments and without a regulatory variance in place, it needs to be. All elements of the kitchen are outdated, inadequate, with limited functionality. It is very clear they lack storage for all that is required in a modern day fire station.

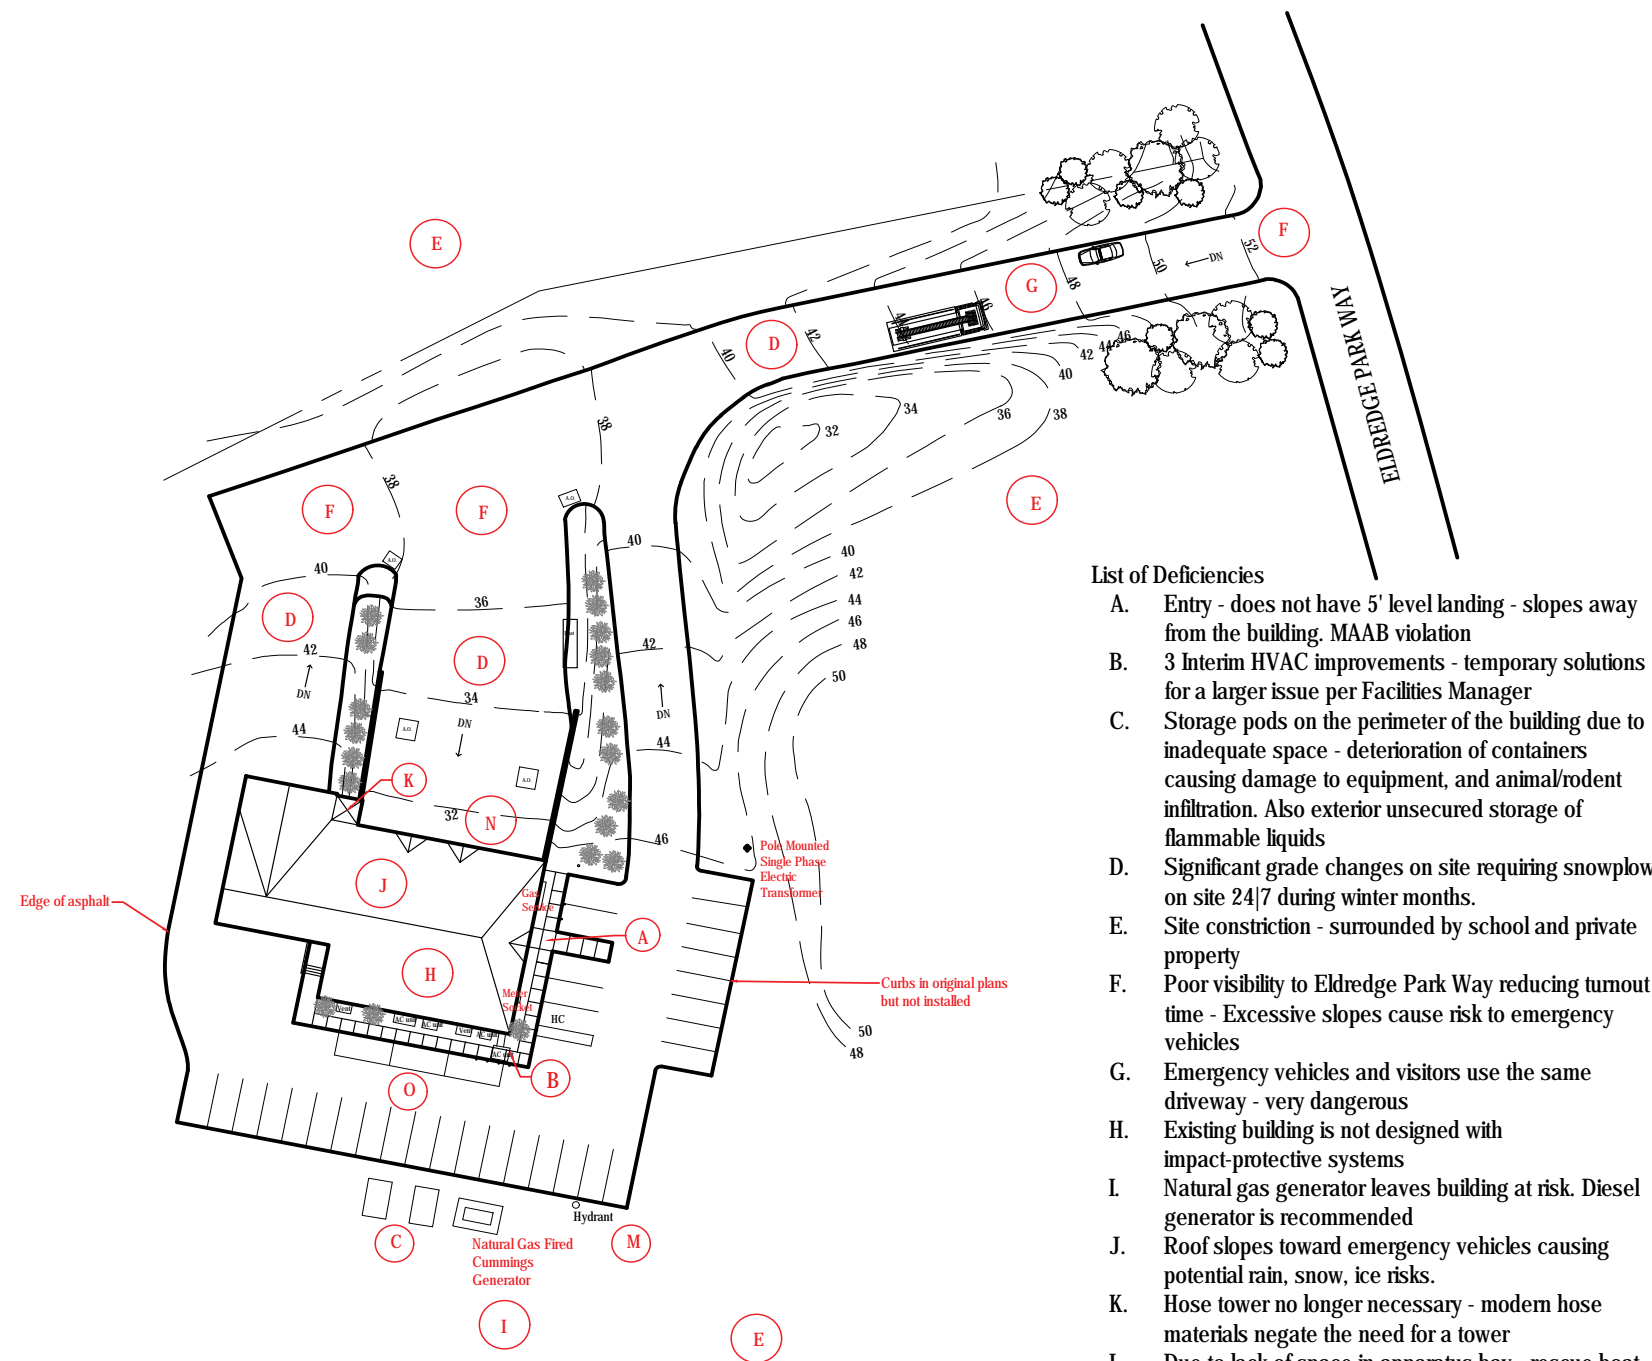
**List of Deficiencies**

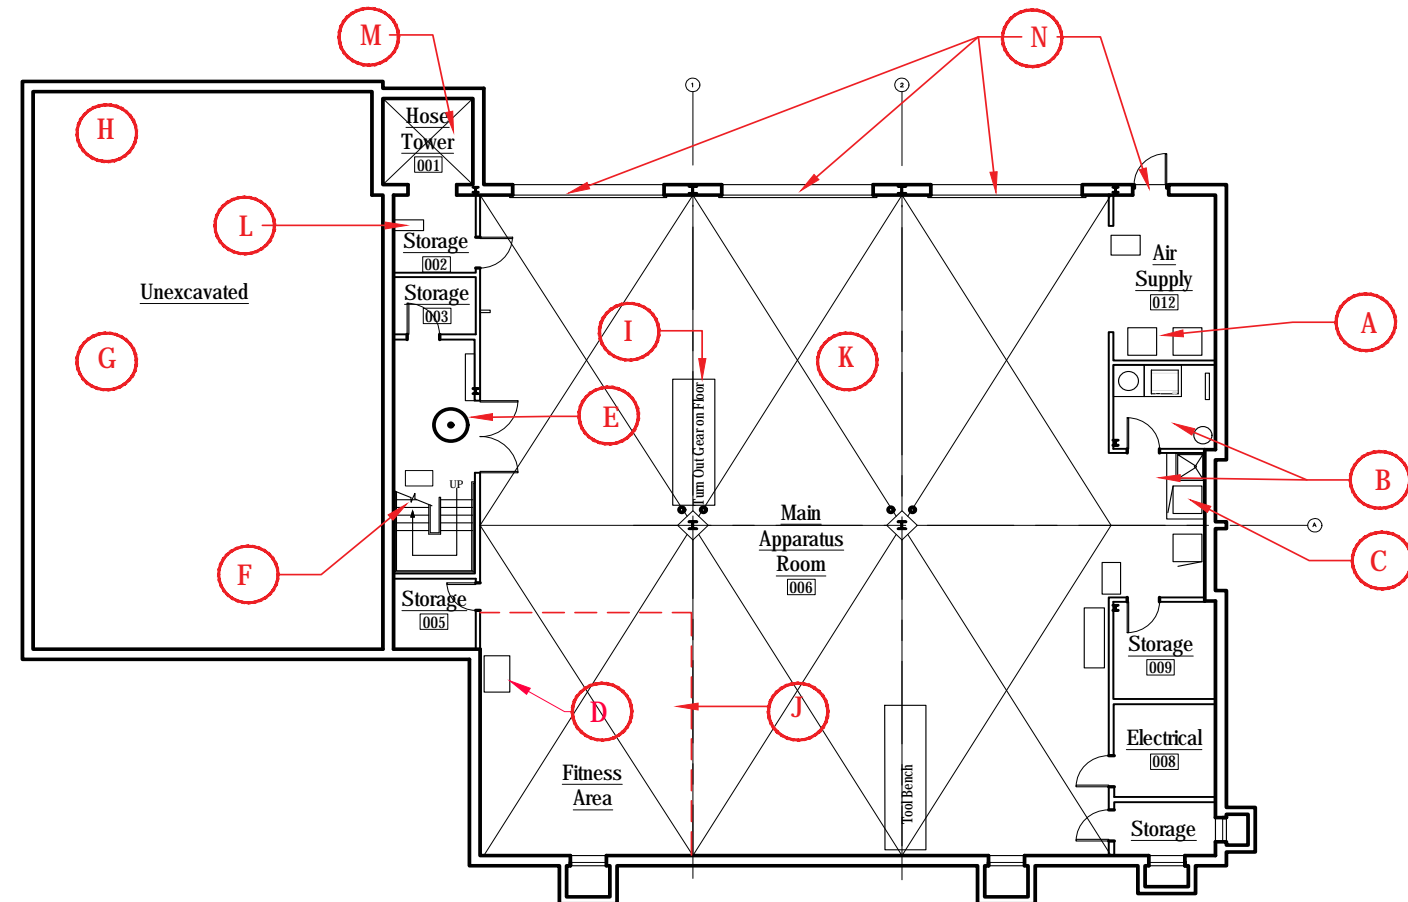
- Lower floor Apparatus door height/Ceiling height - Inadequate for apparatus. Door height at lowest point is currently 11'6", contemporary standards require 14'-0" doors
- Very limited storage
- Electrical service will be insufficient for new service requirements
- Flooding and equipment loss on basement level - potential mold on walls where supplies are stored

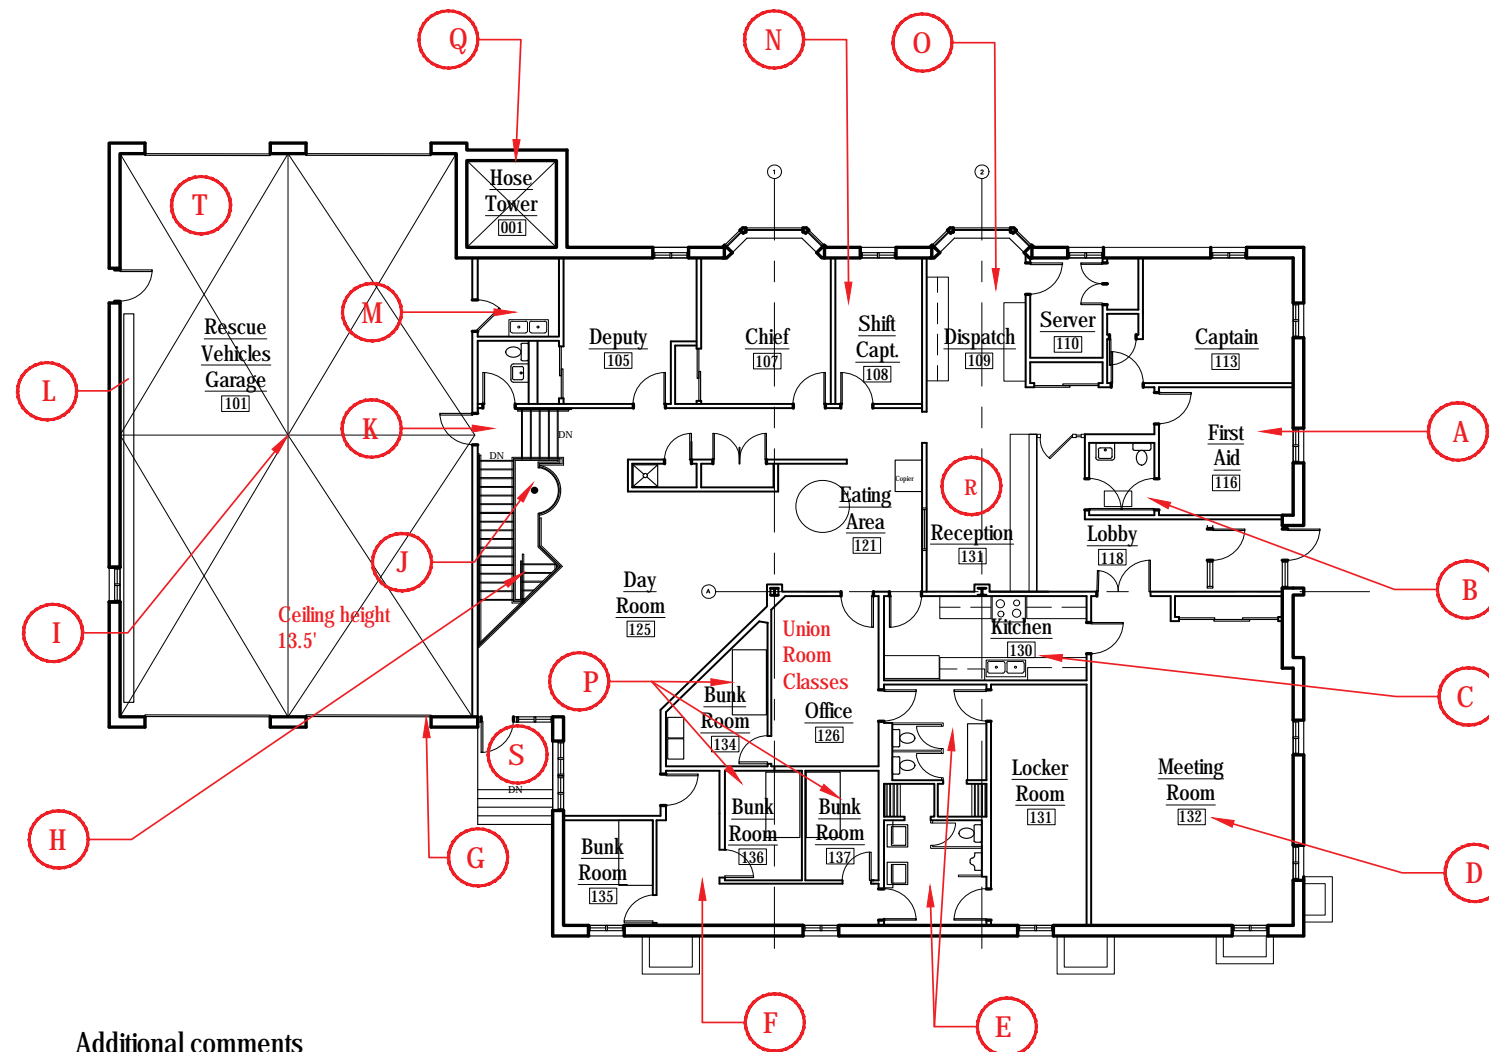
- T. Vehicles must be driven out of the back of the upper apparatus bay - can not back up the hill during minimal snow and ice (even with plowing and sanding)

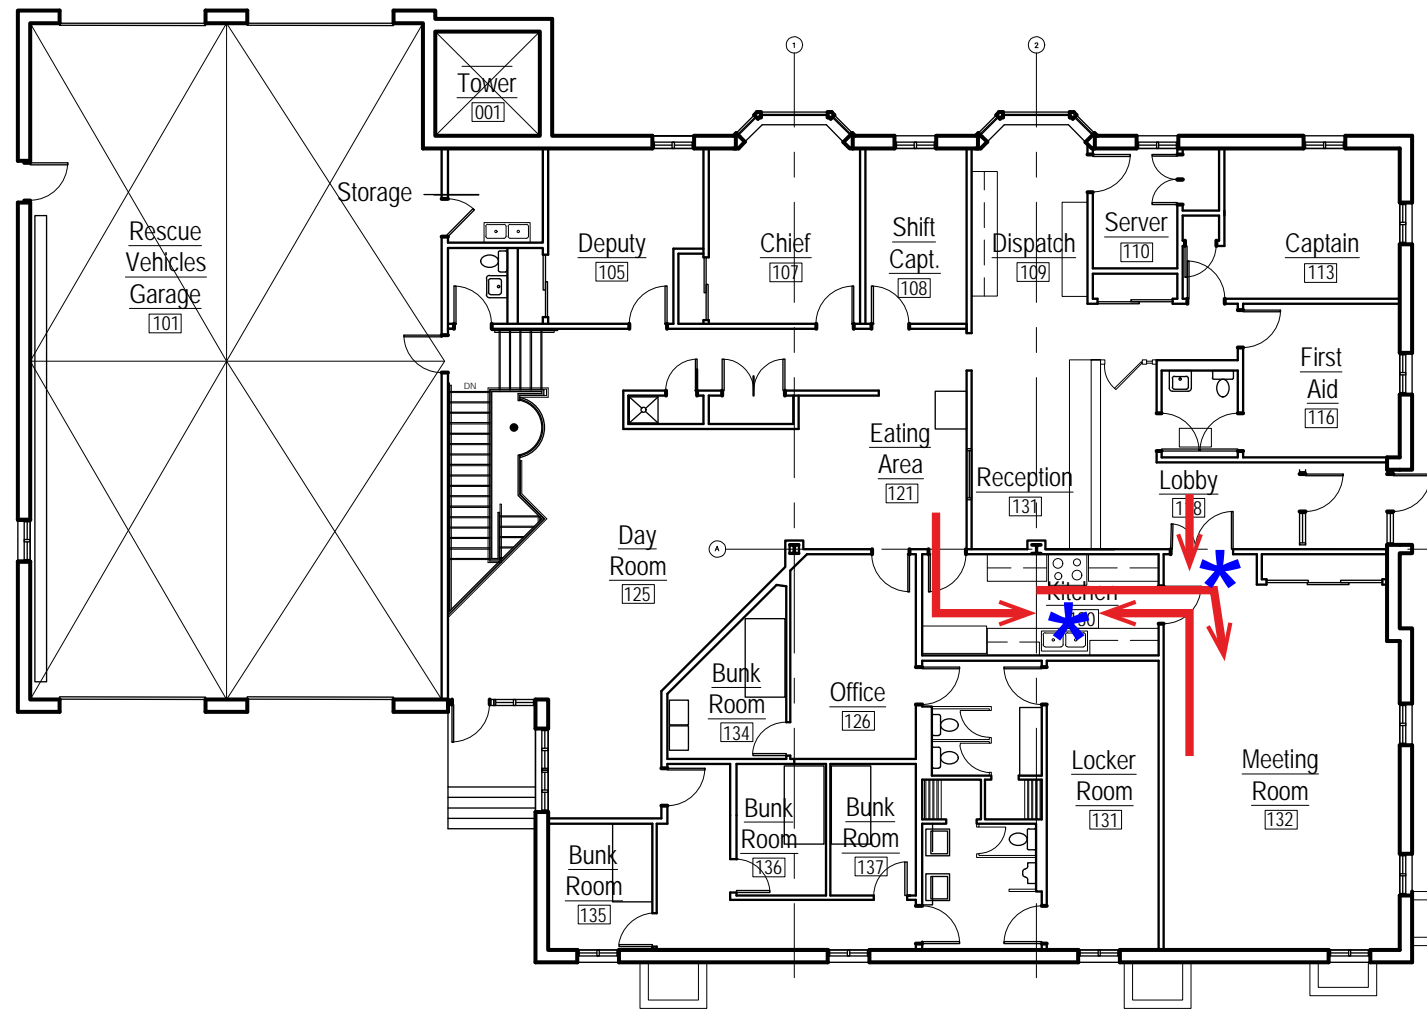
Kitchen - Path in/through kitchen is problematic

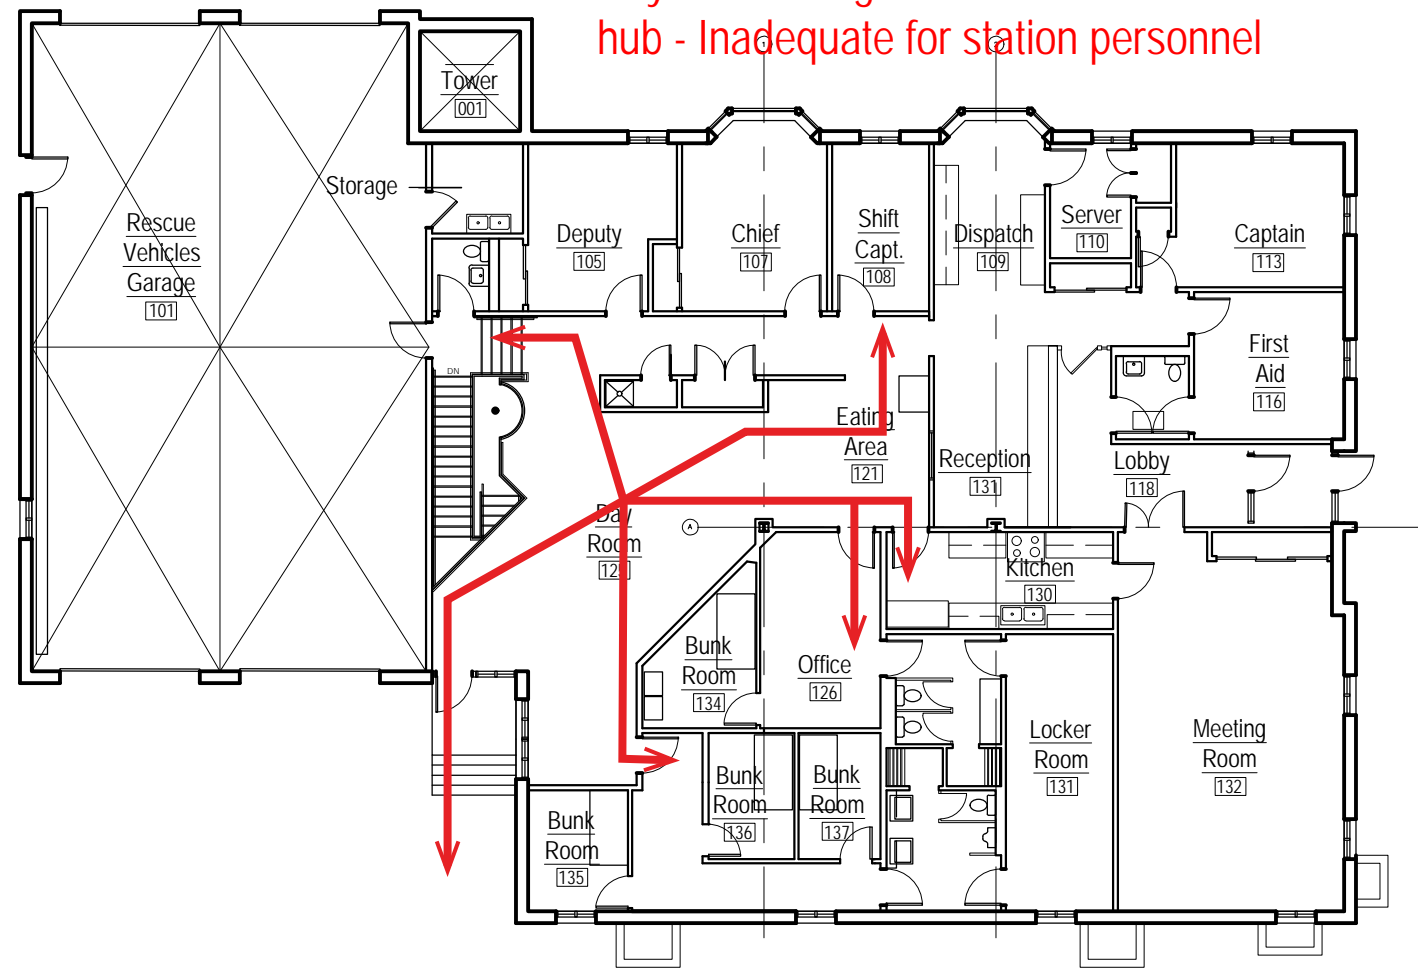
Dayroom/eating area is the main circulation hub - Inadequate for station personnel

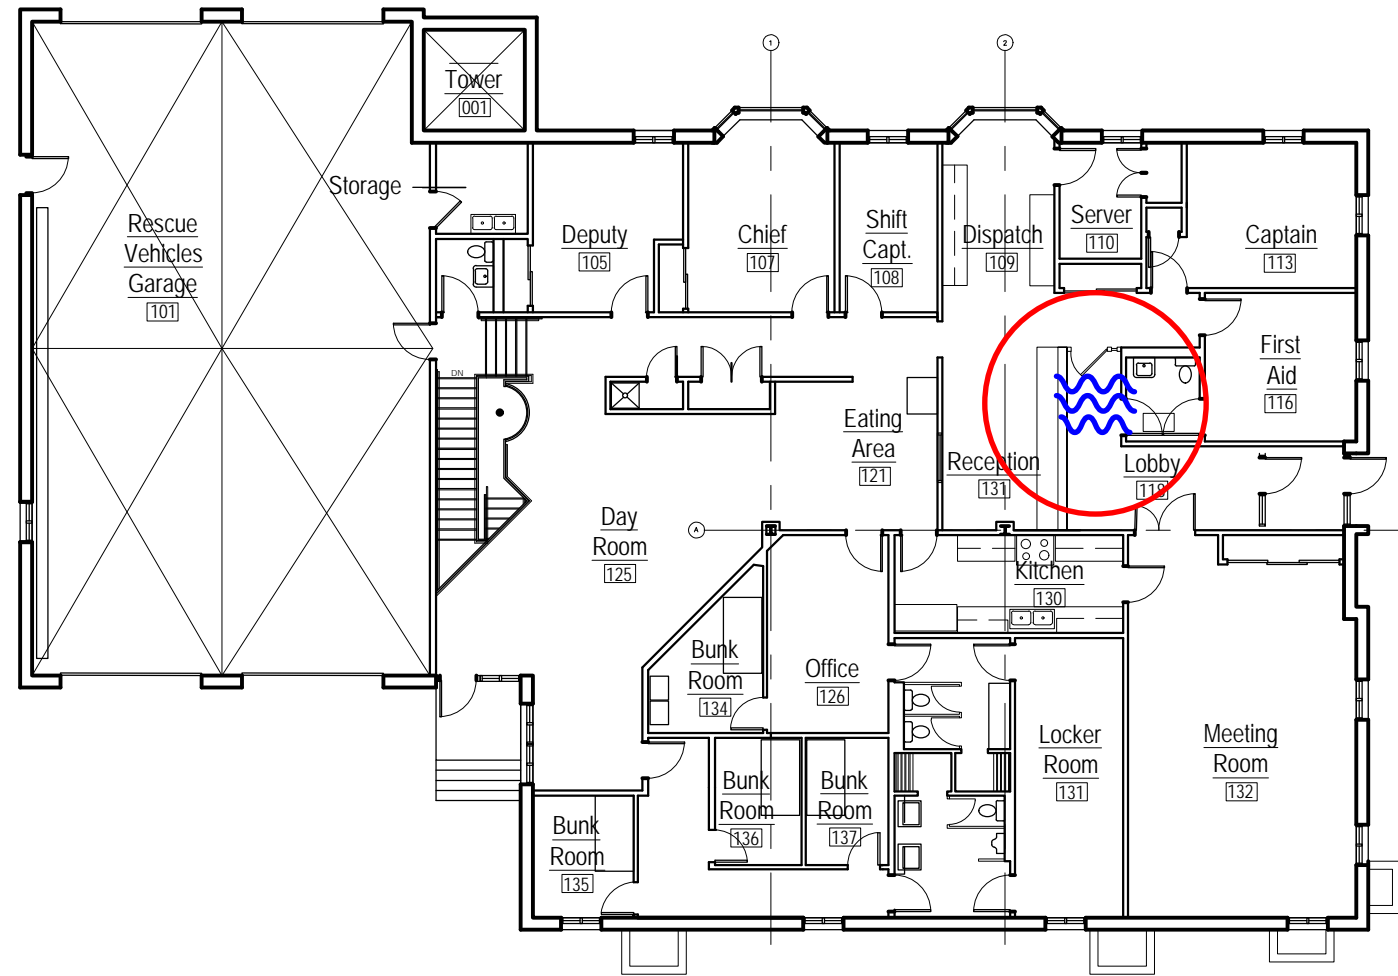
Location of restroom -  
distracting/odors

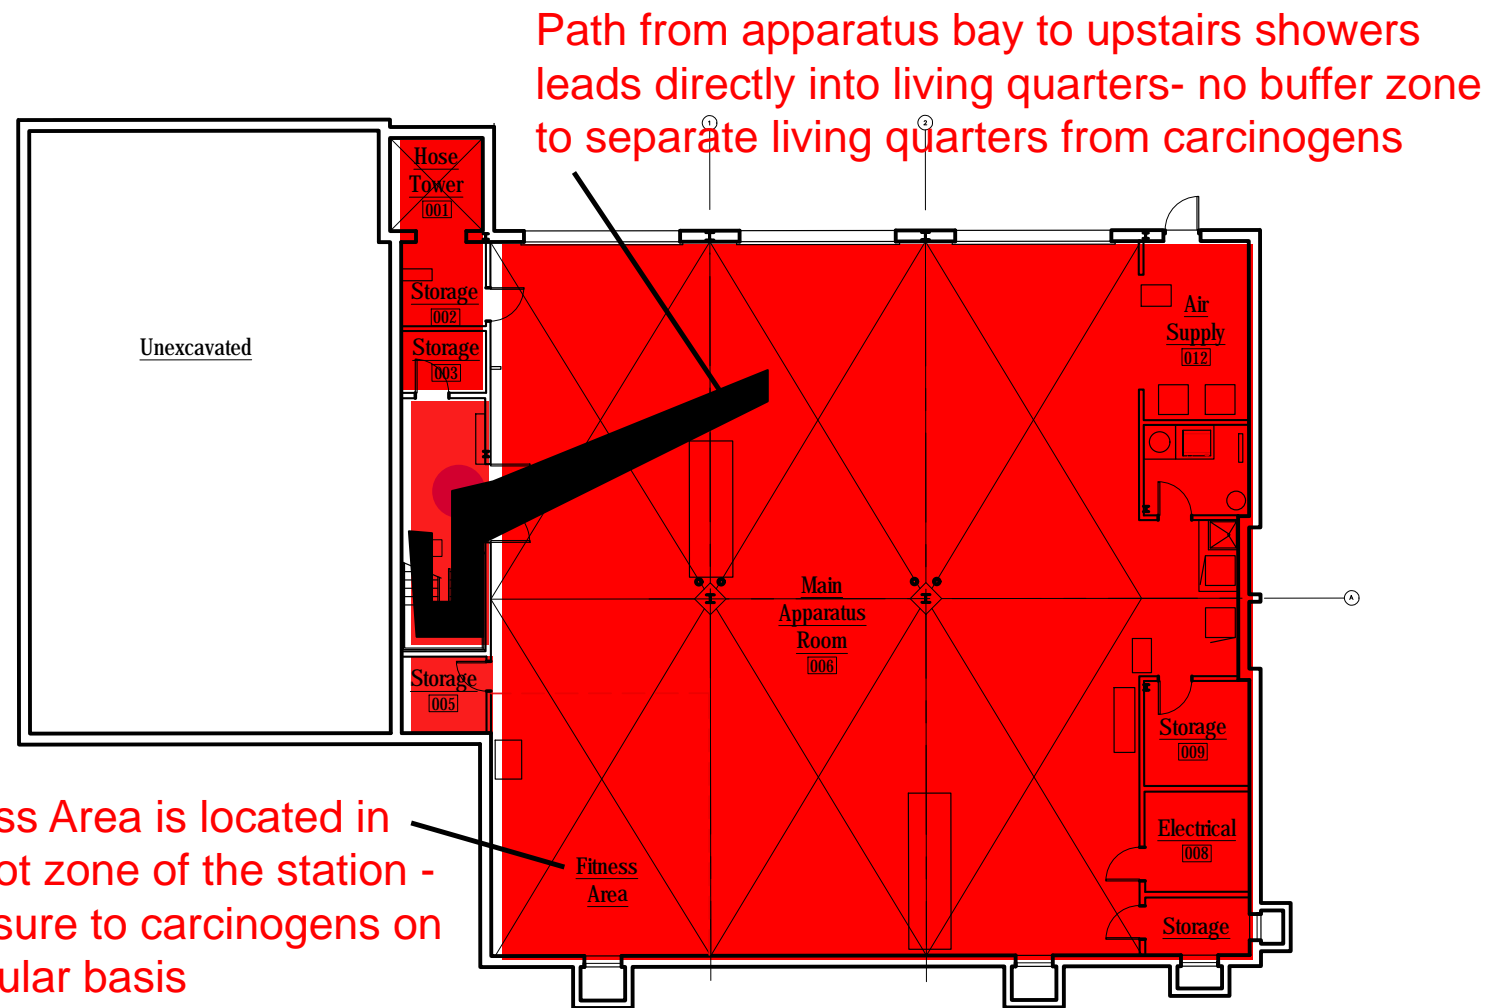
No air separation between apparatus (hot) zone and showers allowing for dangerous exposure in the living quarters

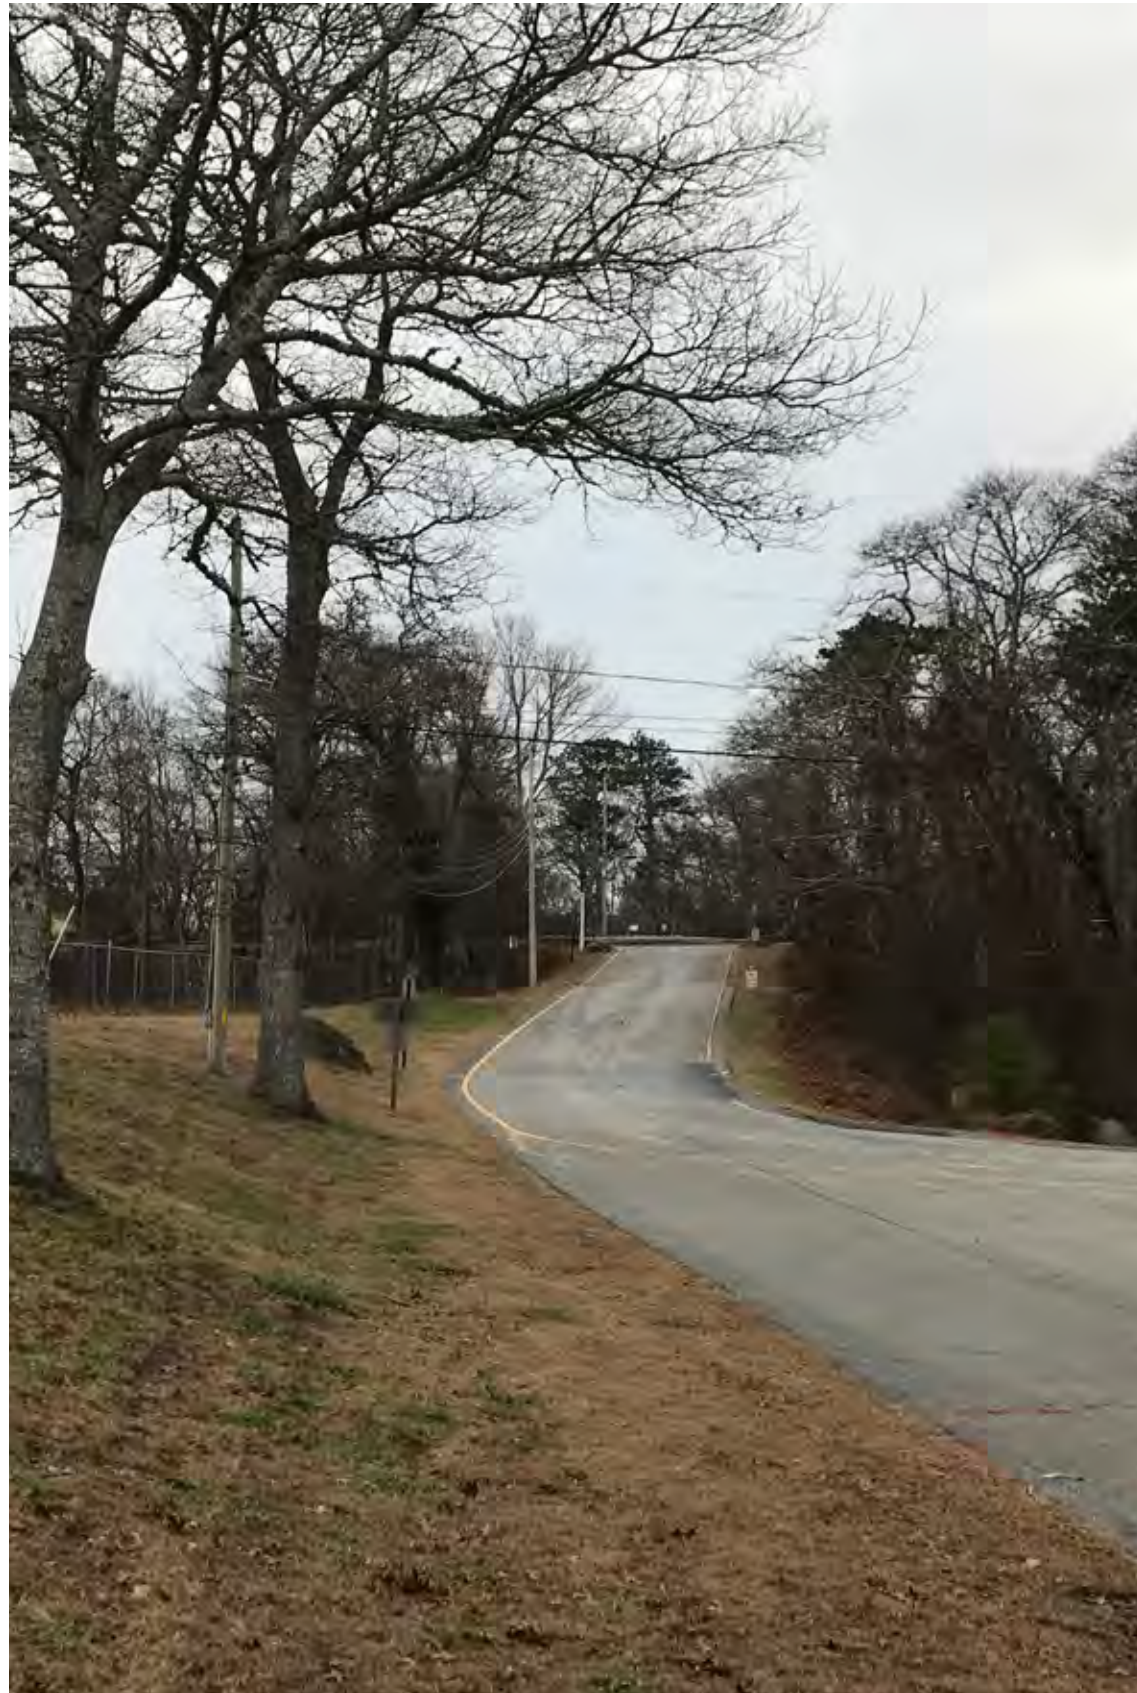
Significant grade changes causing slow turnout time in winter storms

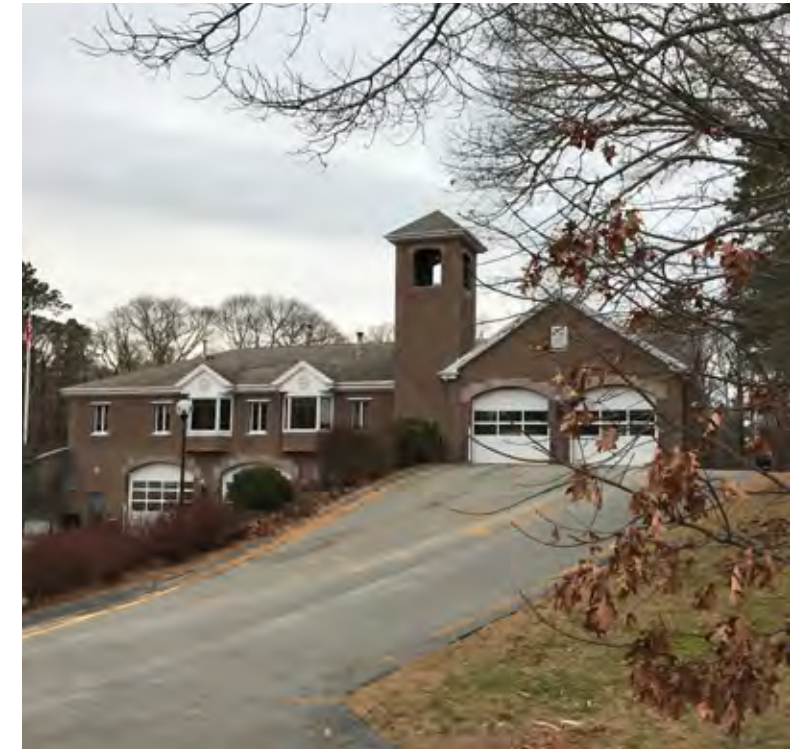
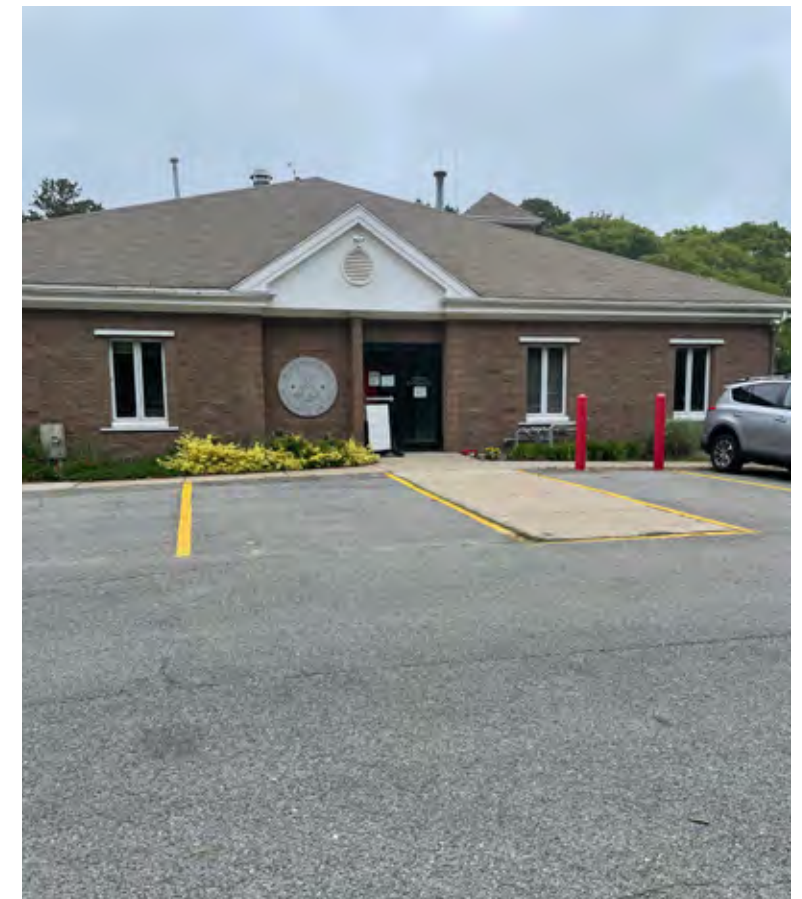
Main Entry to building is not clear, and access has non-compliant slope

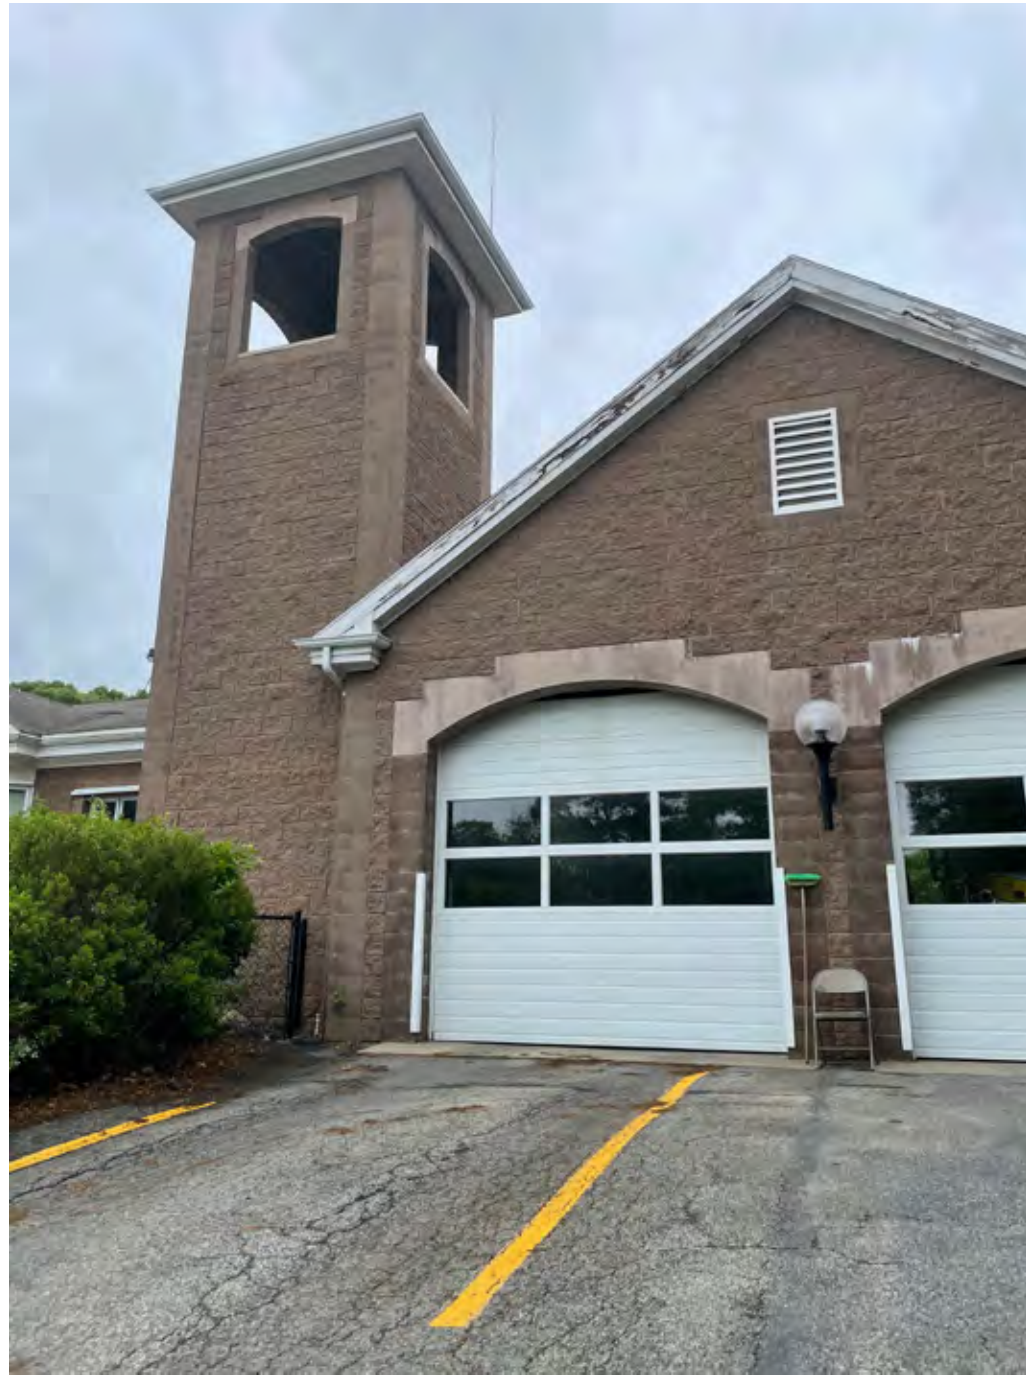
Apparatus bays lack a concrete apron, and asphalt is in poor condition. Precast arch shaped lintels limit effective overall height of doors which limits apparatus selection

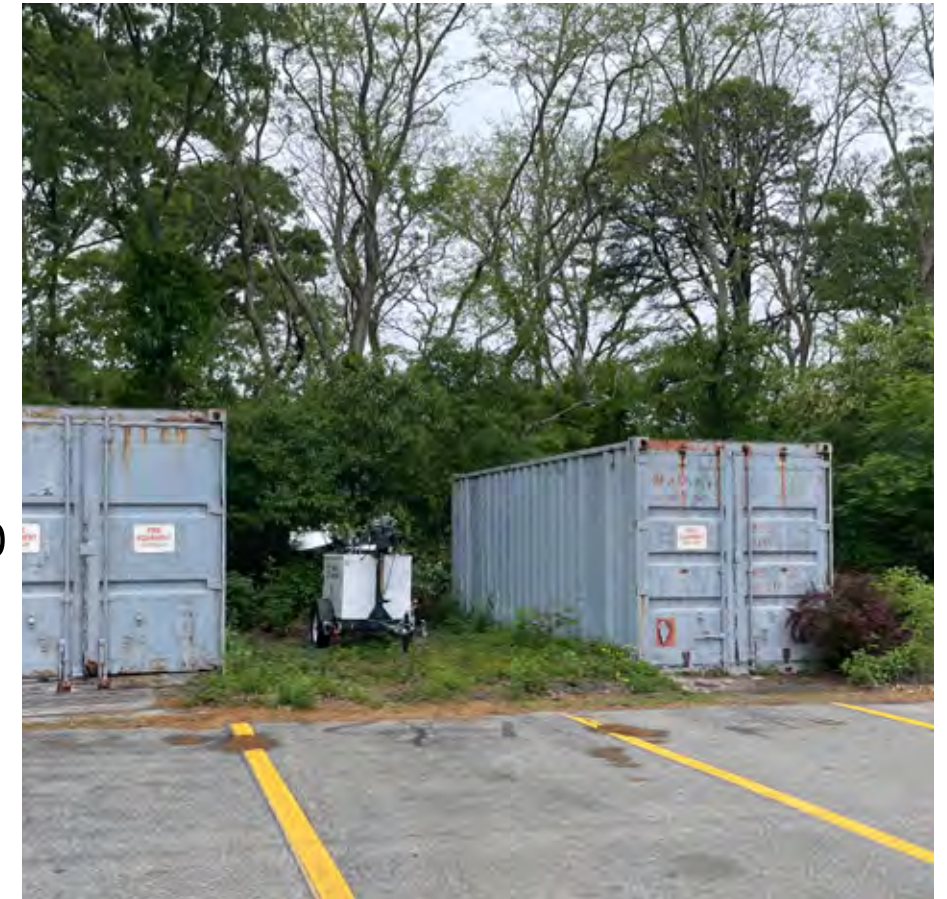
Interim HVAC improvements located to minimize sound issues and structure modifications

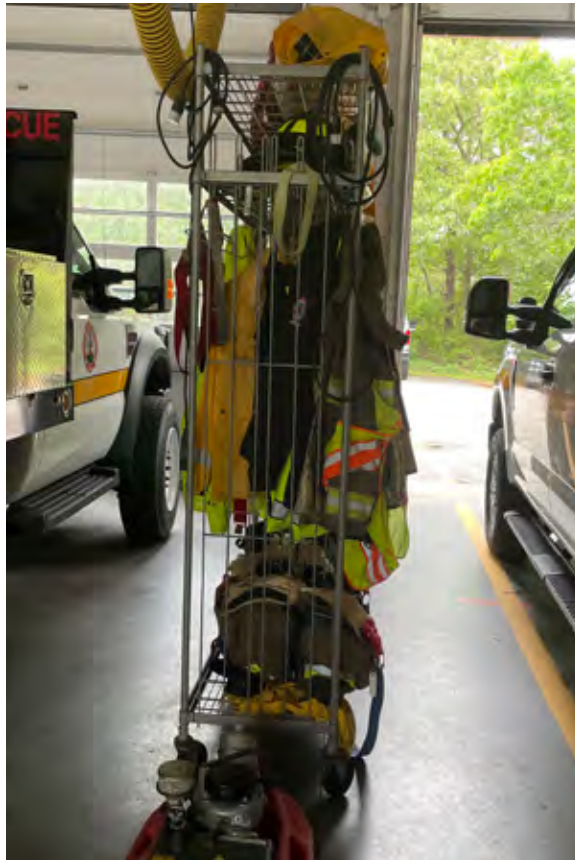
Turnout gear is stored in unsafe conditions in the apparatus bays and does not conform to NFPA standards
