# TOWN OF ORLEANS

# FIRE STATION FEASIBILITY STUDY

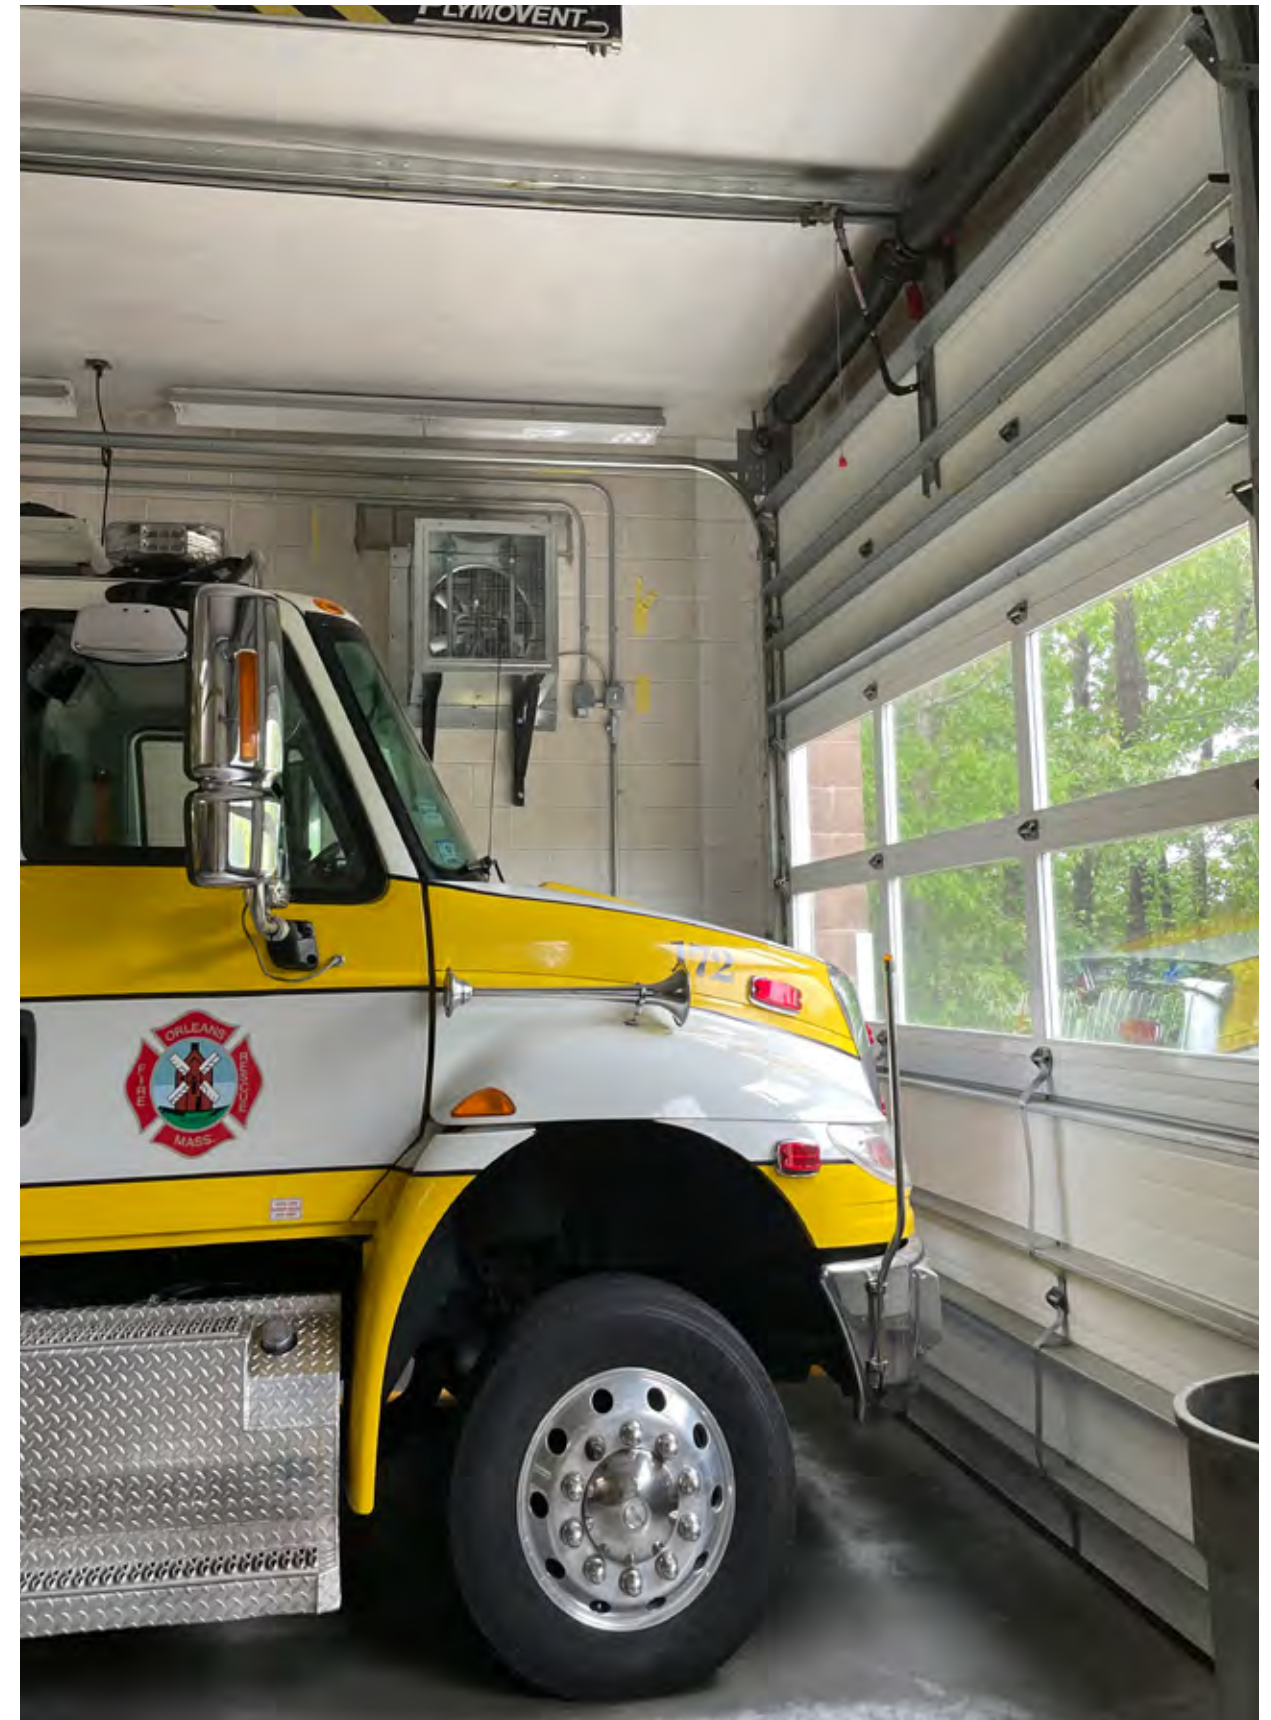
Turnout gear is stored in unsafe conditions in the apparatus bays and does not conform to NFPA standards

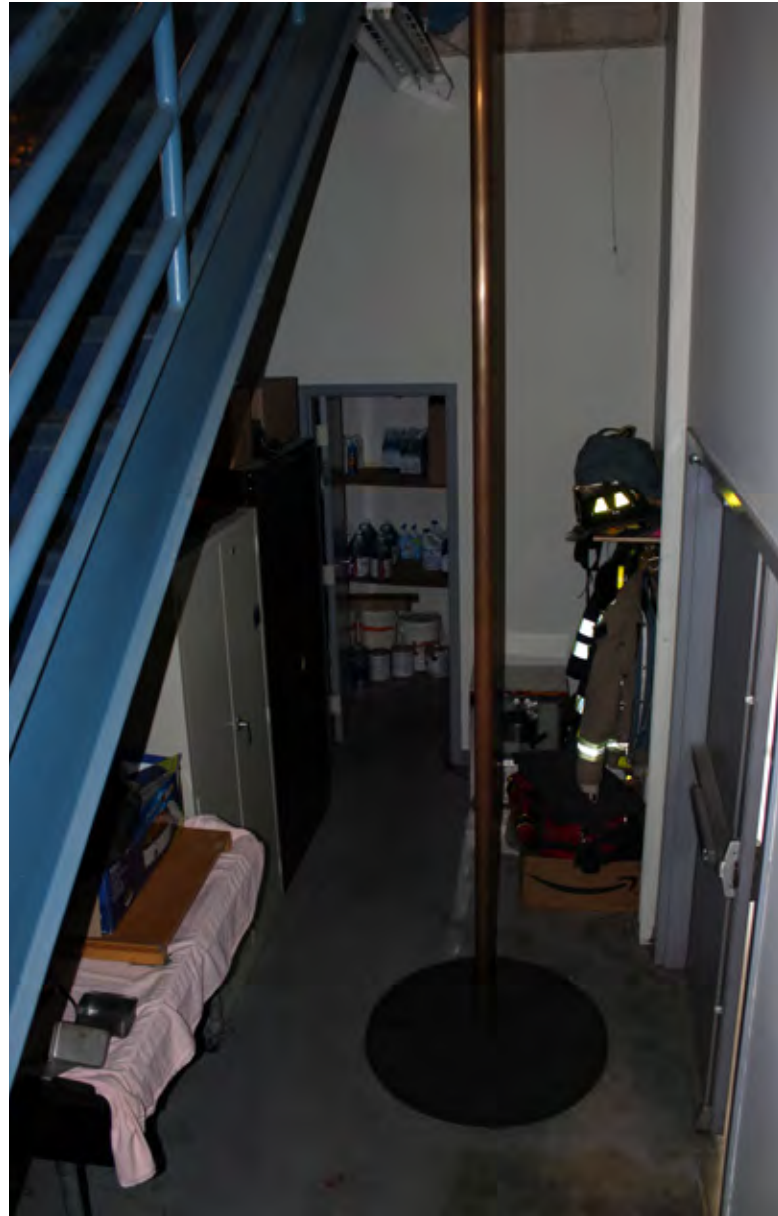
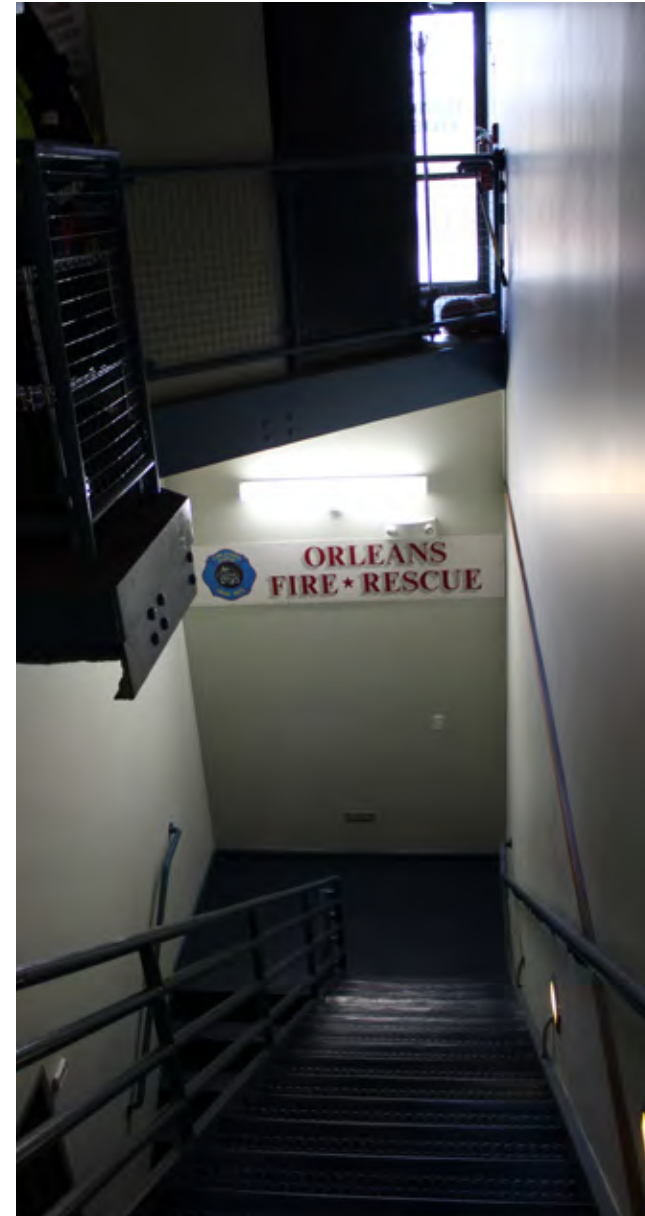
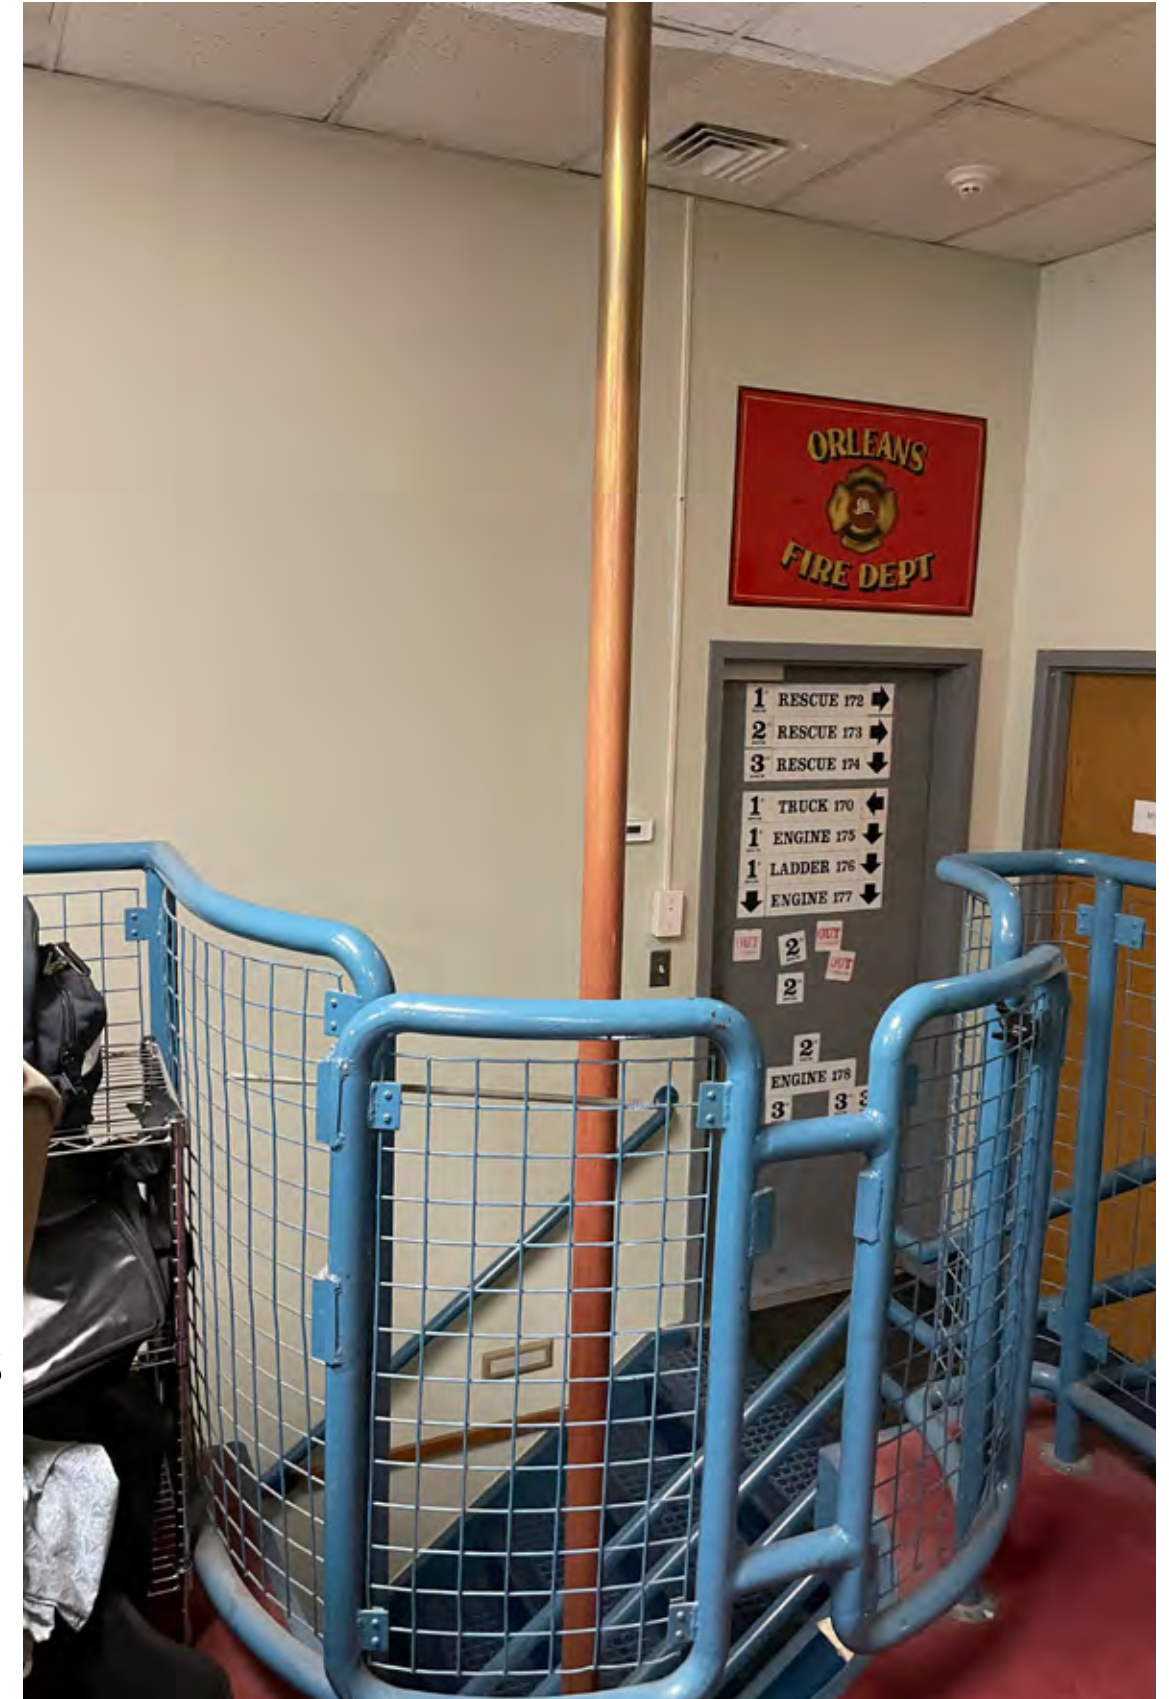
- No air separation between the apparatus bay and the living quarters
- Pole does not meet safety guidelines
- Pole is not used and is a space waster

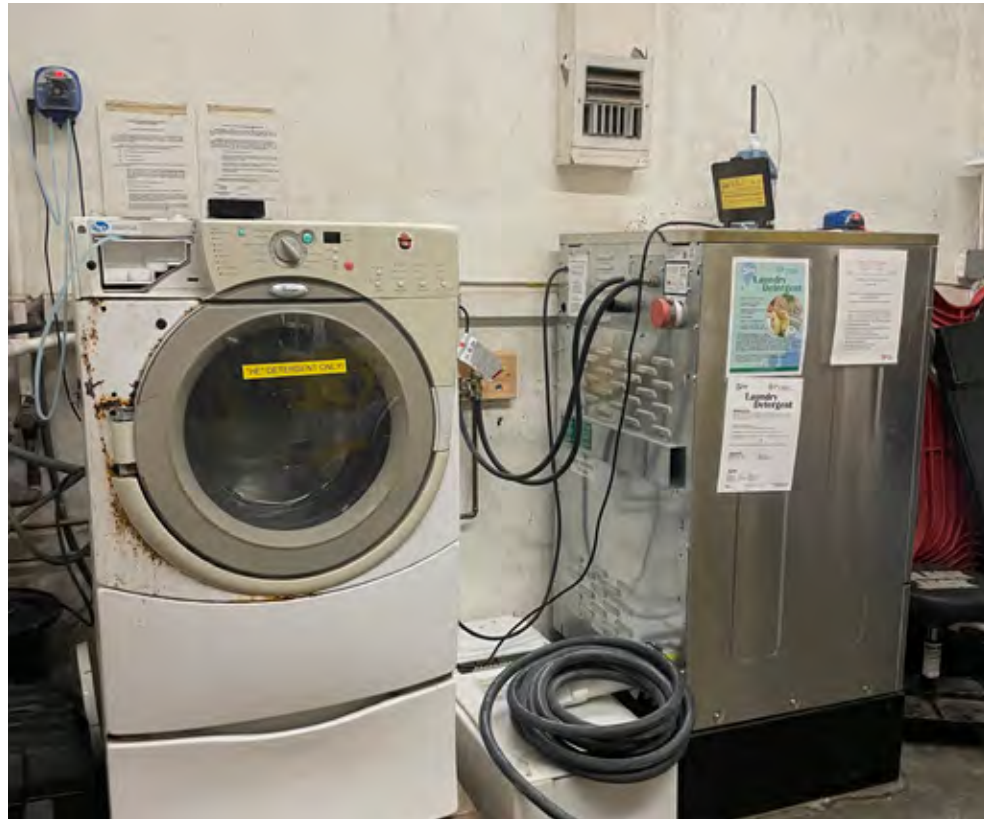
## Lower Apparatus Bay Issues

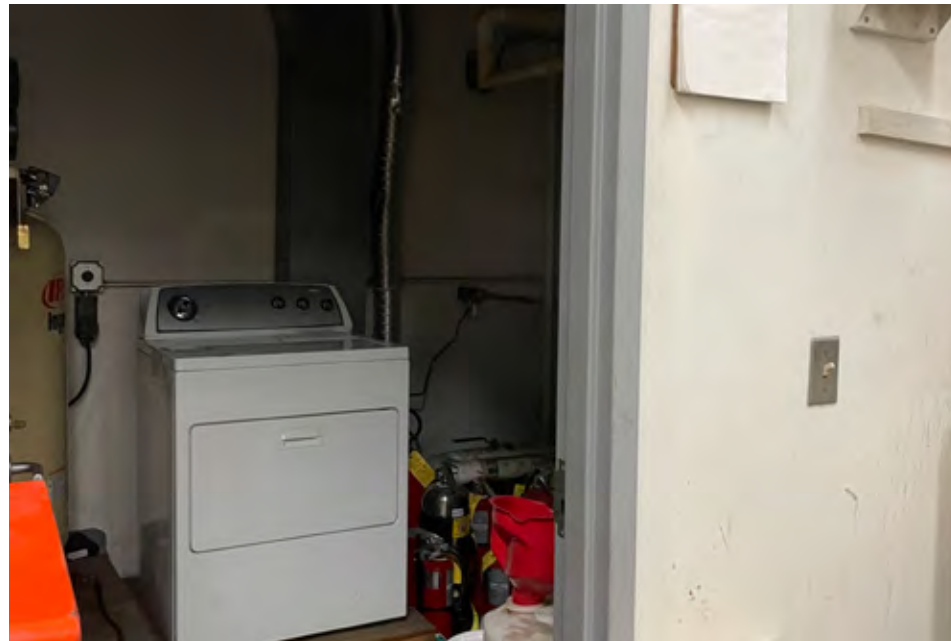
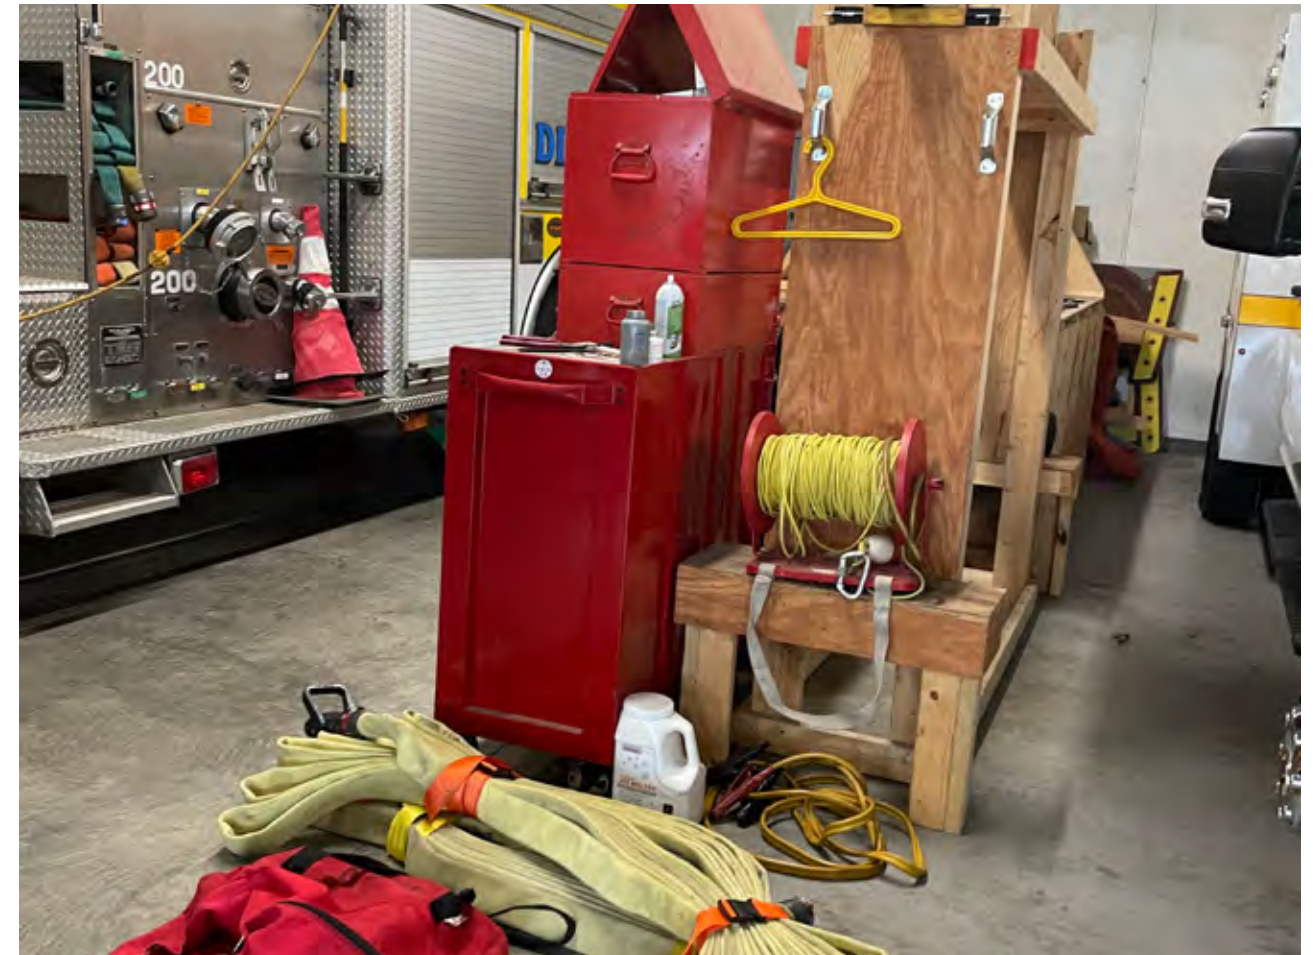
- Inadequate and not isolated laundry facilities
- Inadequate repair space
- No proper ventilation
- Inadequate plumbing services

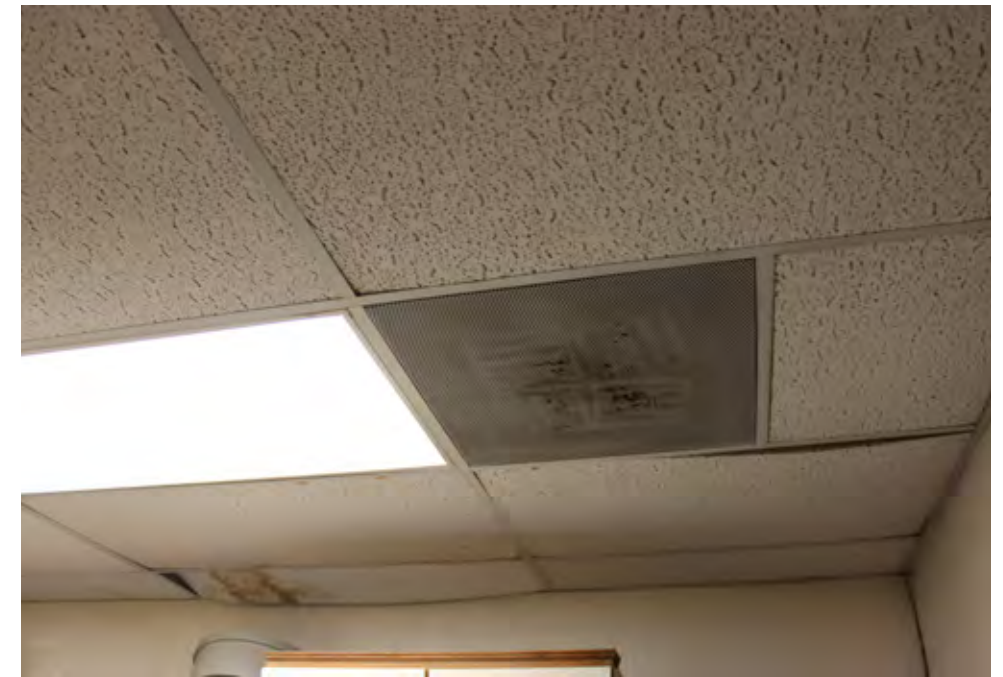
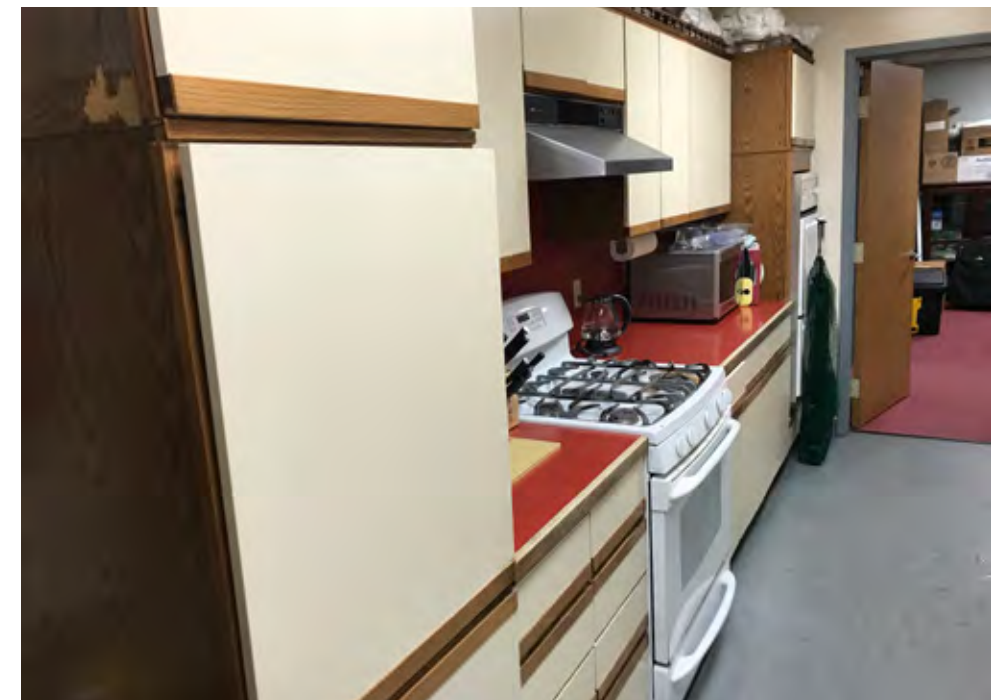
- Inadequate Facilities
- Outdated and outgrown
- Not MAAB Compliant

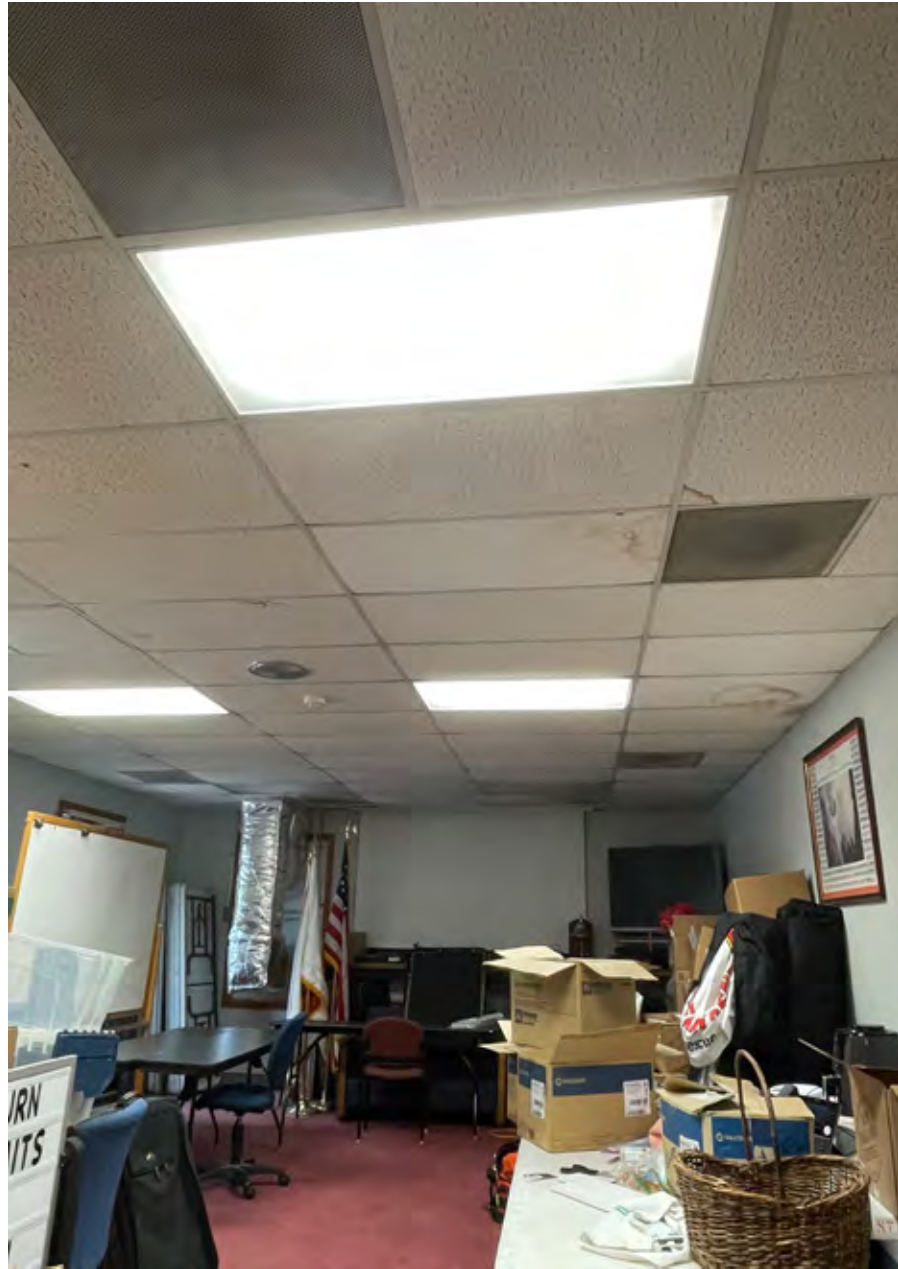
Training/Meeting Room currently serves primarily as storage. Space needed for station meetings/back up Emergency Operations Center

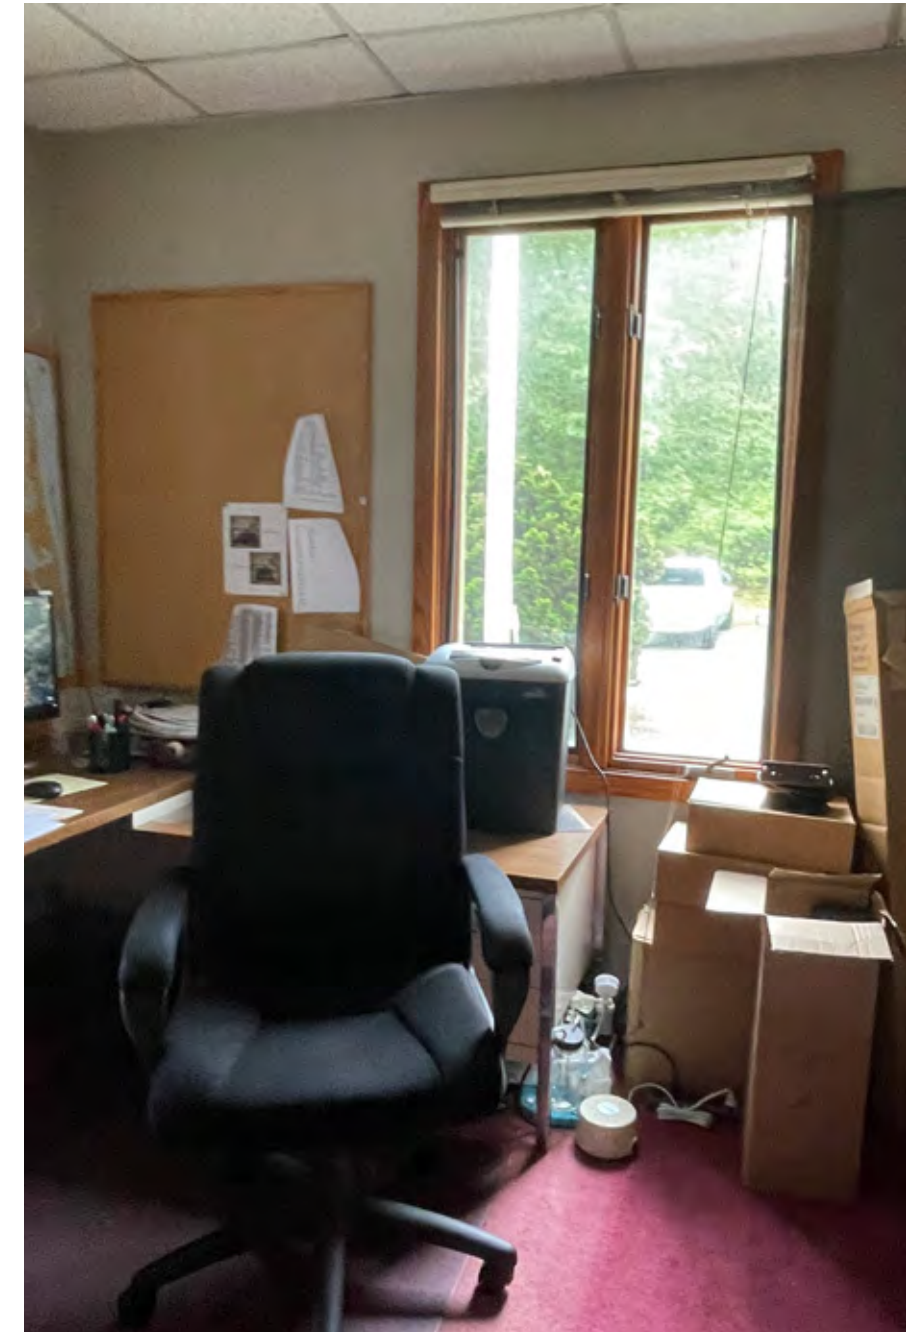
Office space crowded with stored equipment and supplies

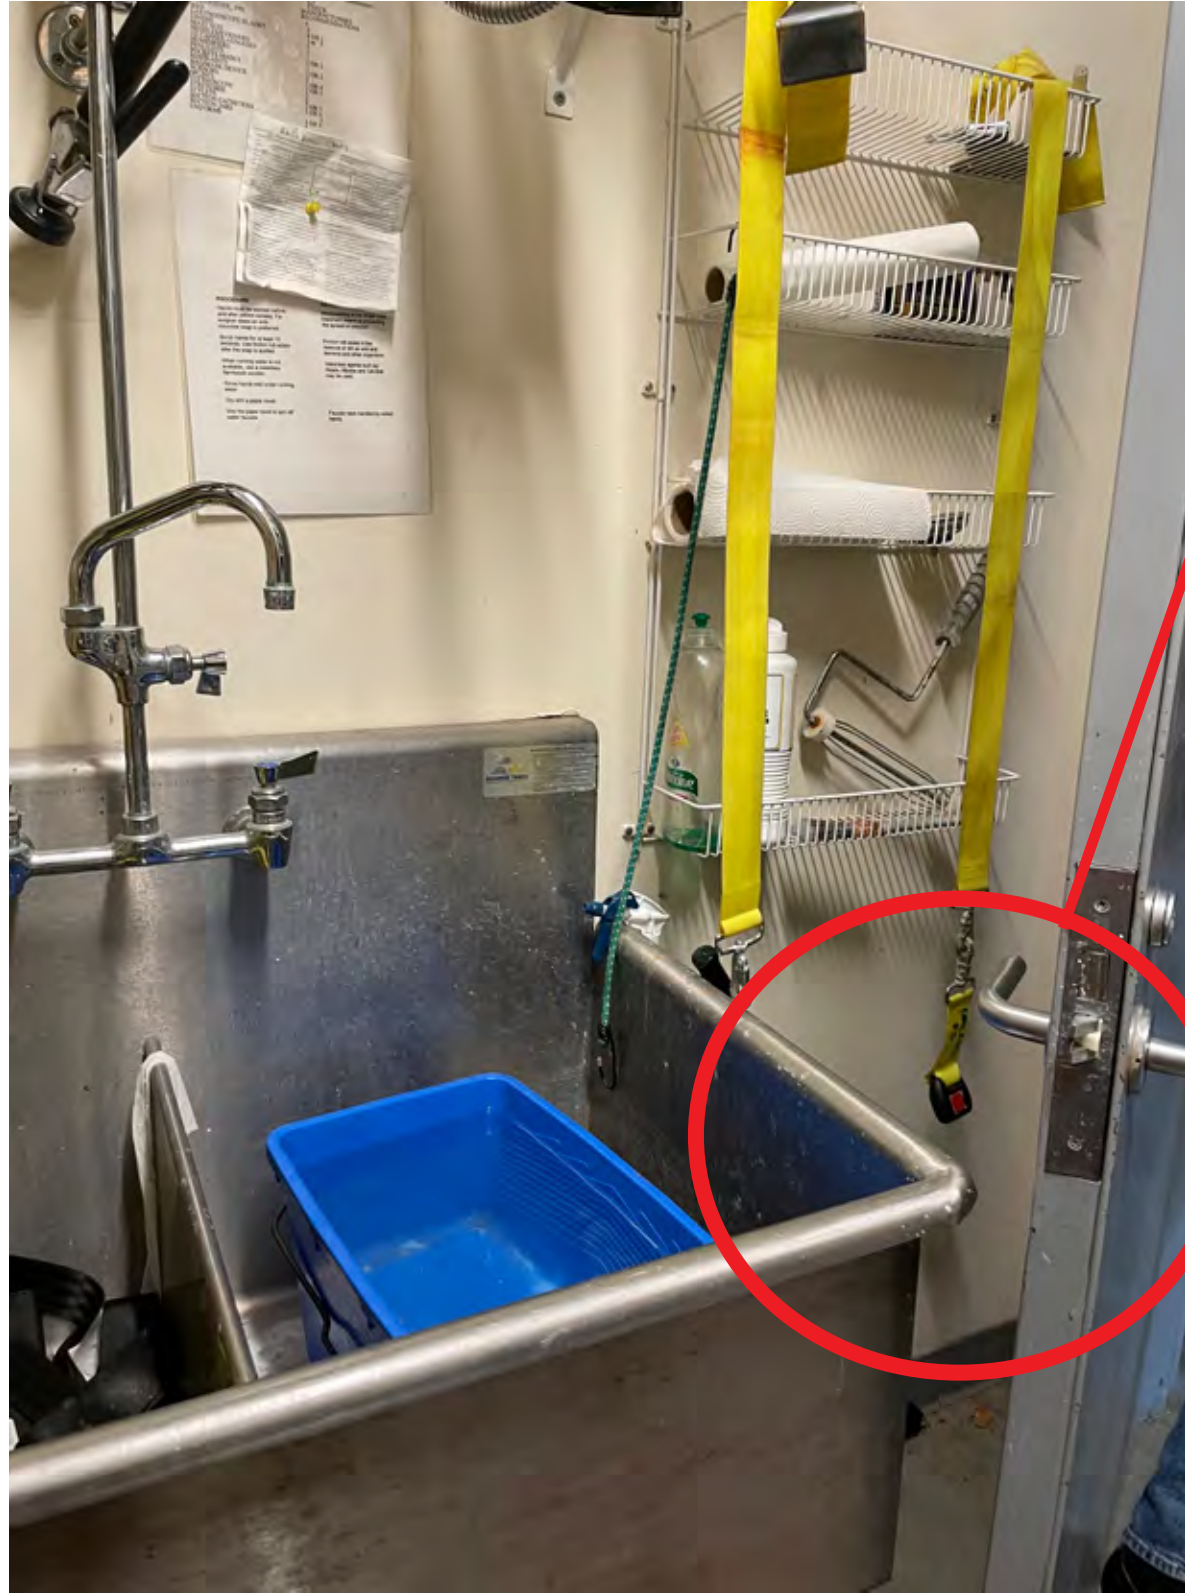
EMS Supply Room was retrofitted with a sink. Because of crowded conditions door can not fully open.

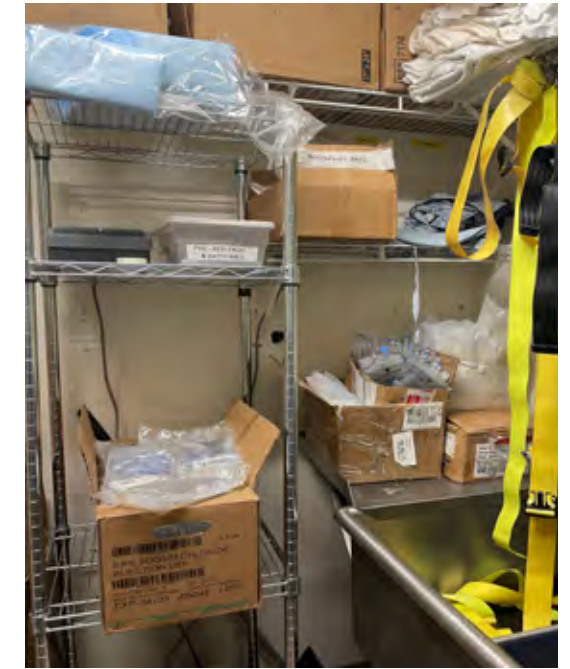
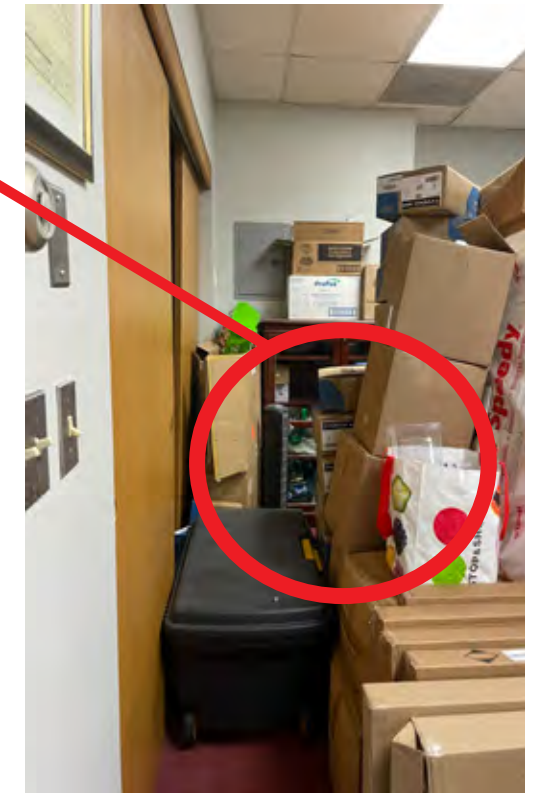
Storage found throughout the building in non-designated areas including in the dayroom, under stairs, and on top of cupboards

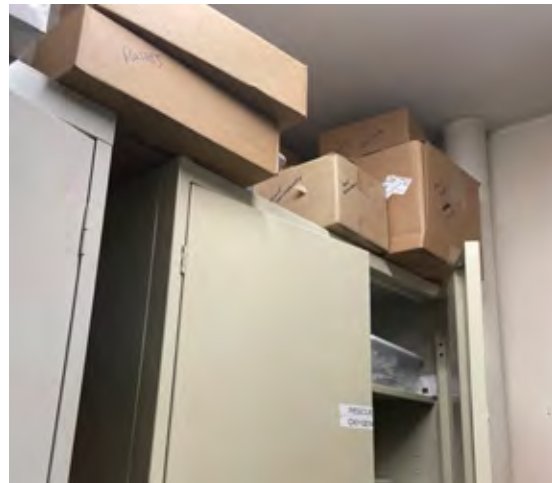
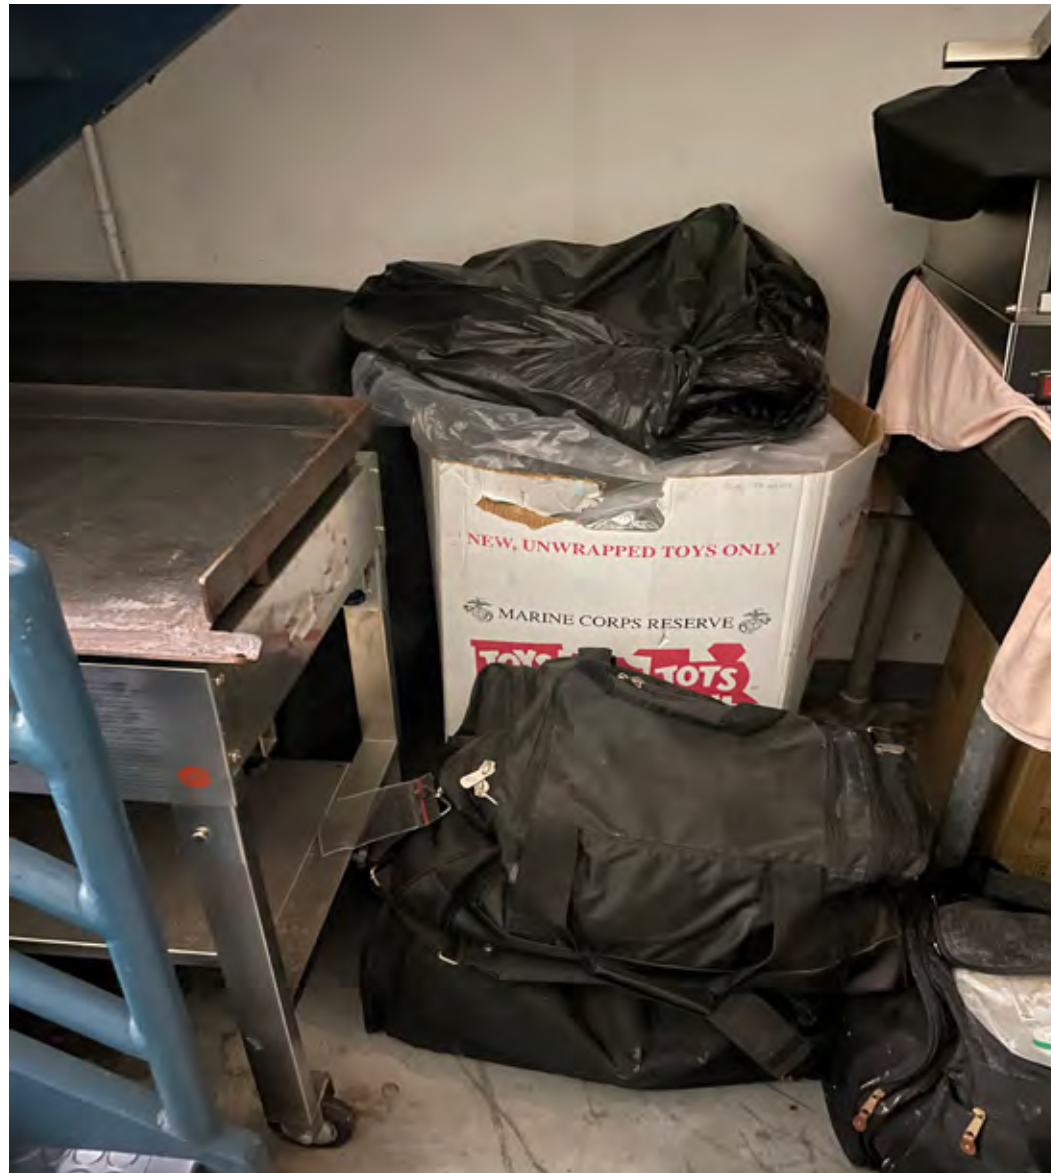
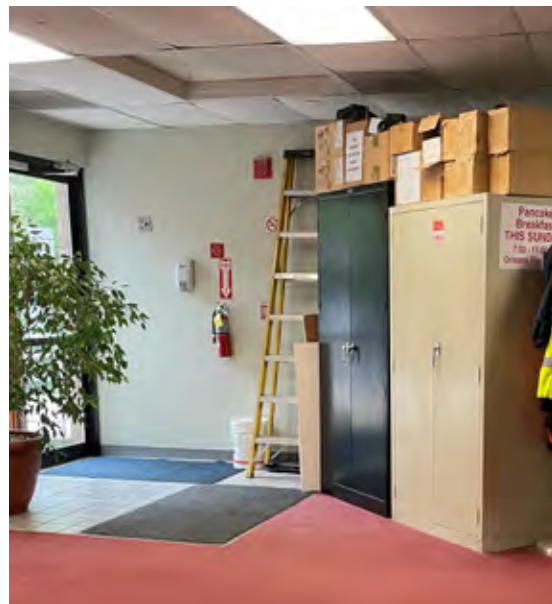
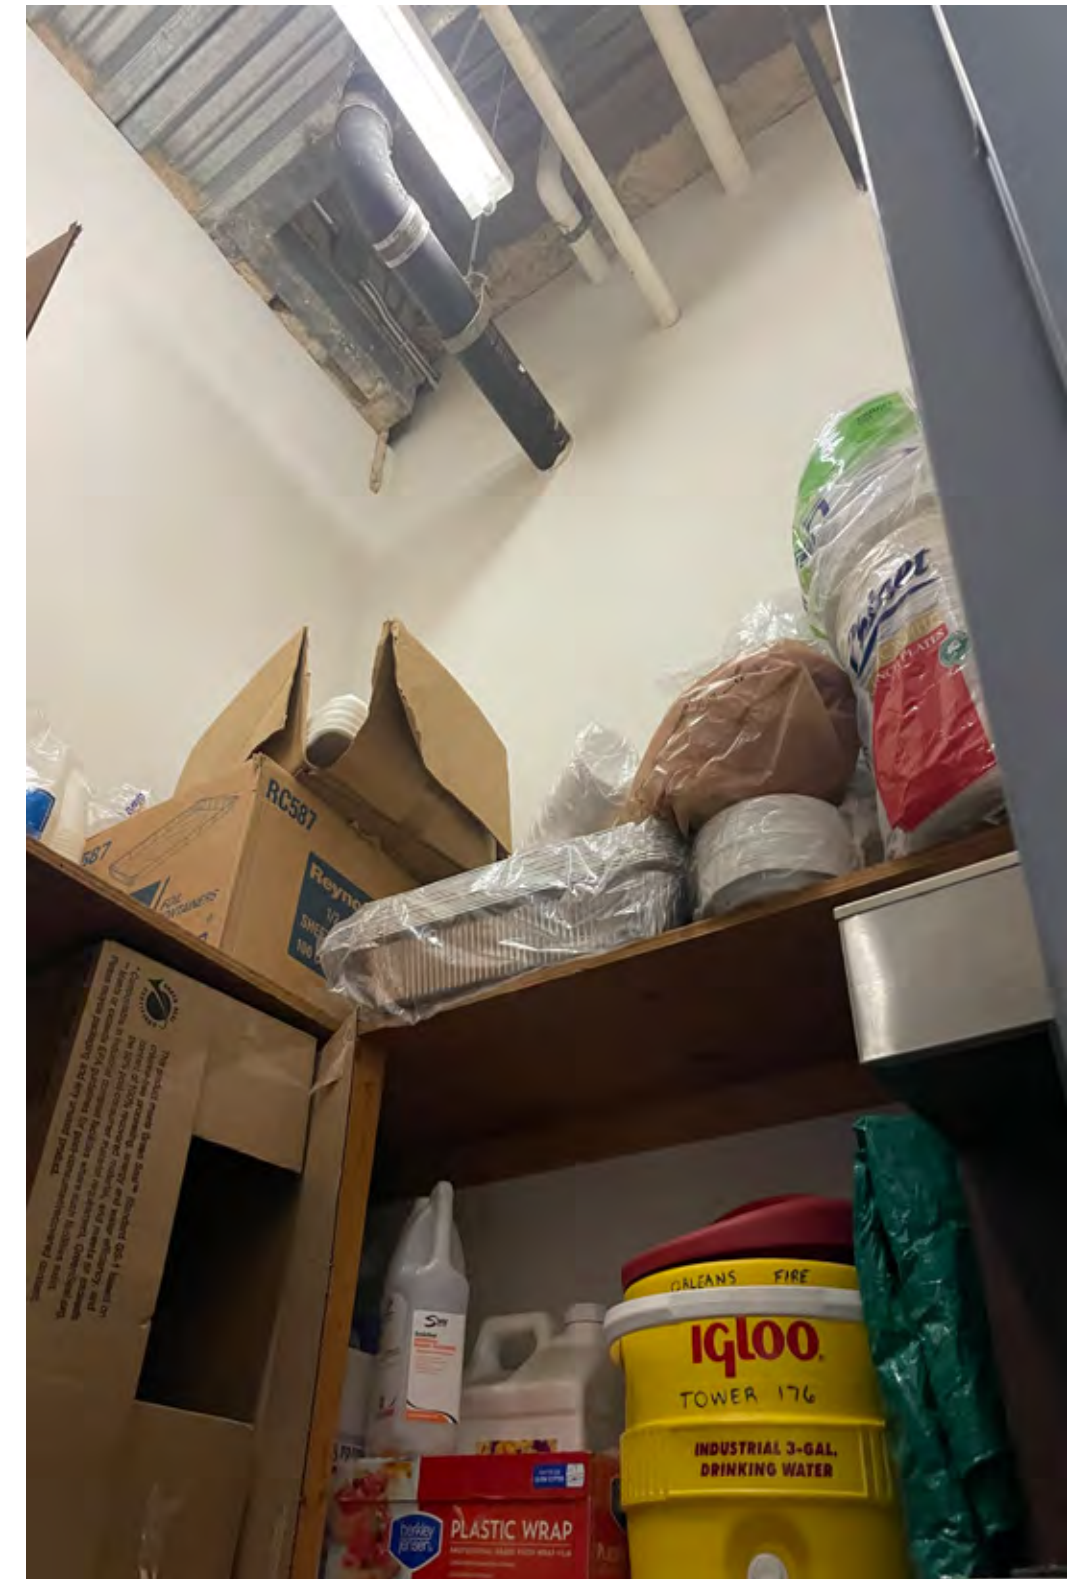
Town	Chatham	Brewster	Wellfleet	Harwich	Dennis	Orleans
Population - 2019	5,982	9,775	3,481	12,142	13,871	5,788
Est. Summer Population	35,000	20,000	16,000	63,000	63,000	20,000
Current Fire Station • Area	21,184 SF	22,500 SF	18,662 SF	Station #2 9,500 SF	Station #2 21,922 SF	11,500 SF
• Cost	\$10.6 million	\$13.5 million	\$5.5 million	\$6.75 million	Estimate \$14 million	
• Built	2016	2018	2009	2018	Projected 2022	1987
Total # of Calls 2020	2,785	2,644	1,152	4,351	5,030	2,364
Personnel/Station	32 Personnel 1 Station	31 Personnel 1 Station	18 Personnel 1 Station	31 Personnel 2 Stations	55 Personnel 2 Stations	34 Personnel 1 Station
Size Acres(est)	1.75	2.5	1.35	1.0	3.0	1.5

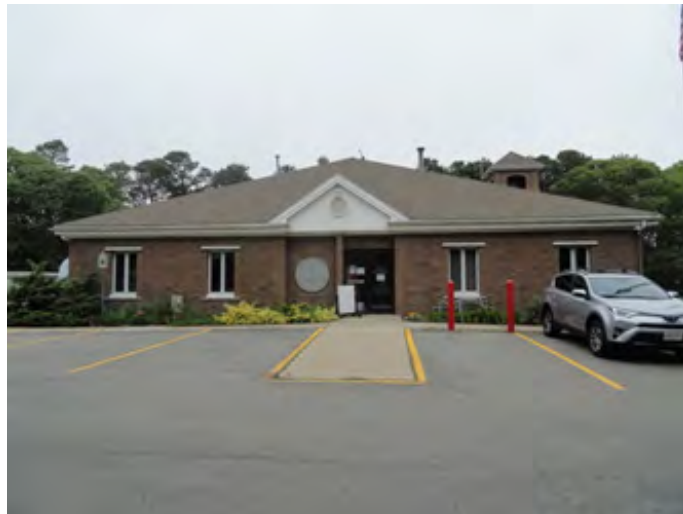
Photo #1 Building South Elevation  
Main Entrance at the 1st Floor

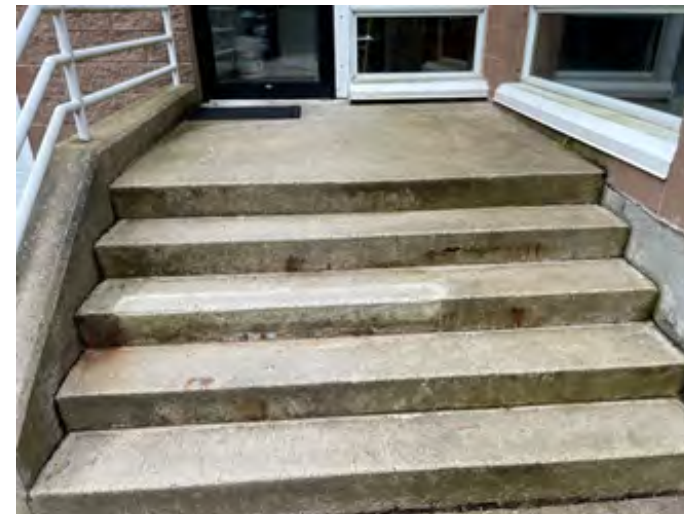
Photo #4 Building West Elevation  
Concrete steps with minor cracks and surface  
rusting observed

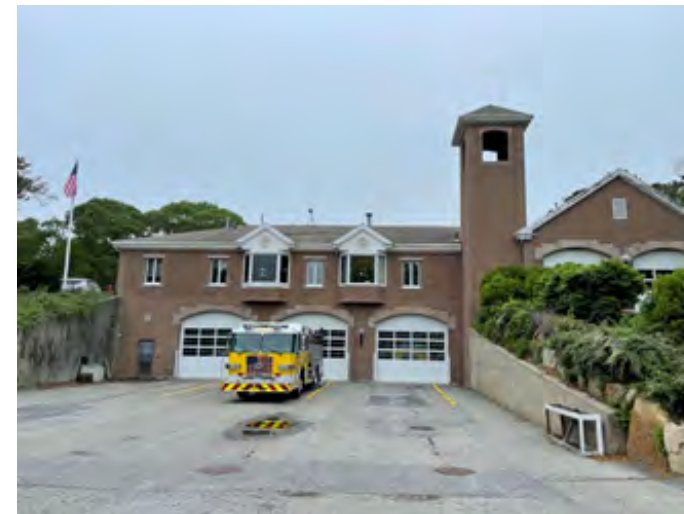
Photo #7 Building East Elevation  
Hose Tower and the Main Apparatus Garage  
Doors at the basement level

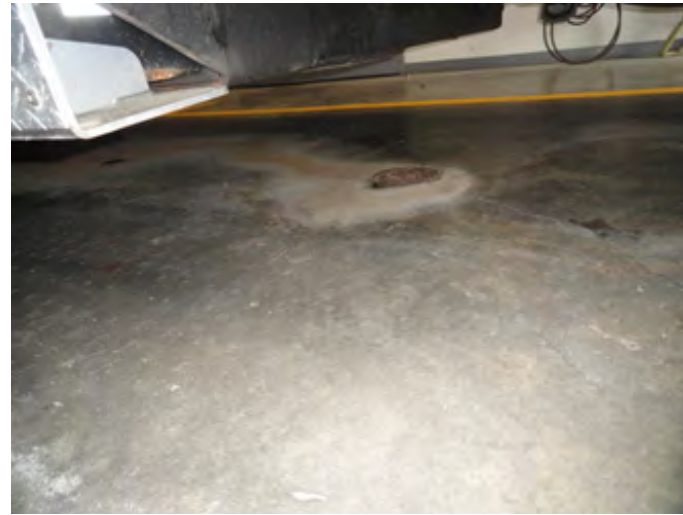
Photo #10 Basement Apparatus Room slab  
Shrinkage cracks at the front north bay

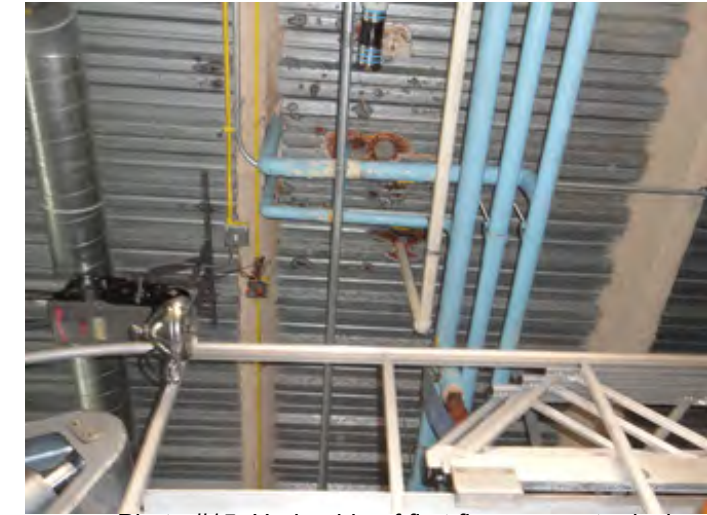
Photo #15 Underside of first floor concrete deck  
above the apparatus front north bay  
Surface rust is observed at the steel deck and  
floor penetrations

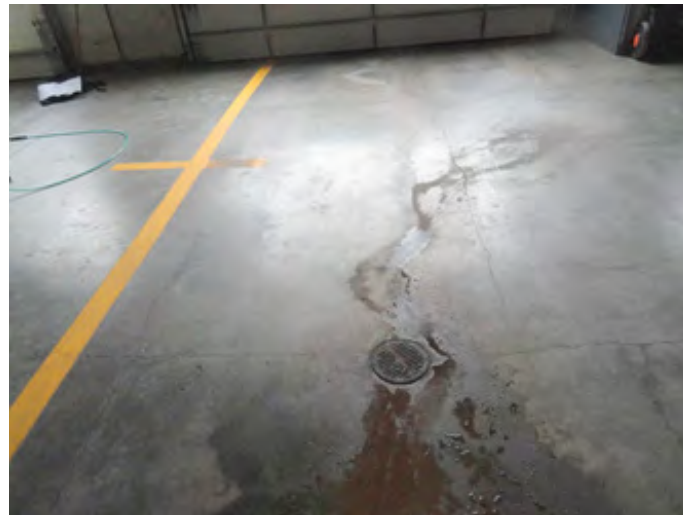
Photo #11 Basement Apparatus Room slab  
Shrinkage cracks at the front middle bay

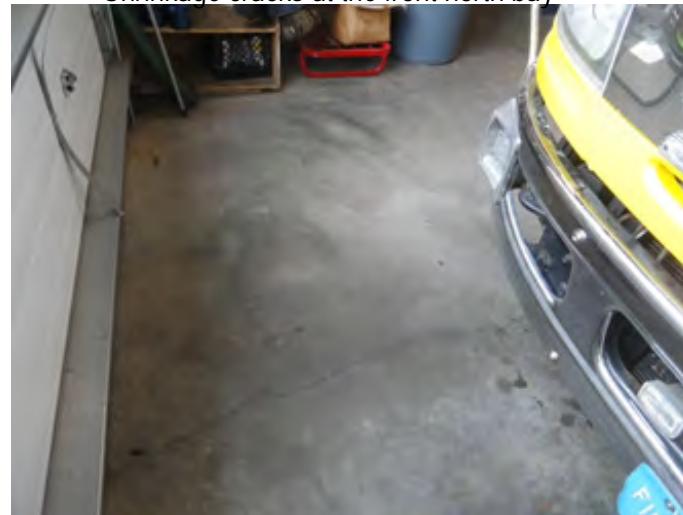
Photo #12 Basement Apparatus Room slab  
Shrinkage cracks at the front south bay

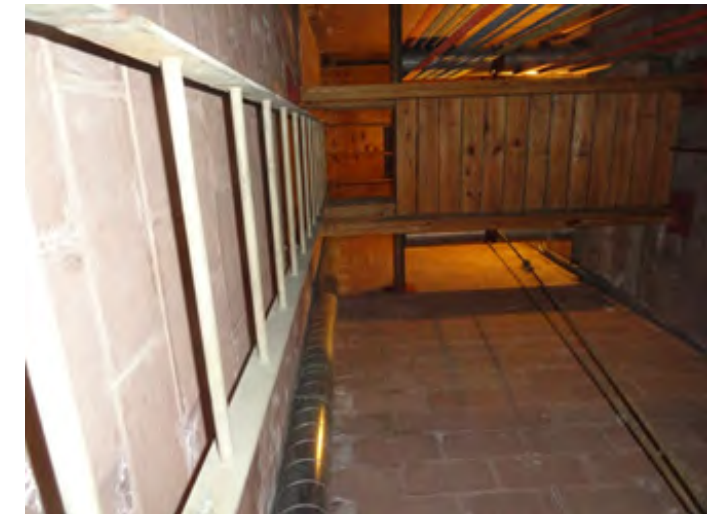
Photo #16 Hose Tower - interior masonry

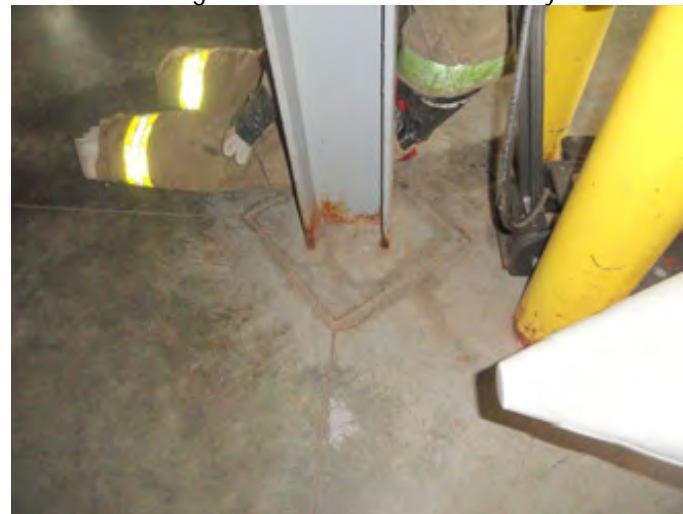
Photo #14 Basement Apparatus Room Surface rust is  
observed at the bottom of the steel column

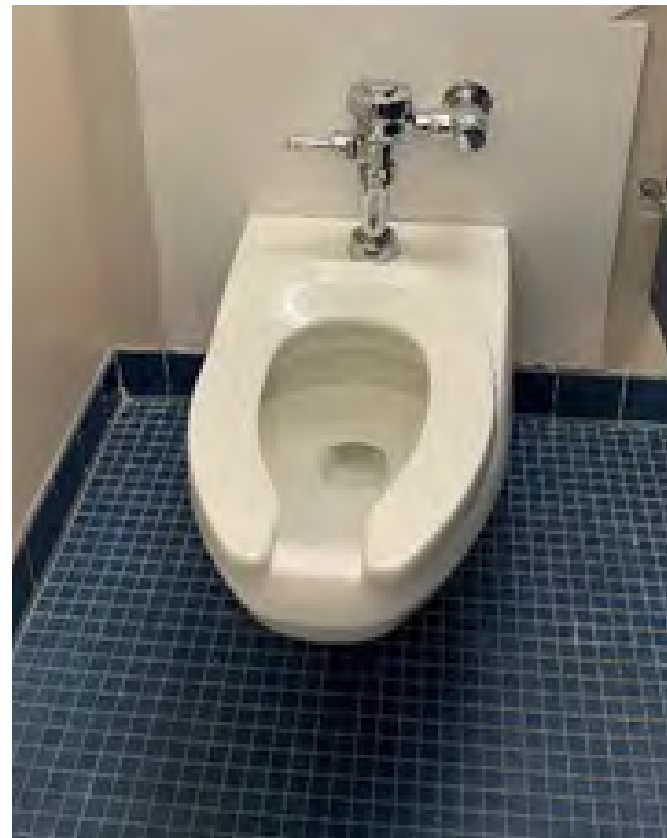
Existing Water Closet
