# TOWN OF ORLEANS

# FIRE STATION FEASIBILITY STUDY

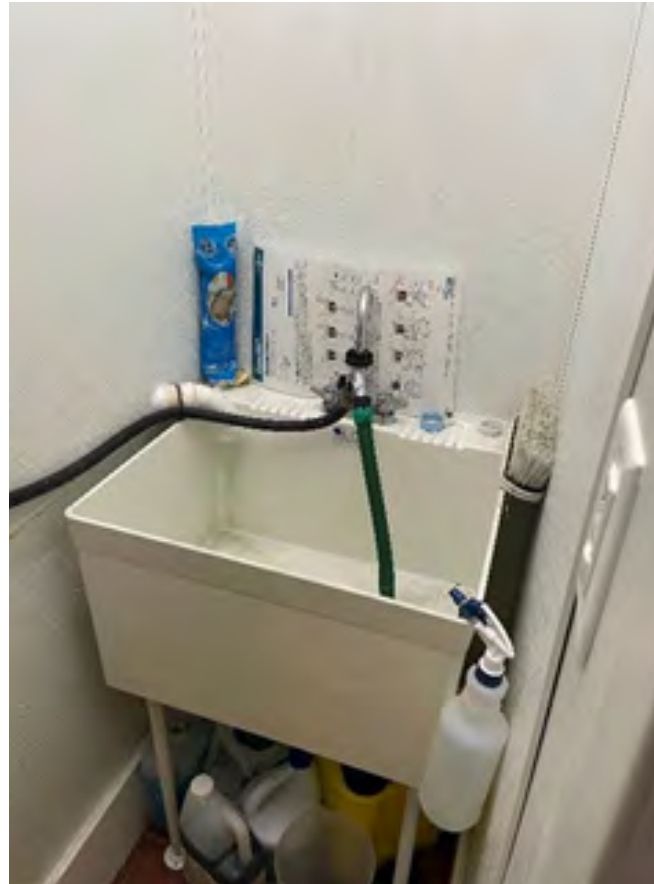
4. Janitor's Sink: The janitor's sink is a laundry tub style with two lever faucets. The sink is in good condition but space is tight inside the room with number of chemicals and cleaning supplies. The sink is provided with a cleaning chemical dispensing unit mounted on the wall. There is no testable backflow preventer installed between the unit and the water supply in order to protect the water supply from contamination. It is recommended to install a testable backflow preventer.

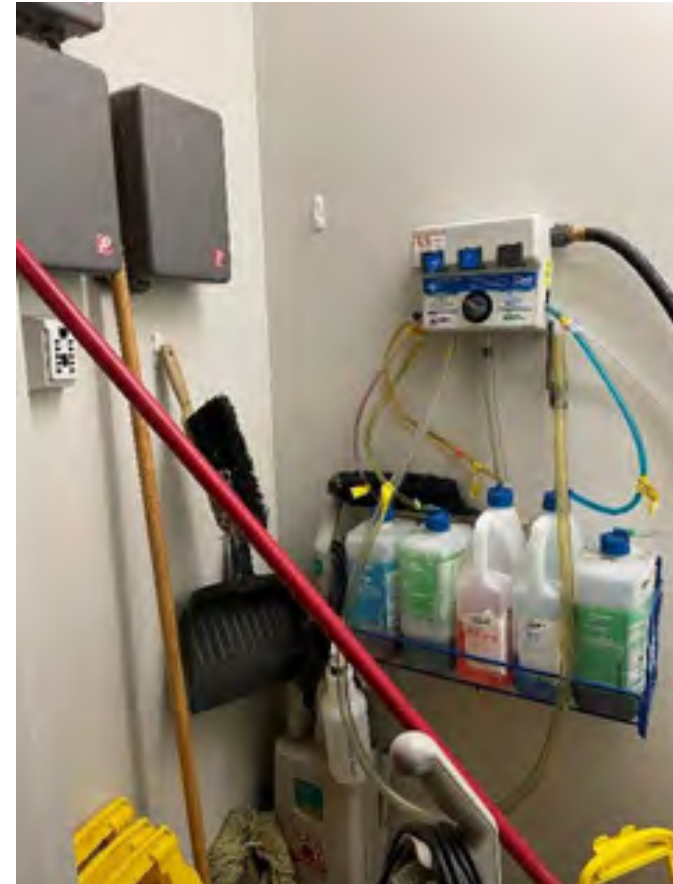
Chemical Dispensing Unit

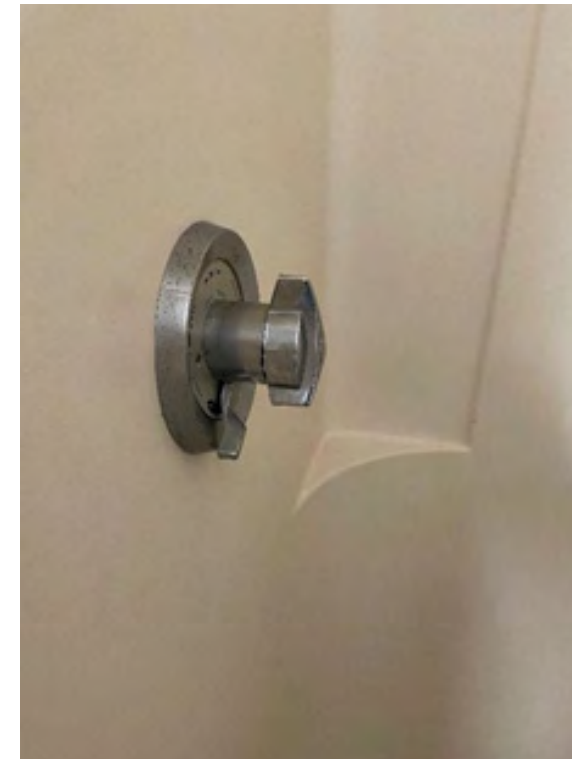
Existing Shower Valve

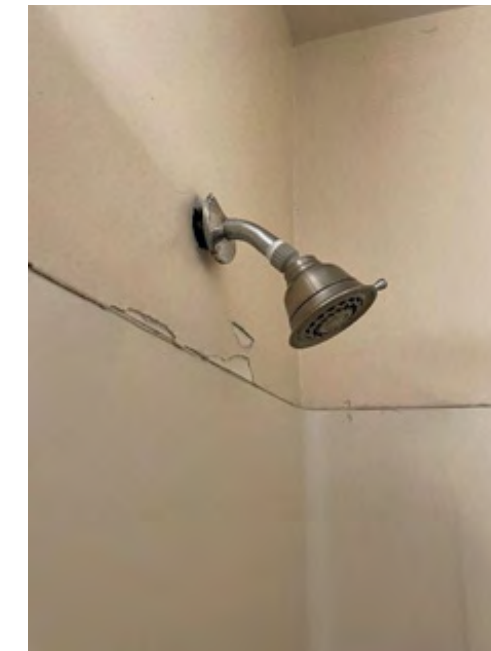
Existing Shower Head

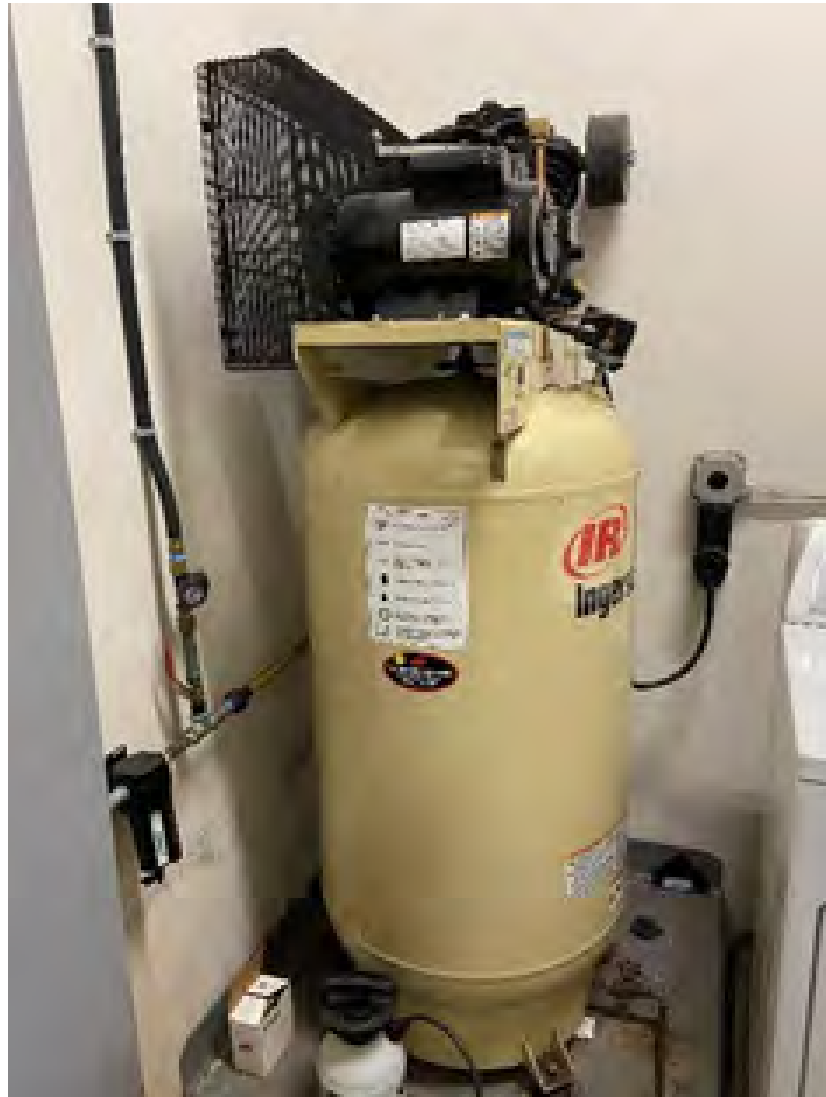
6. Air Compressor: An air compressor is provided for compressed air throughout the facility. The air compressor appears to be in good condition but there are no acoustical barriers between the compressor and washer/dryer room

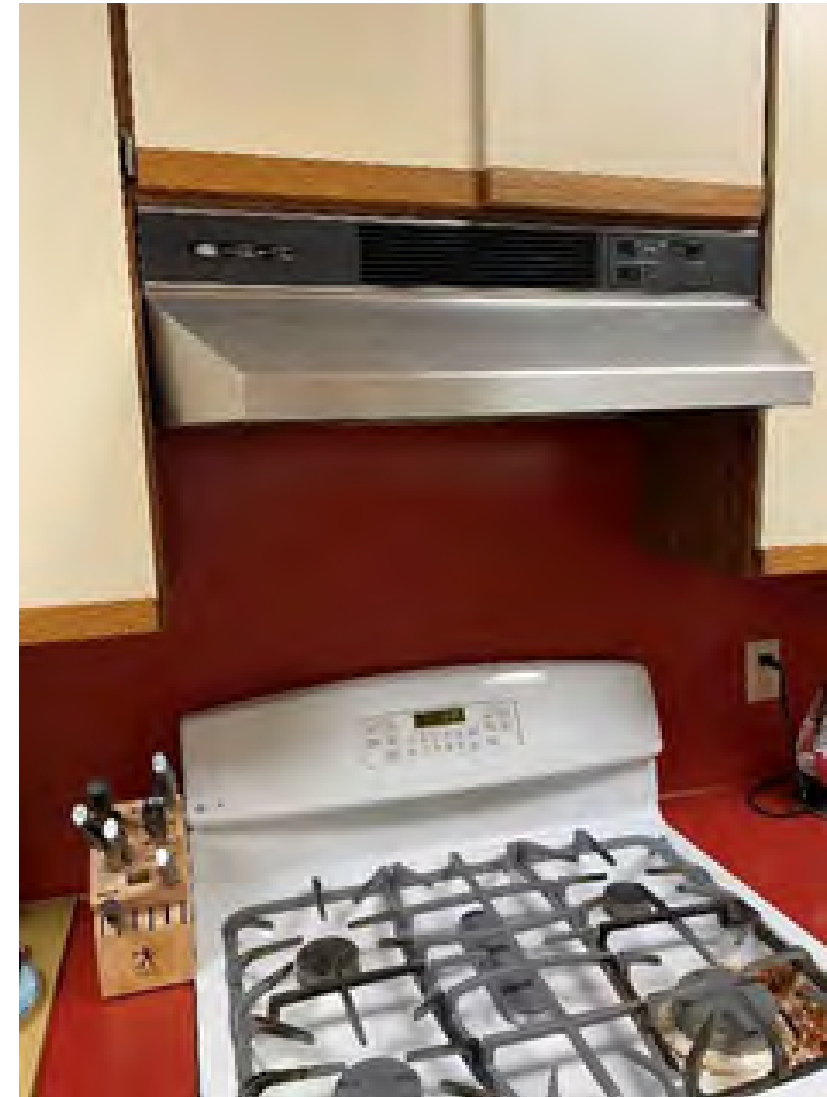
Kitchen Oven and Cooktop

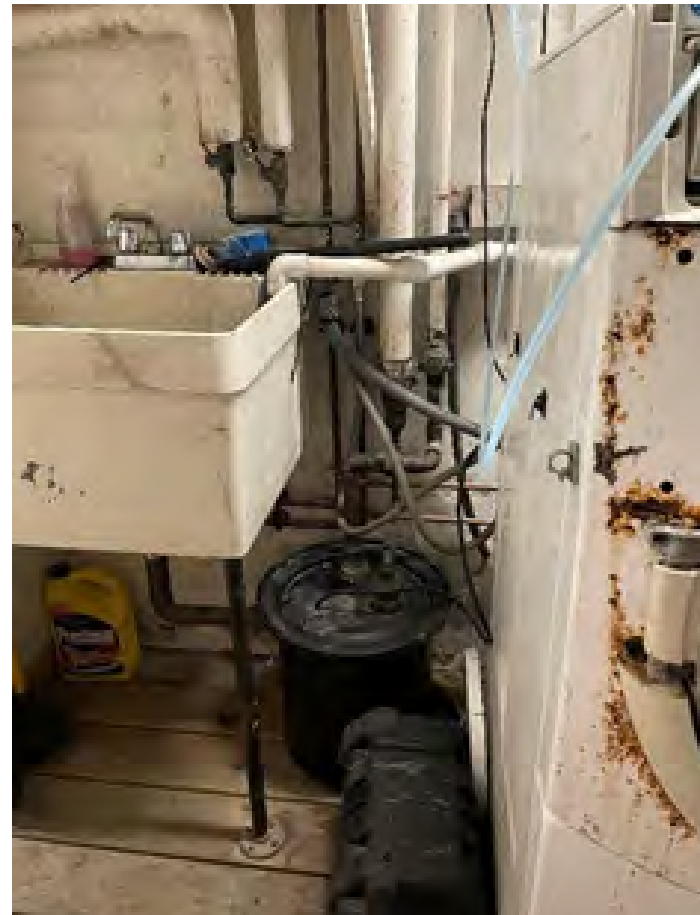
Ejector Pump for Laundry Tub

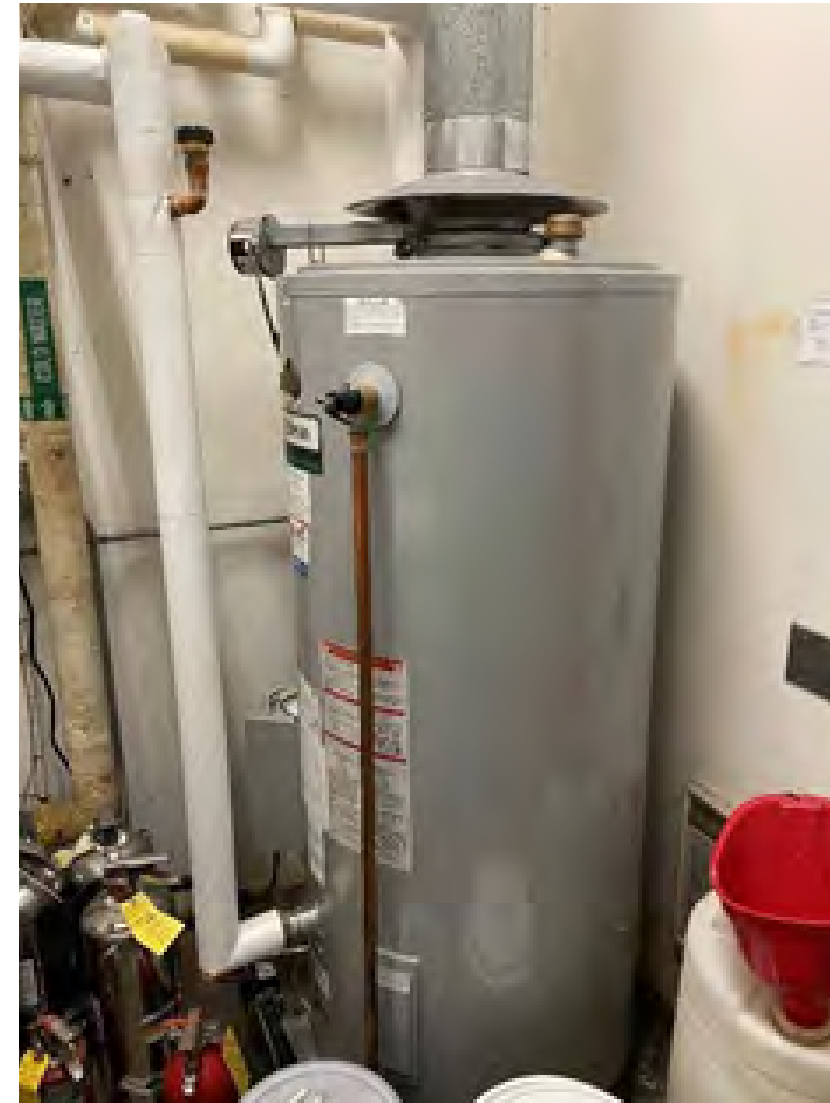
Gas Fired Water Heater

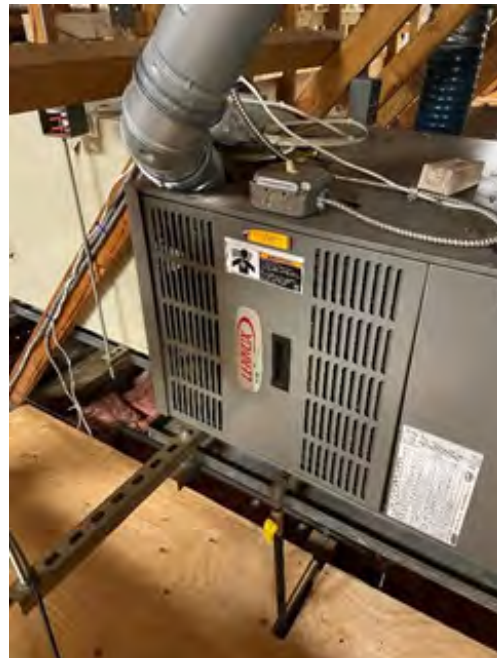
Furnace Unit in Attic Space

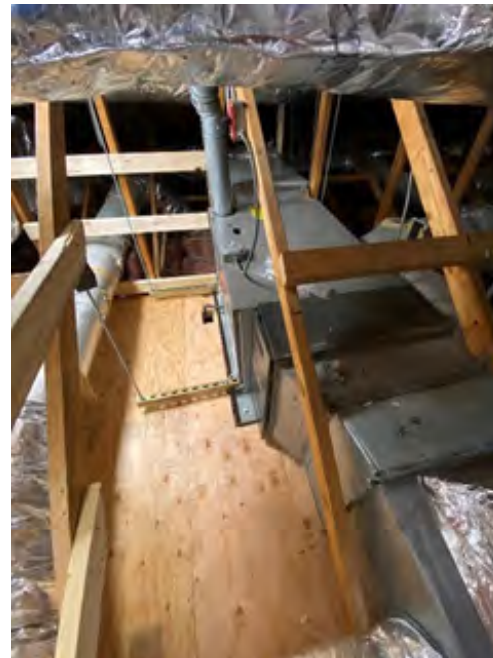
Furnace Unit in Attic Space

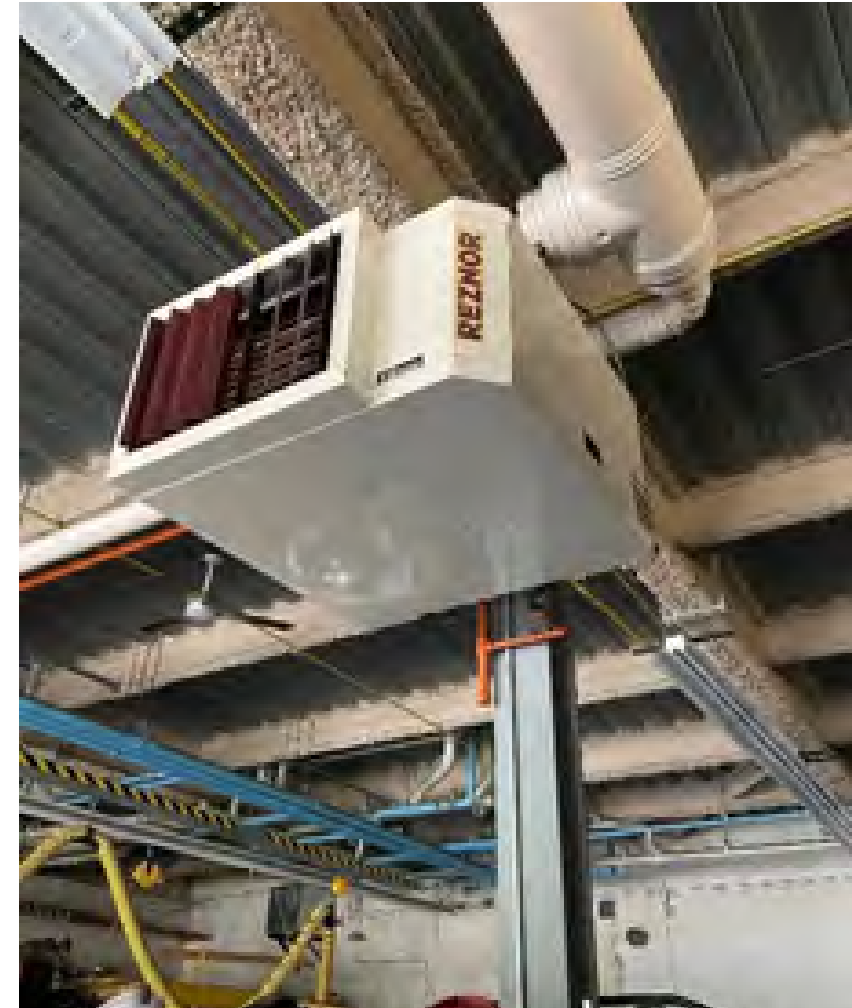
Gas Fired Unit Furnace

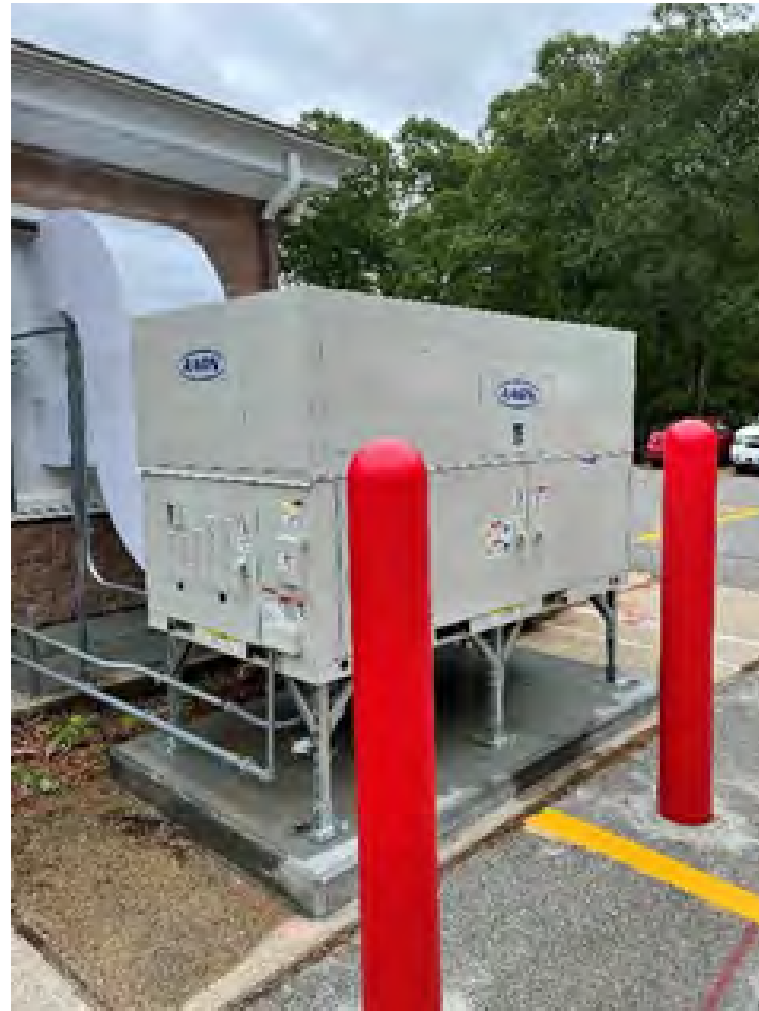
Outdoor Energy Recovery Ventilator (ERV)

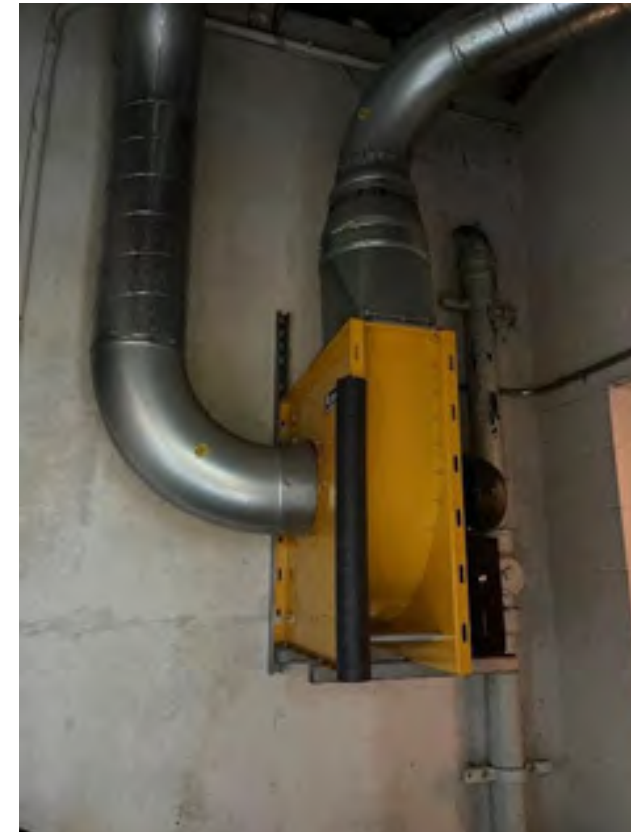
Plymovent Exhaust Fan

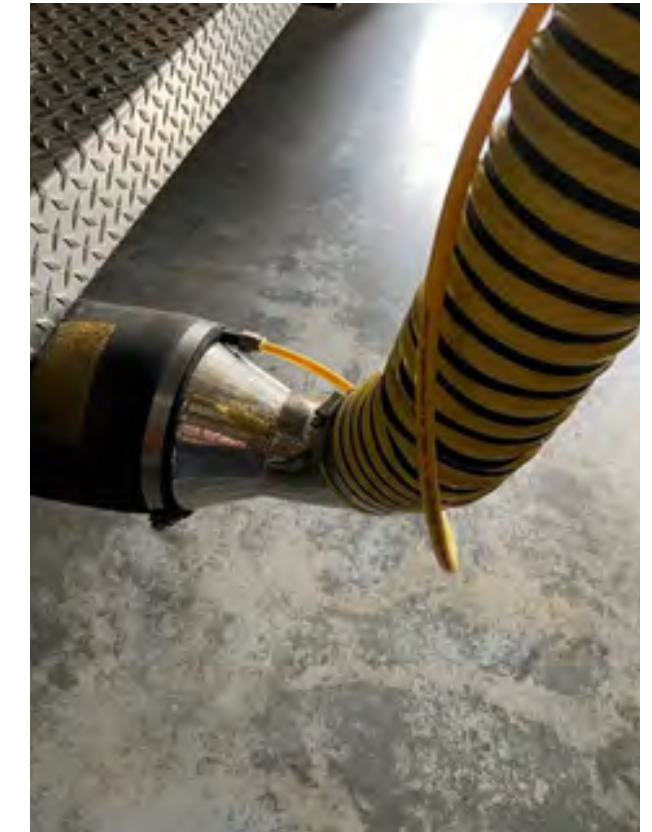
Vehicle Exhaust Pneumatic Grabber

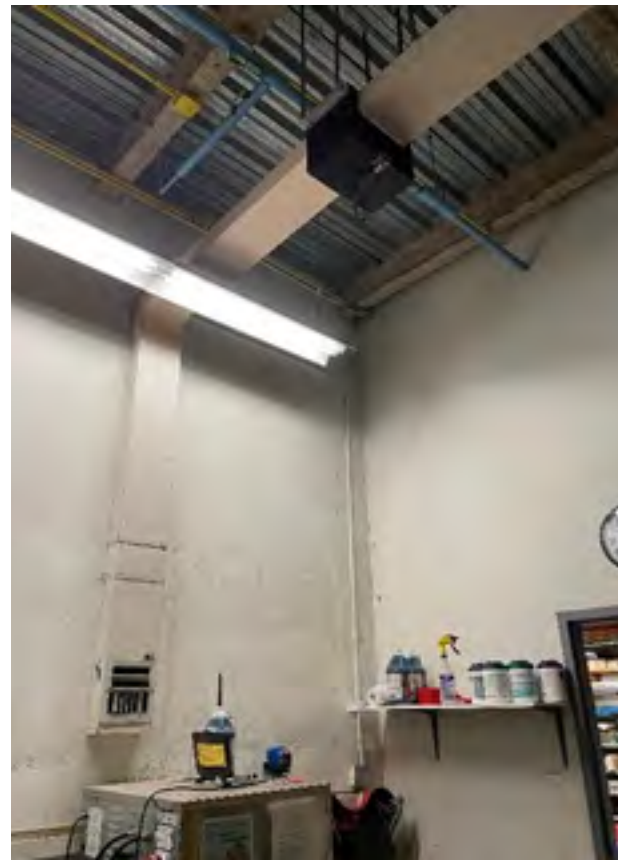
Washing Machine Area Exhaust Fan

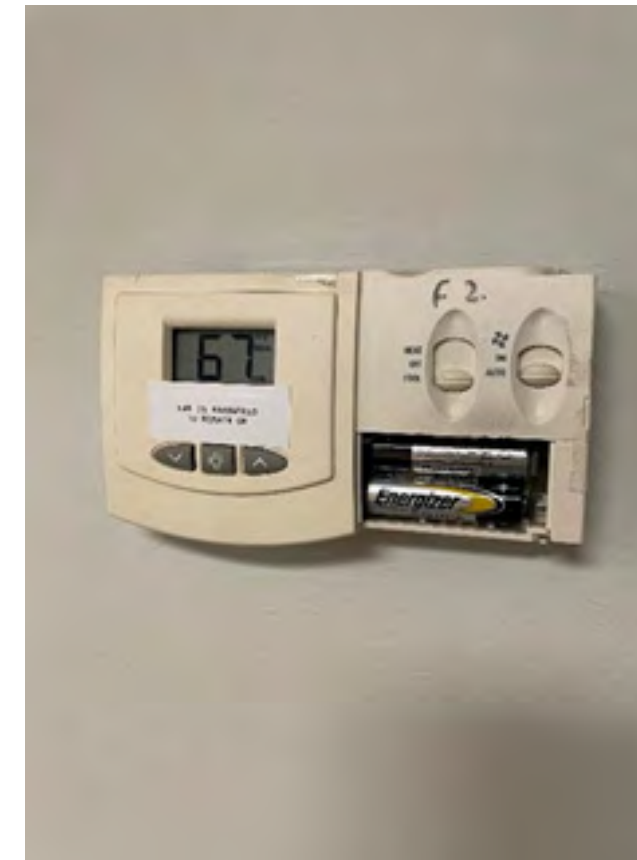
1. Each furnace is provided with local thermostats in the space. There is currently no centralized building management system at the facility. Thermostats do not appear to have energy saving controls. It is recommended that these be replaced with programmable thermostats at a minimum. The ideal solution is to bring in a building management system (BMS) for the overall building for better control and energy efficiency.

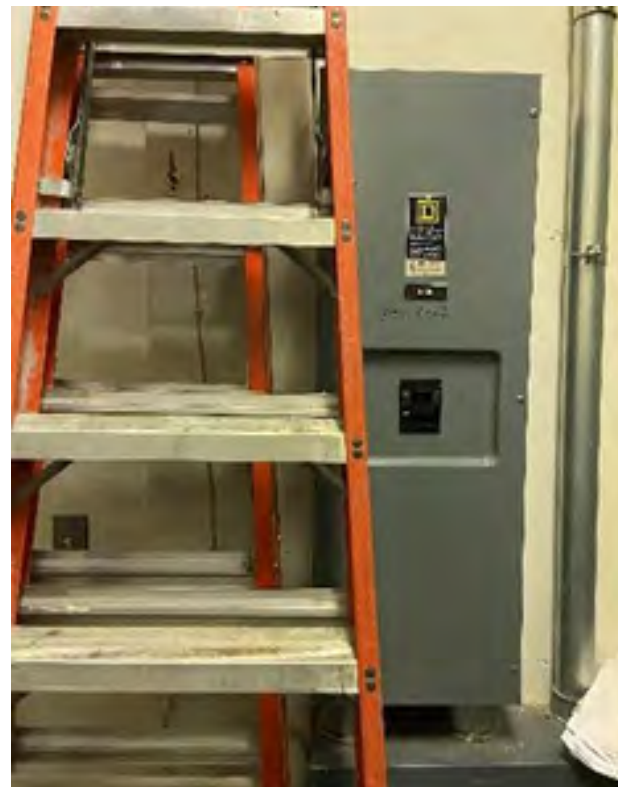
Electrical Service Equipment

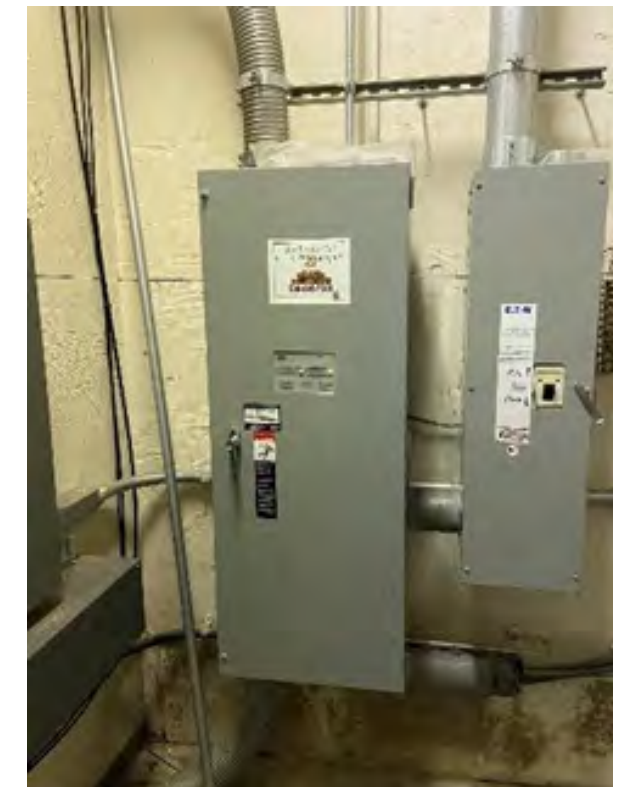
Automatic Transfer Switch

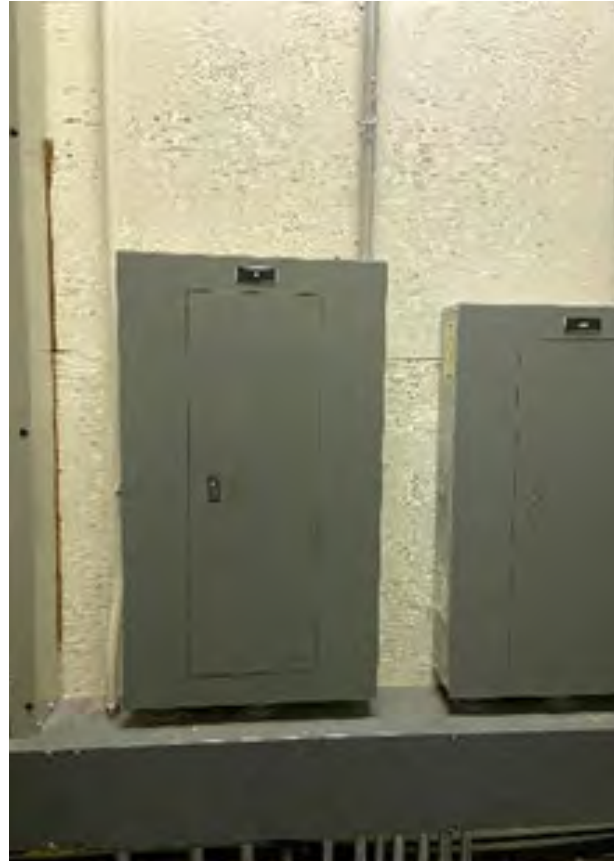
Older Electrical Panels

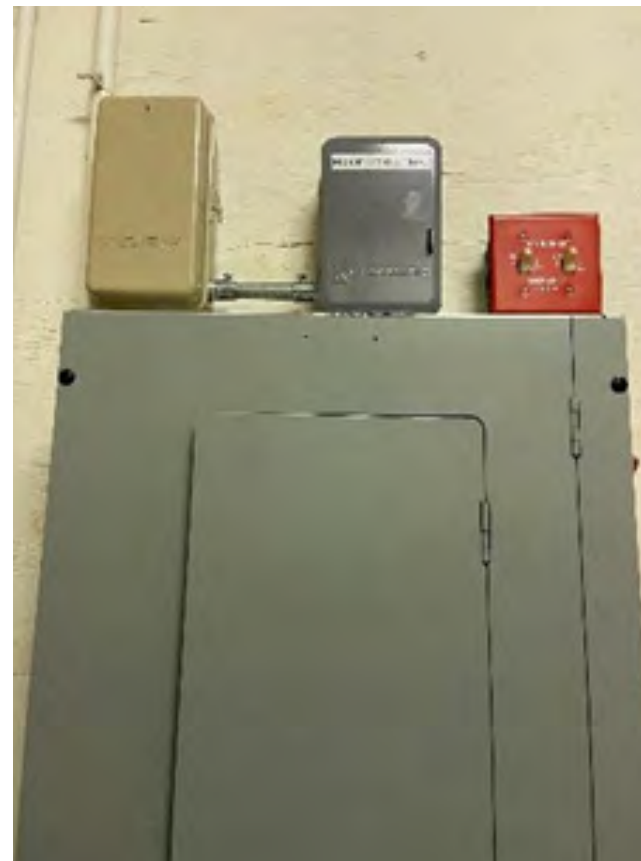
Newer Electrical Panel

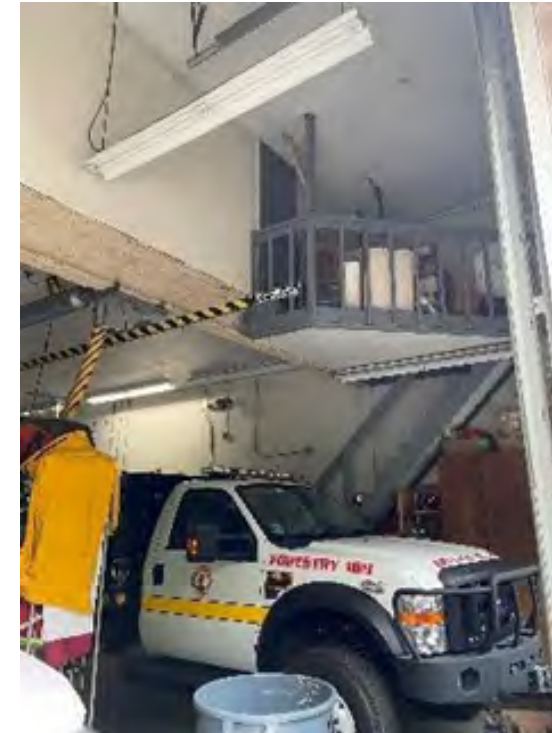
Pendant Industrial Fixture

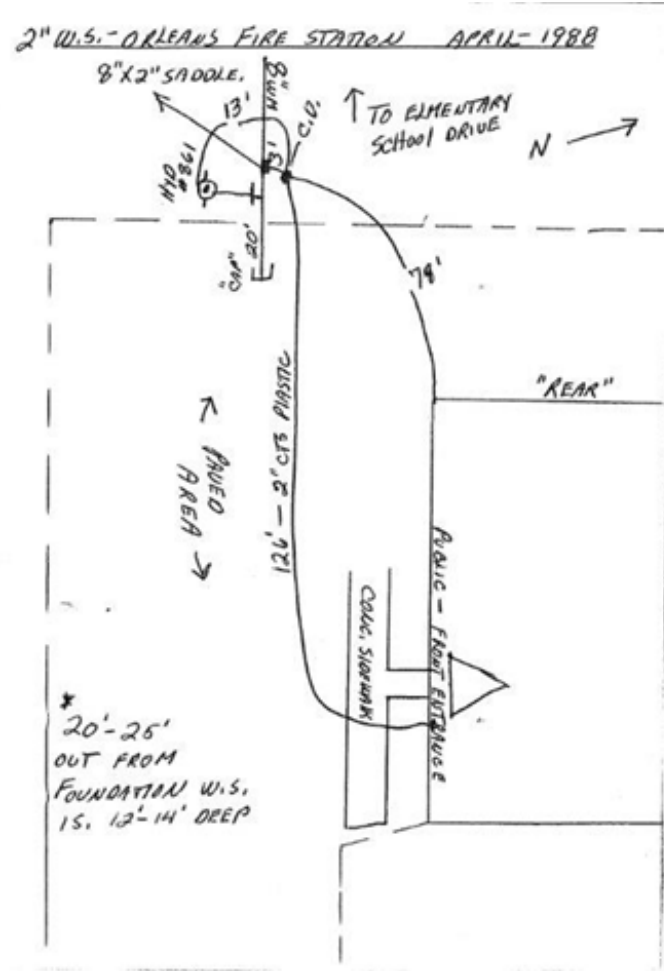
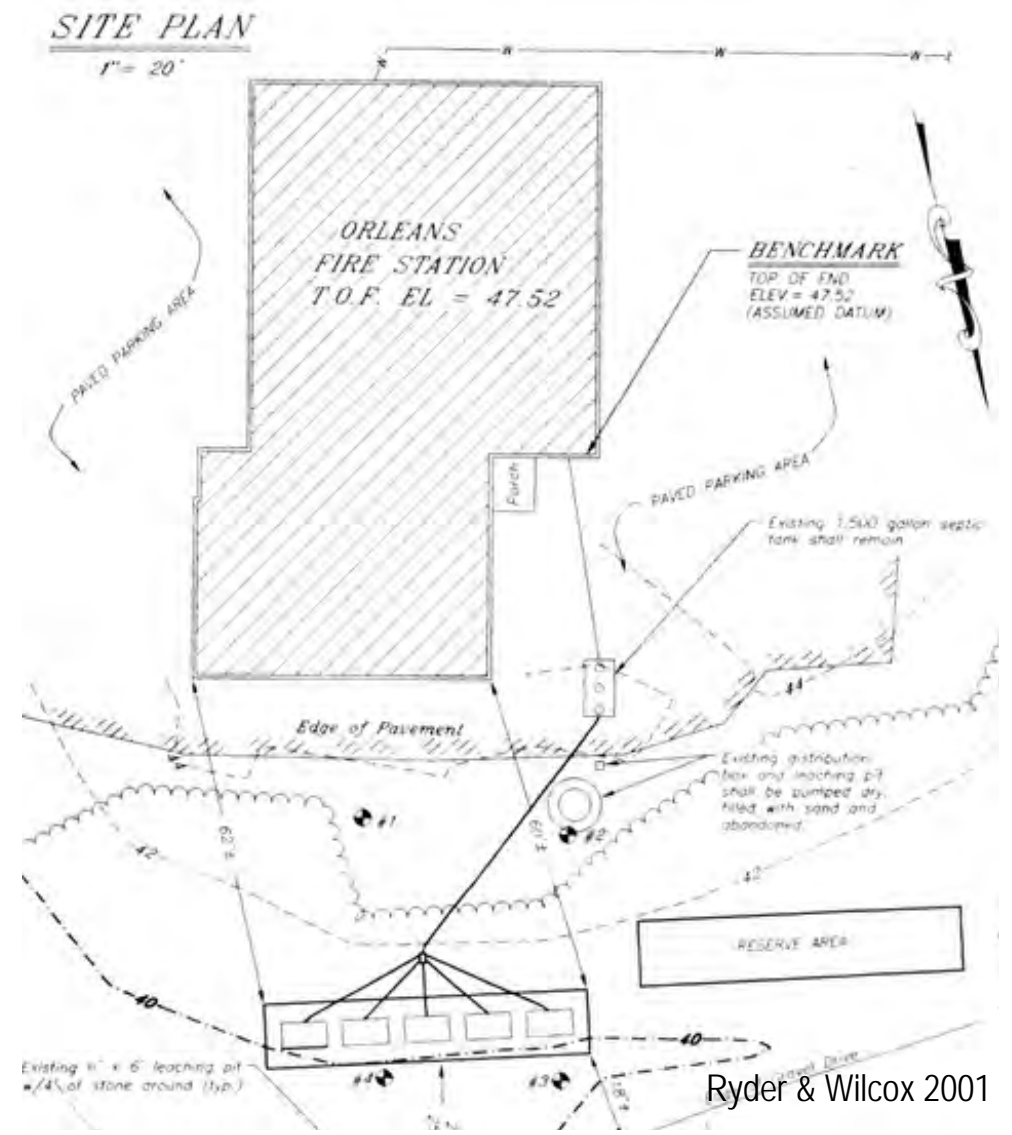
# National Flood Hazard Layer FIRMette

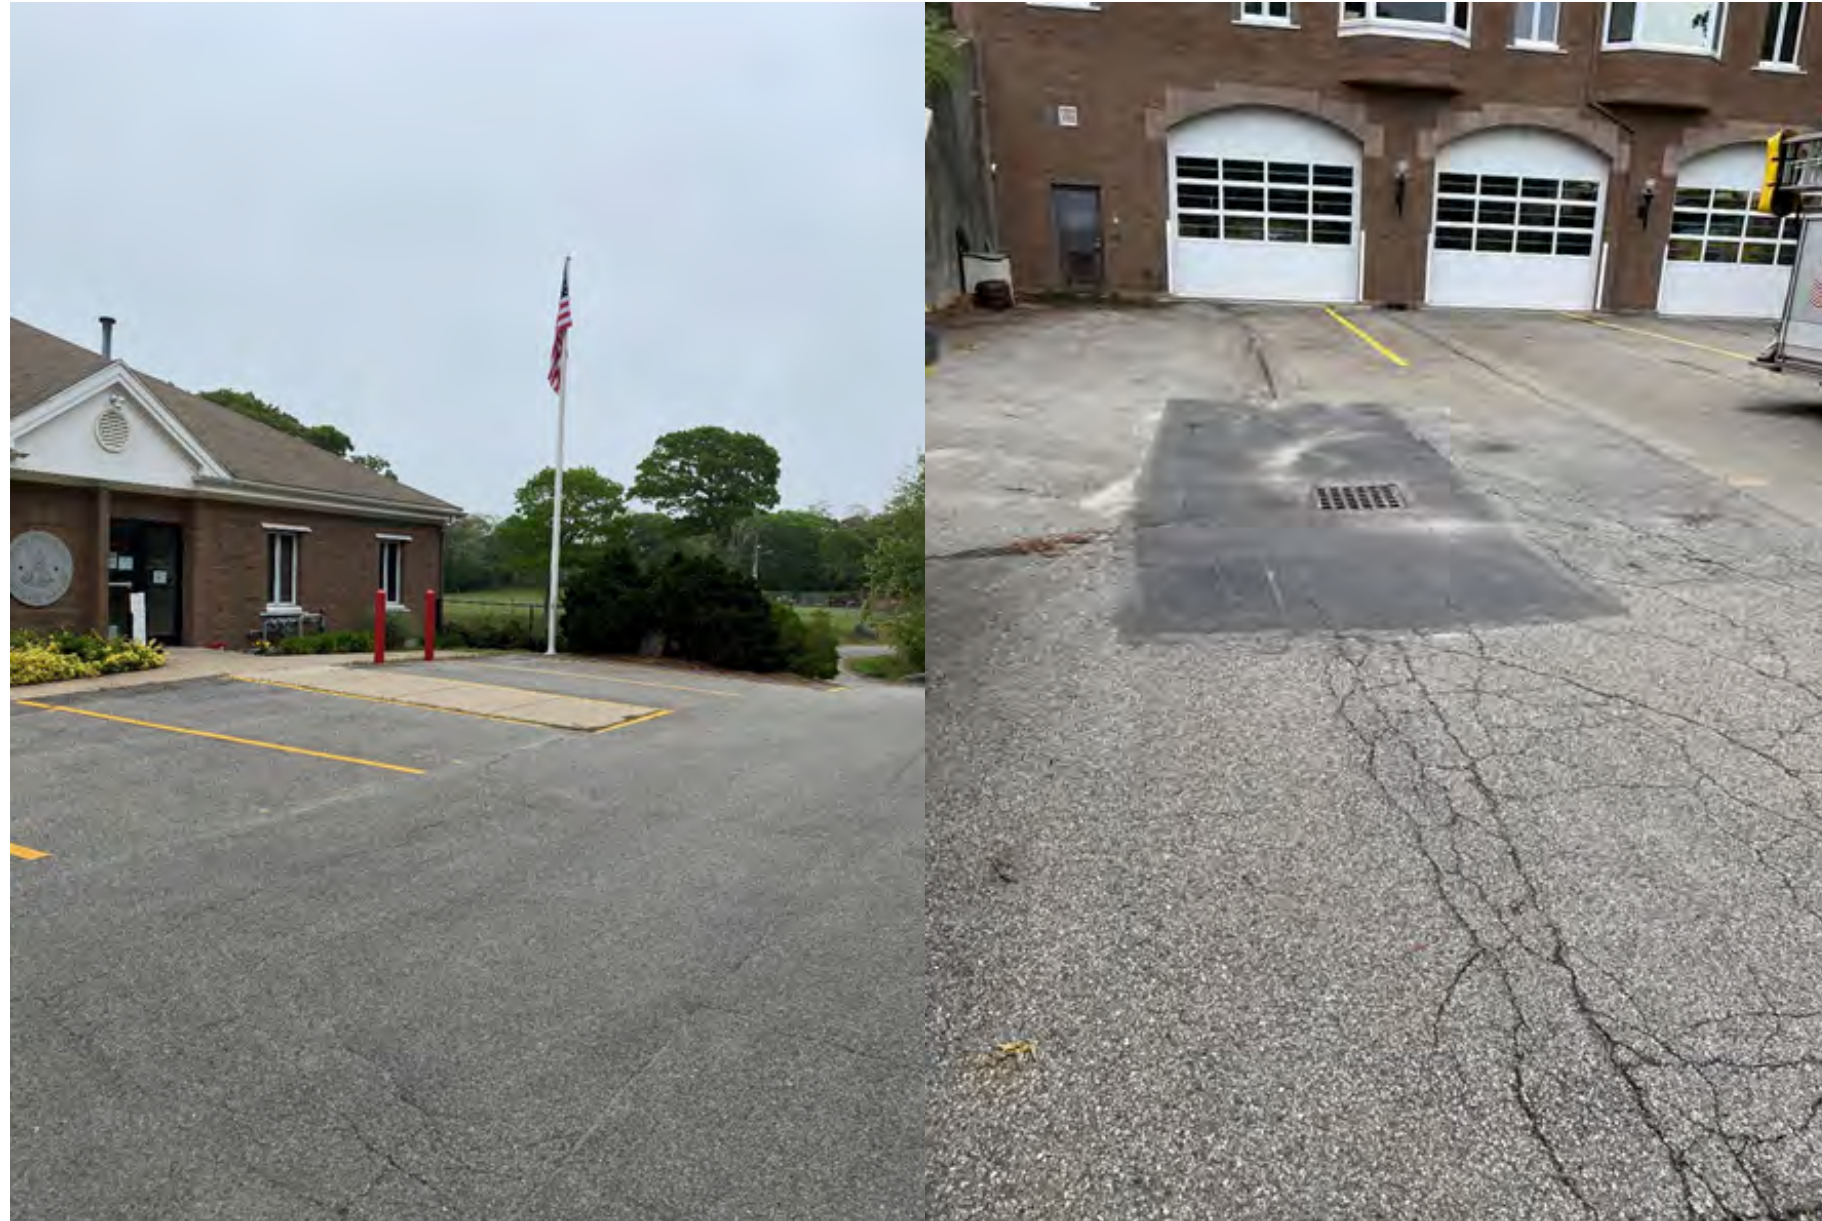
Figure 6: Existing asphalt conditions - Public entrance (left); Lower Apparatus Bays (right). Varying levels of pavement deterioration.

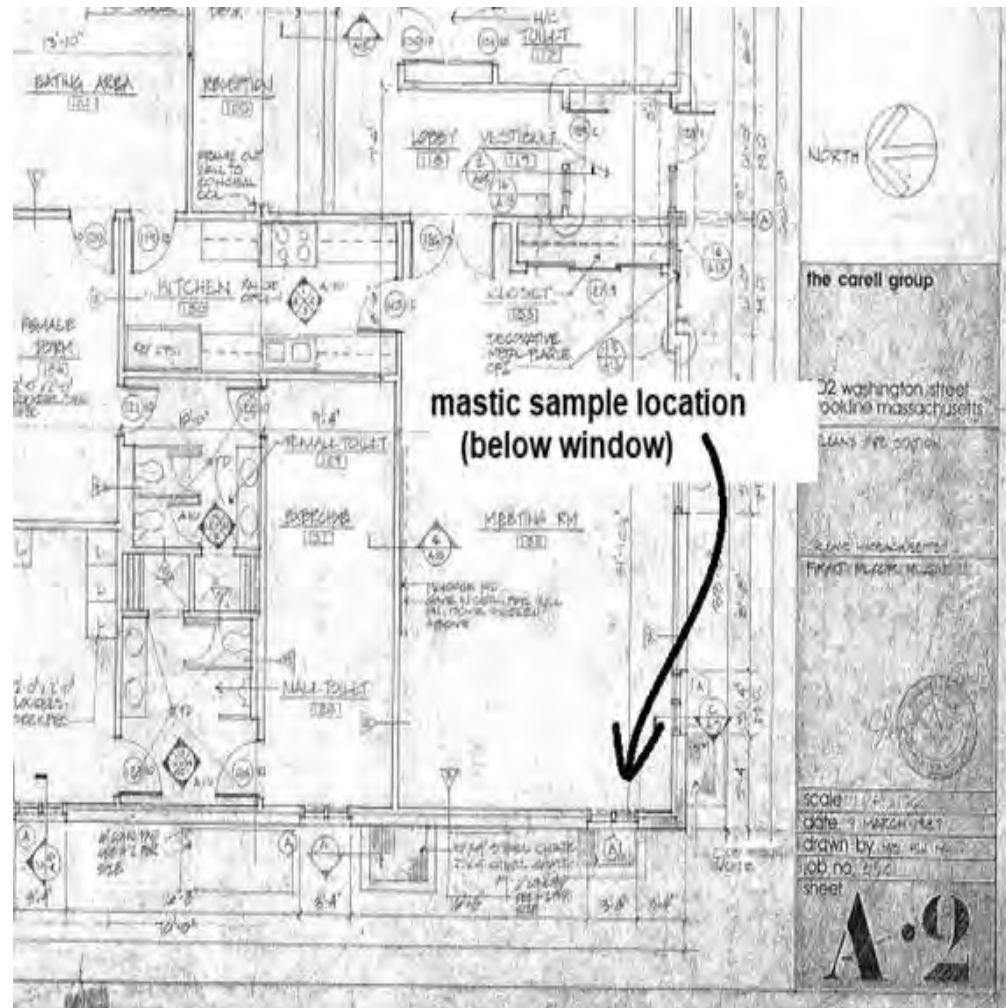
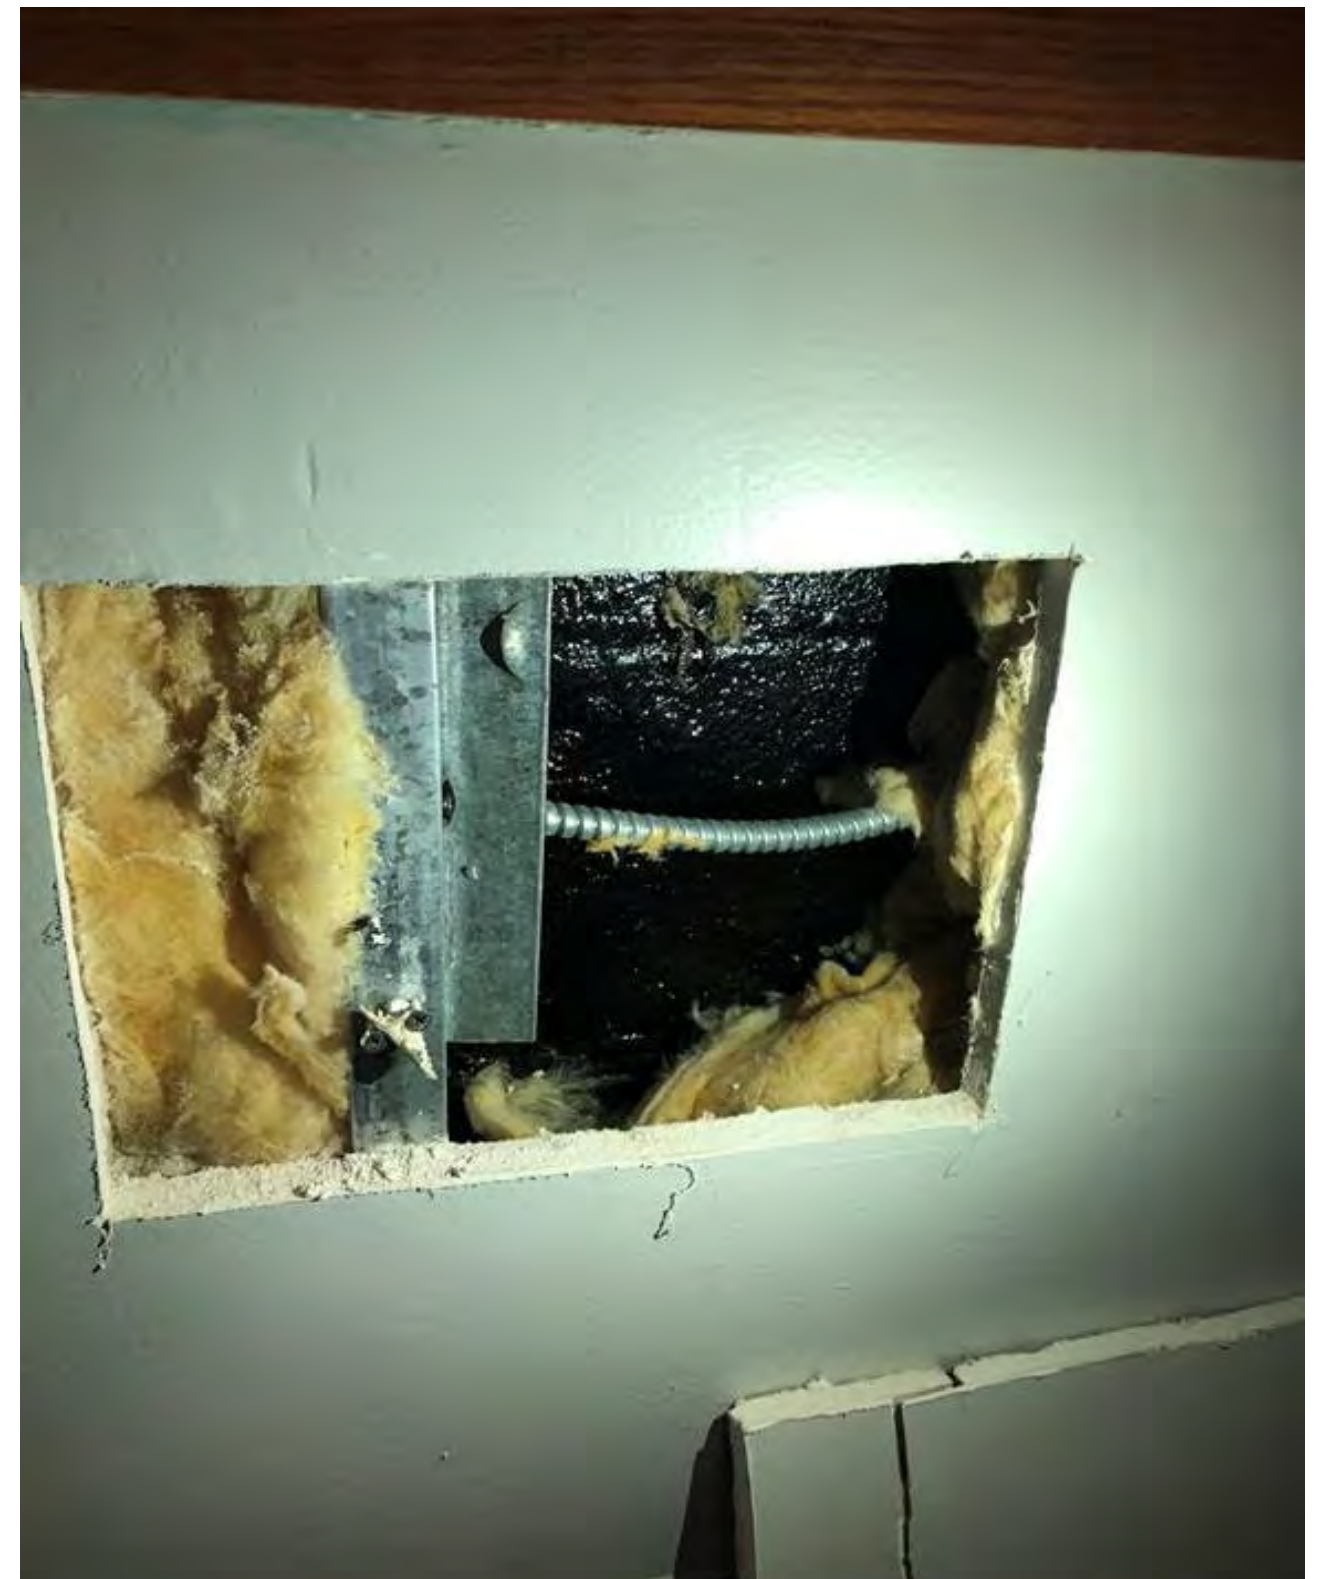
# FIREHOUSE RENOVATE OR REPLACE?

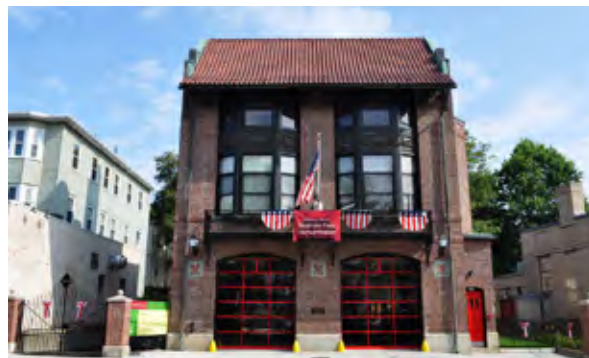
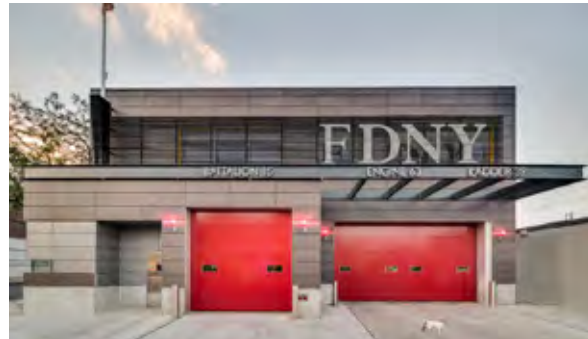
color or even structural density requires a lot of effort on the part of the architect. Moreover, mortar needs to be replicated in a way that matches existing conditions, but also structurally performs in equal capacity to existing mortars. However, historic preservation provides the opportunity to save beloved building elements like an old cornice line, a limestone carving or some other element that shows the public that we believe in preserving the department's institutional heritage.

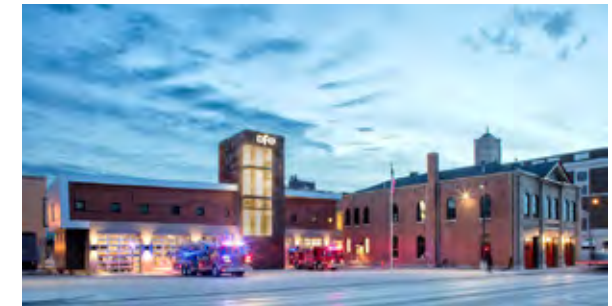
# TEMPORARY FACILITY STUDY
