Cedar Pond
Adaptive Management Monitoring Program:
Annual Technical Report
January 2019 to December 2019

FINAL REPORT

September 2020

Town of Orleans

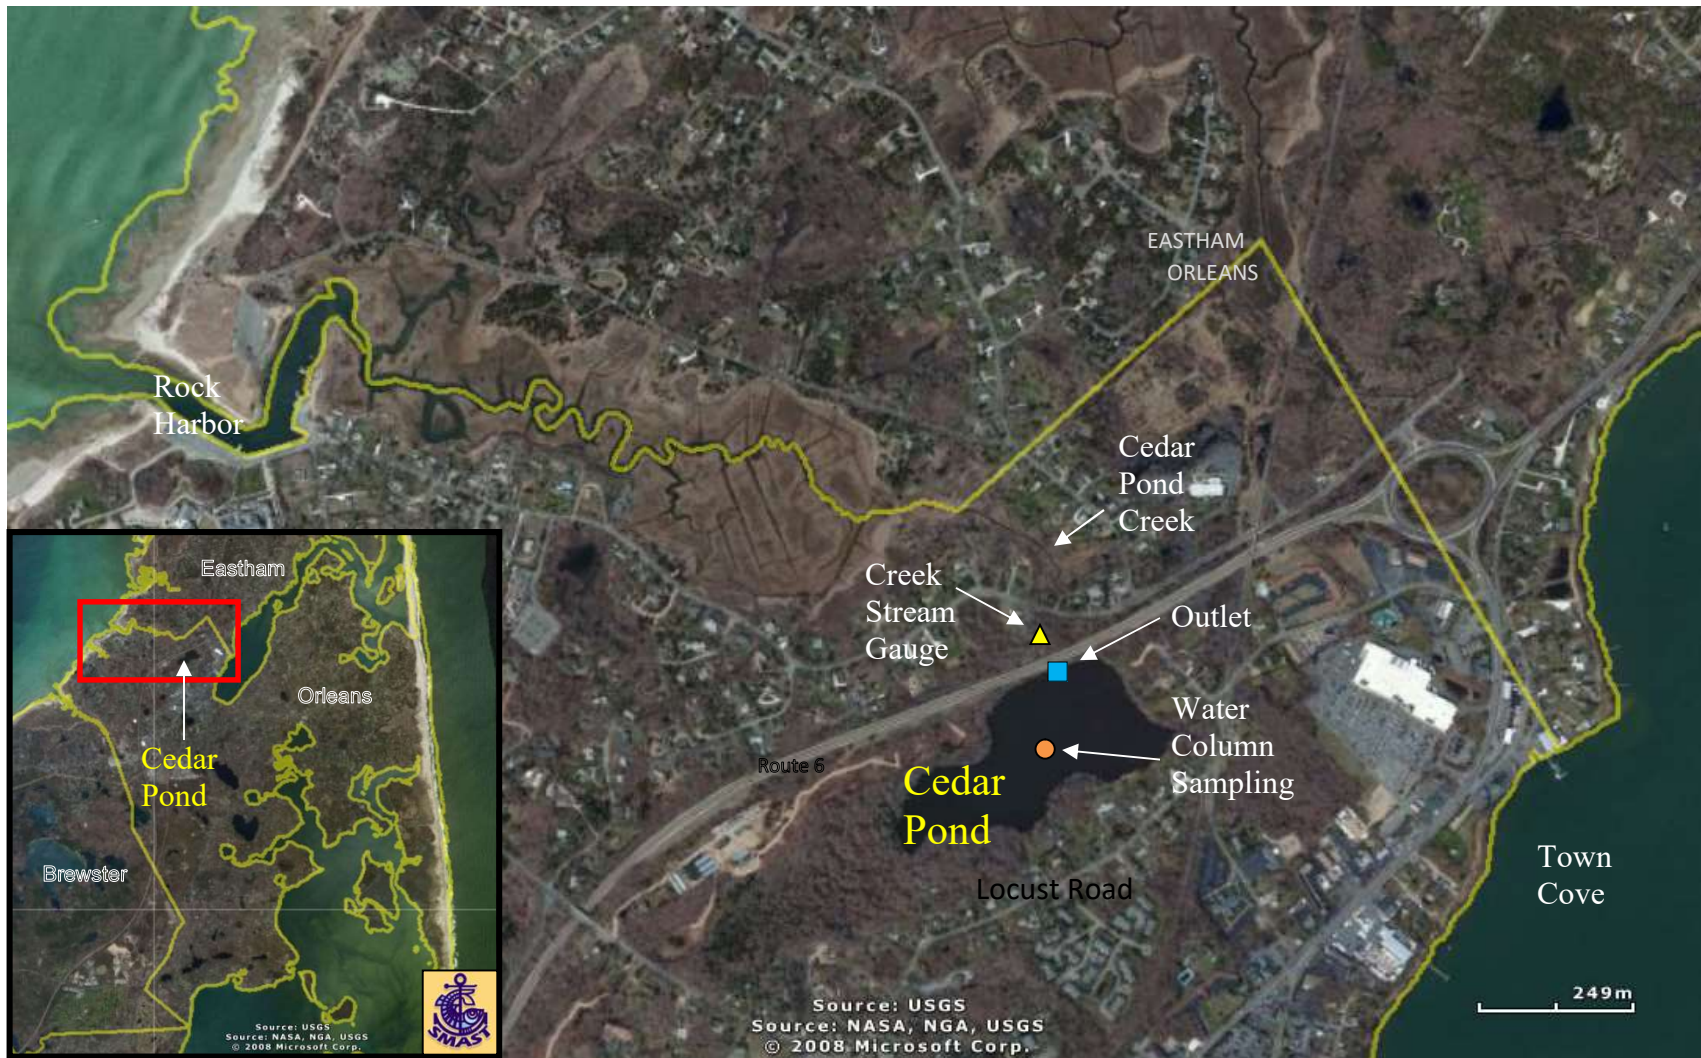
Figure 1. Cedar Pond Locus in the Town of Orleans, MA. Cedar Pond is located in northern Orleans, south of Route 6 and west of Town Cove. The Pond is connected to the Rock Harbor estuary on Cape Cod Bay via Cedar Pond Creek. The creek leaves the pond through a weir at the pond outlet (blue square), flows under Route 6 and Rock Harbor Road, and through a salt marsh to Rock Harbor. Creek flow and water quality have been measured several times at the same location (yellow triangle) and the pond has been sampled regularly since 2000 at the same deep location (orange circle).

Streamflows have been measured in Cedar Pond Creek at the same location (just north of Route 6; see Figure 1) continuously since November 2017. This is the same location used during the MEP assessment of Rock Harbor,²⁹ for the development of the Cedar Pond Management Plan,³⁰ and throughout 2018.³¹ Collecting the data continuously, at the same location, and using the same measurement methods has allowed data from the various time periods to be directly comparable. During 2019, low tide instantaneous flow readings and water quality samples were collected 21 times, generally every two weeks. Flow readings were compared to the existing stage-flow relationship and they were consistent with previous flow records.

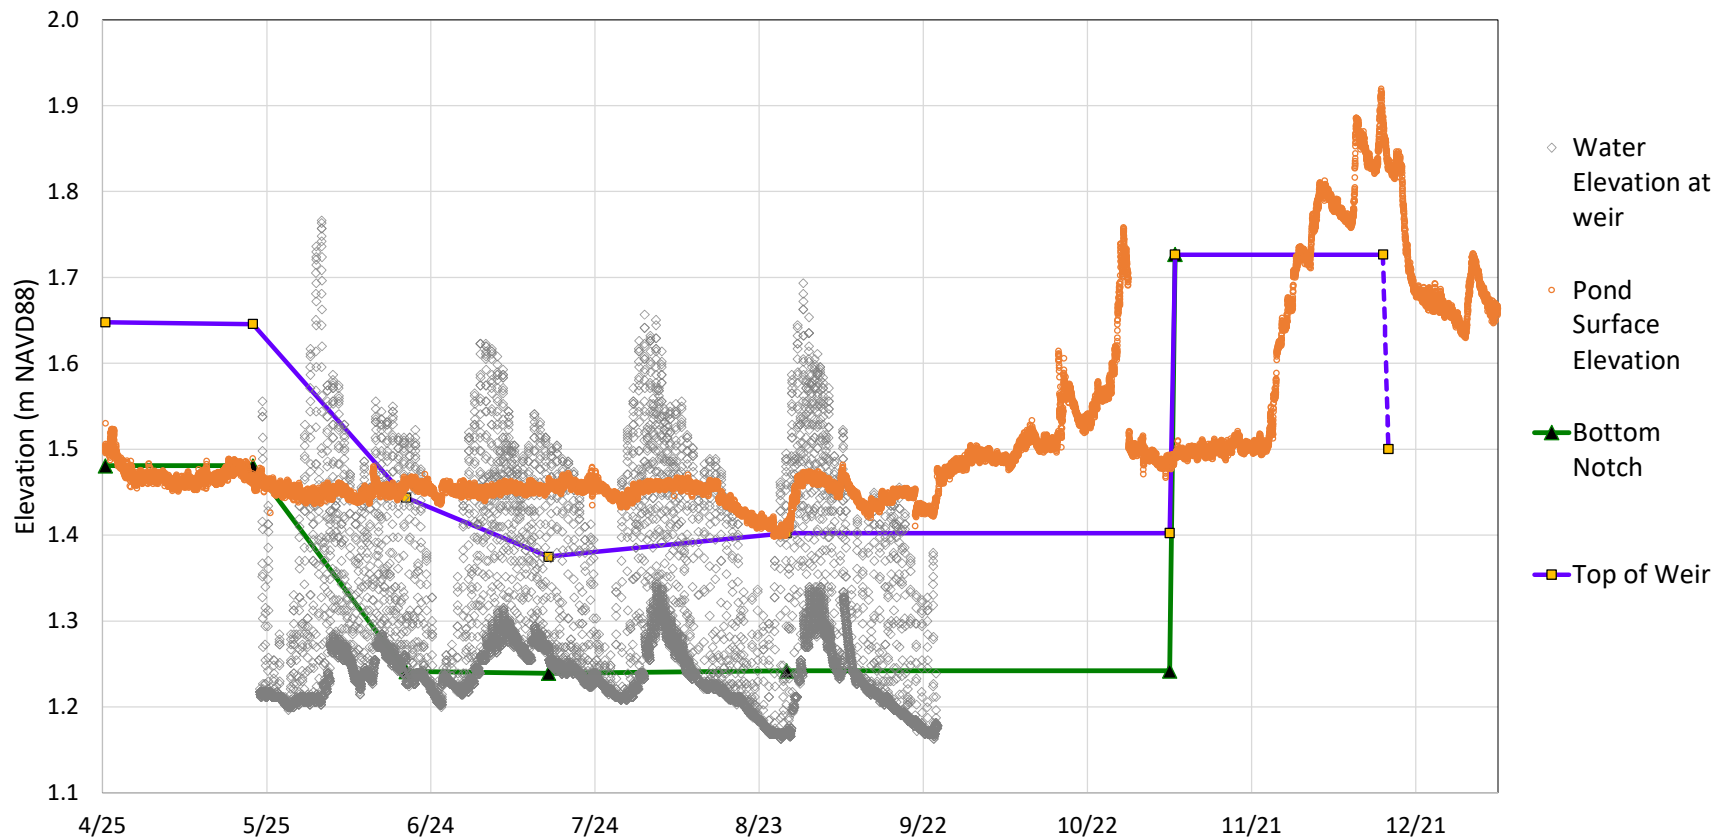
Figure 2. Cedar Pond 2019 Water Levels and Inlet Board Heights. CSP/SMAST staff installed an autonomous recording device programmed to record water levels every 10 minutes at the pond outlet on May 23, 2019. The device recorded readings until September 24, when its battery failed. Staff recorded elevations beginning April 25 for the top of the boards in the weir, as well as the bottom of the notch opening in the boards when it was installed. The notch was first installed on March 17 and was removed on November 7, when weir boards were also raised to 1.73 m NAVD88. Boards were lowered again to approximately 1.5 m NAVD88 during the week of December 16 (dashed line). Comparison of the water levels at the center of the pond and the outlet show that outlet levels varied over a wider range, which would be consistent with the relatively small input being distributed over the large surface area of the pond. Comparison of the bottom of notch elevations and outlet water levels showed that outlet water levels were greater than the 1.24 m NAVD88 bottom of the notch elevation 44% of the time during the overall deployment. This comparison also shows that all tides with their accompanying high salinity reached the pond once the boards were lowered to 1.24 m NAVD88.

While the 6 inch water level over the boards was not noted on any of the Town visits, the autonomous recordings showed the inlet water level was 6 inches (0.15 m) above the 1.24 m NAVD88 bottom of the notch elevation in 44% of the water level readings collected at the outlet during the device deployment.

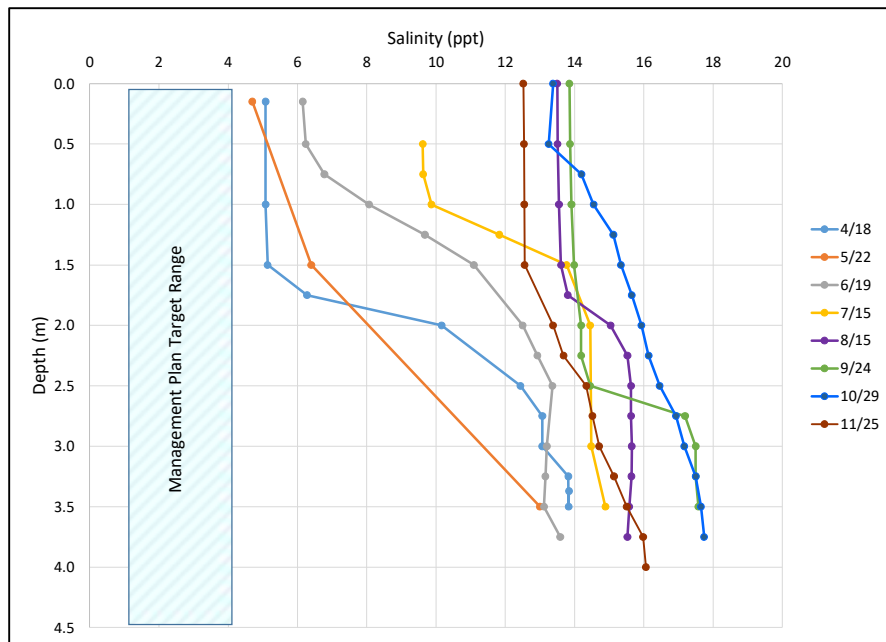
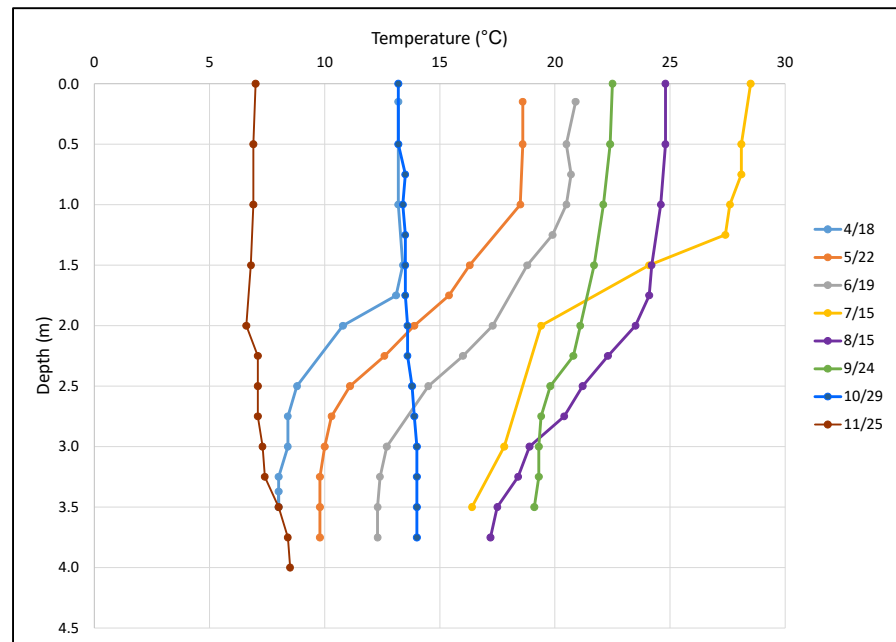
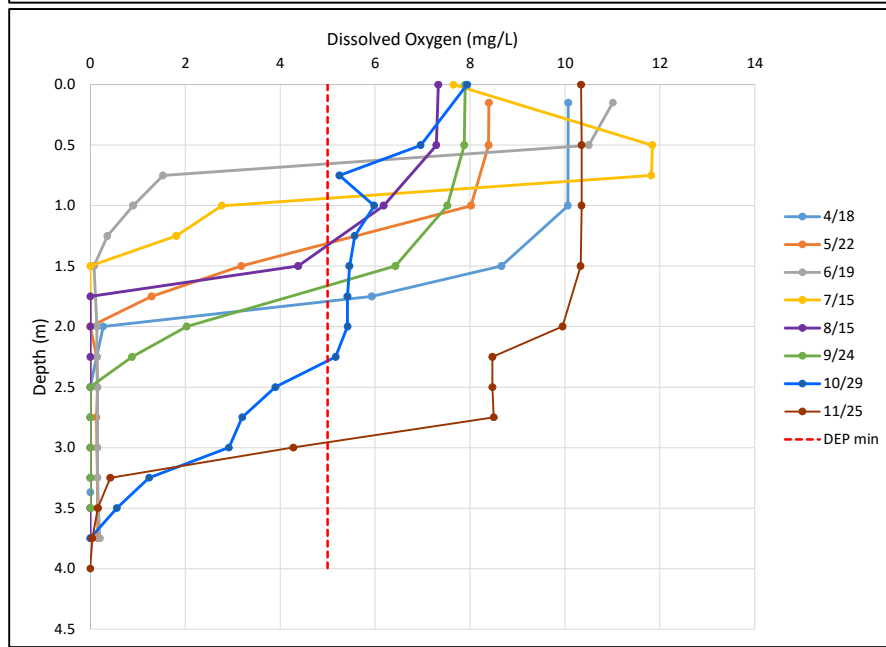
Figure 3. Cedar Pond 2019 Salinity, Dissolved Oxygen, and Temperature Profiles: April to November. April shallow salinity profile readings were just above the Pond Management Plan target range of 1-4 ppt, due to higher board levels during the 2018/2019 winter. Salinities increased slowly between May and October, but were generally lower than 2018 concentrations due to the lower starting point. Temperature readings followed a similar warming pattern to 2018, but showed larger differences between shallow and deep levels. DO levels were slightly lower than 2018 likely due to greater salinity and temperature stratification, but none of the 2019 profiles had concentrations as low as those in September 2018 and had acceptable DO concentrations in the upper 0.5 m in all profiles and the upper 1.0 m in 6 of the 8 profiles.

As expected, as boards were removed at the pond outlet, shallow salinity levels increased from ~5 ppt in April to 13.8 ppt in September. Deep concentrations increased less starting at 13.8 ppt in April and increasing 17.7 ppt in October. The deeper levels remain high because higher salinity waters coming into the pond sink to the bottom. It is notable, however, that the low salinity starting point in April kept deep 2019 concentrations 2 to 3 ppt less than maximum levels in 2018.²¹

Water quality samples were collected on the same dates as the temperature and oxygen profiles (see Figure 3). Water samples were generally collected at shallow, middle, and deep depths: averaging 0.15 m, 1.5 m, and 3.5 m, respectively. All collected samples were assayed at the Coastal Systems Analytical Facility at SMAST using the same assays that have been utilized for all Cedar Pond and MEP assessments, including those for the Cedar Pond Management Plan. Sampling procedures and chemical assay methods are presented in the Town's QAPPs for freshwater²⁶ and estuarine²⁷ water quality monitoring. Samples were analyzed at the laboratory for the following constituents: salinity, ortho-phosphorus, total phosphorus, ammonia-nitrogen, nitrate+nitrite-nitrogen, dissolved organic nitrogen, particulate organic nitrogen, particulate organic carbon, chlorophyll-a, and pheophytin-a.

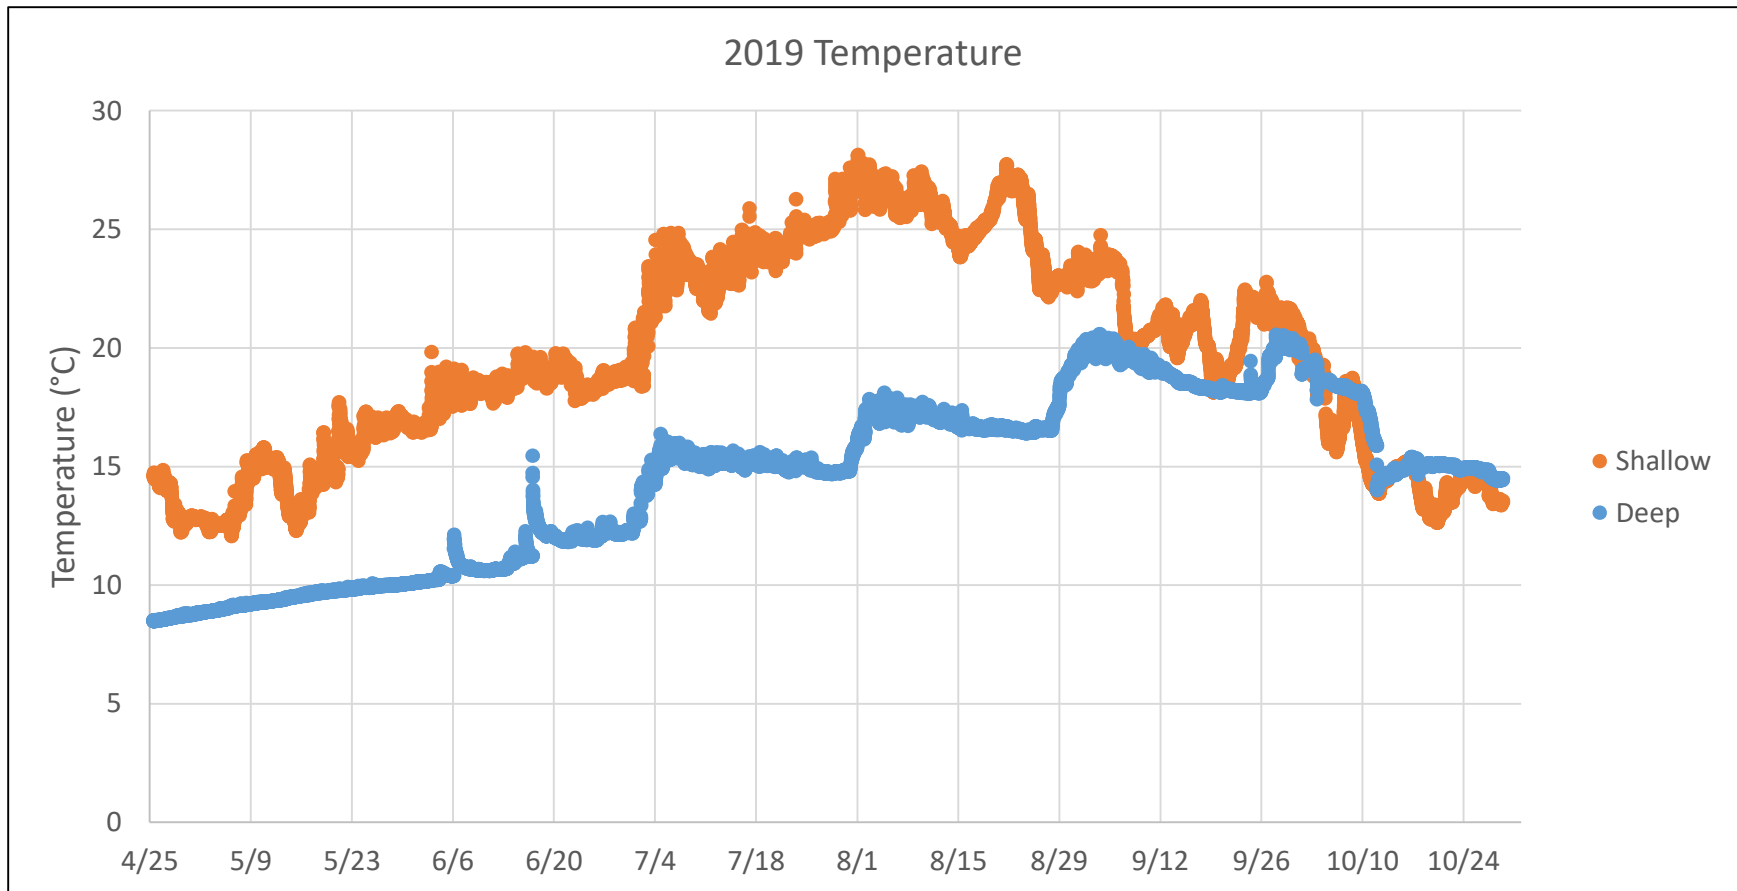
Figure 4. Cedar Pond 2019 Continuous Temperature Readings (April 25 to October 29). Both devices recorded temperature readings every 15 minutes and were located in the main basin at averages depths of 1.2 m and 3.6 m. Shallow temperatures were approximately 7°C higher than the deep reading until mid-September. From mid-May to mid-September, temperature differences at the two depths were sufficient to prevent mixing of the water column. Average shallow and deep temperatures over the entire deployment period were 19.71°C and 14.51°C, respectively.

continuous data showed that 2018 had periods of water column mixing into mid-June, while 2019 readings showed conditions for temperature mixing between the two continuous sensors did not occur from April to early September (see Figure 4). The decrease in deep TN throughout the year suggests that there was a mix of lowered of organic inputs (especially later in the summer due to the decrease in cormorant roosting) and retention of N containing organics (*e.g.*, phytoplankton and bacteria) in the sediments once they were deposited.

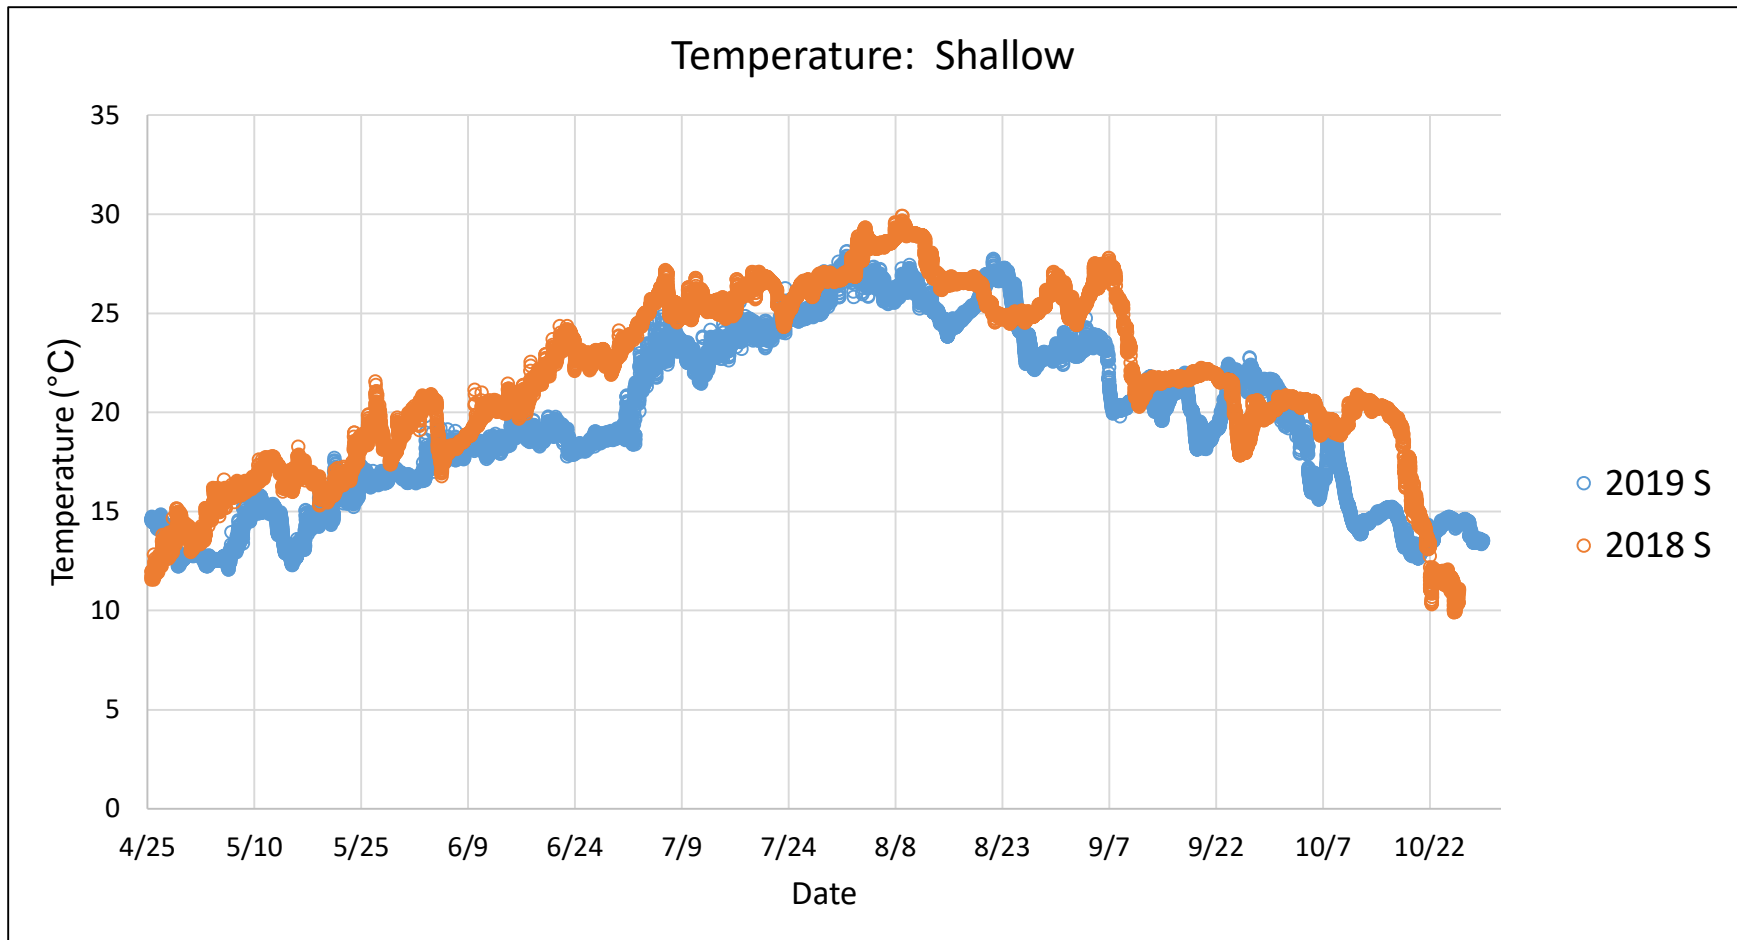
Figure 5. Cedar Pond 2018 and 2019 Continuous Shallow Temperature Readings. The 2019 device was installed from April 25 to October 29, while the 2018 device was installed from November 3, 2017 to October 26, 2018 (only data from April to October is shown). Both devices were located at a depth of approximately 1.2 m. Temperatures followed approximated the same pattern, but the average temperature in 2018 was $\sim 2^{\circ}\text{C}$ higher.

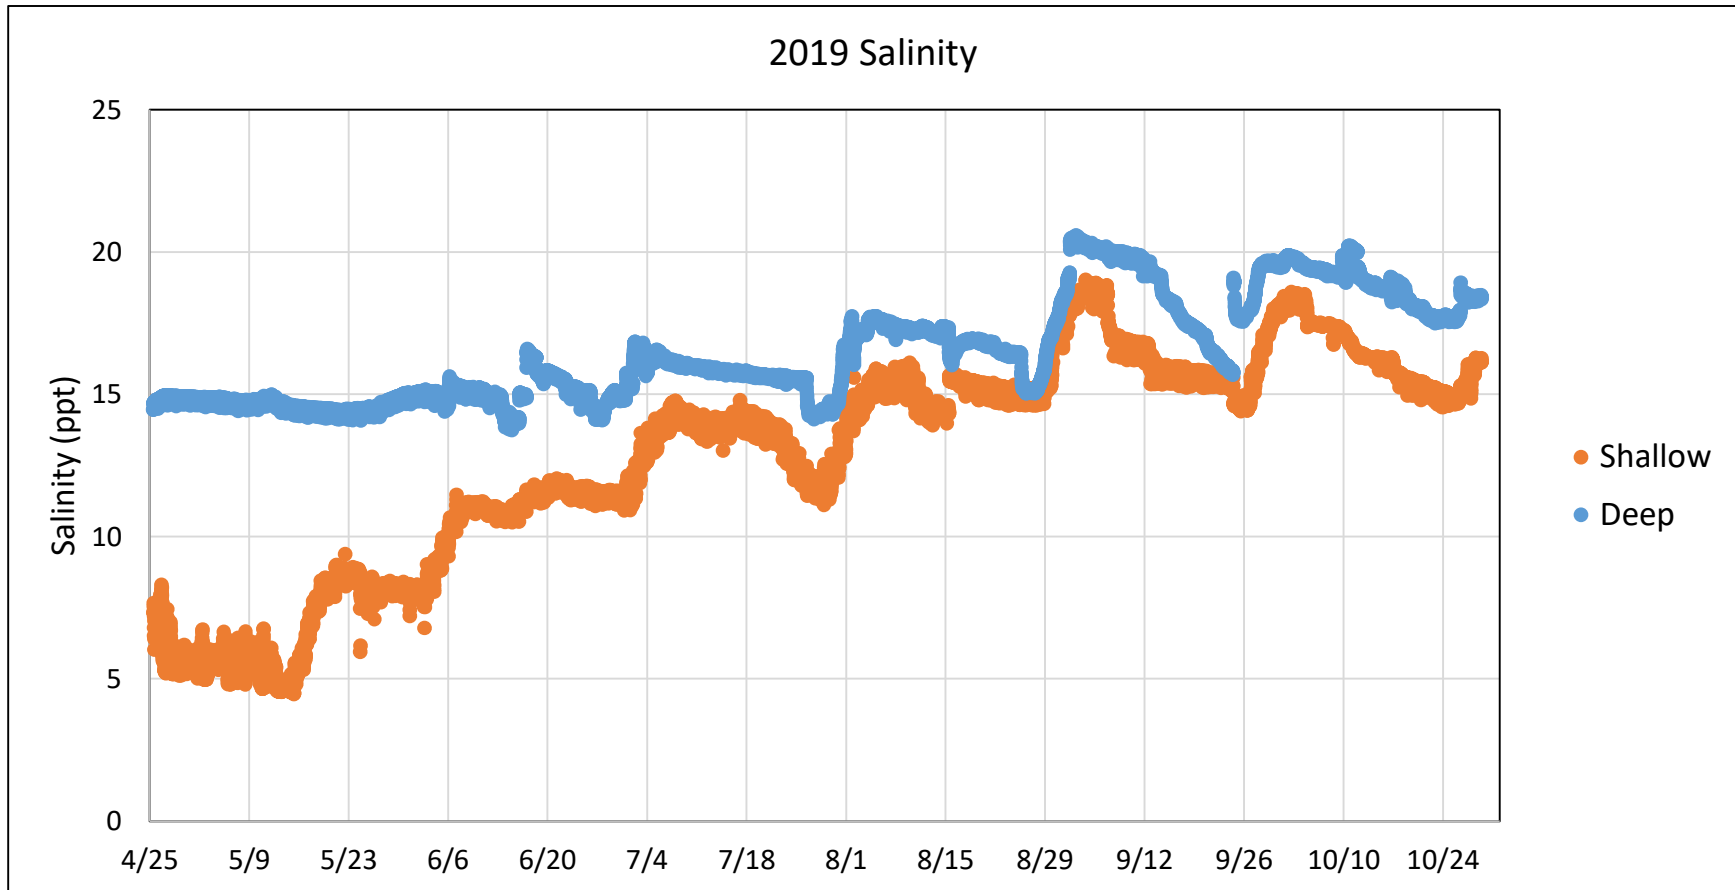
Figure 6. Cedar Pond 2019 Continuous Salinity Readings (April 25 to October 29). Both devices recorded temperature readings every 15 minutes and were located in the main basin at averages depths of 1.2 m and 3.6 m. The shallow salinity concentration at the time of initial deployment was approximately 5 ppt and increased until early September at a rate of 0.086 ppt per day before reaching an equilibrium concentration of 16.2 ppt. Deep salinity began at a concentration of approximately 15 ppt and changed within a much smaller range reflective of incoming tidal water settling to the bottom of the pond: average June to July deep salinity was 15.4 ppt, while average August to September salinity was 17.8 ppt.

These concentrations were ~10 ppt and ~1 ppt lower than respective 2018 concentrations at the same time of the year. The shallow 2019 salinity level increased until early September at a rate of 0.086 ppt per day before reaching an equilibrium concentration of 16.2 ppt. In contrast, shallow 2018 salinity reached a relative equilibrium concentration of 20.4 ppt earlier in the season and lasted between early July and the end of October (Figure 7). Deep 2019 salinities changed within a much smaller range reflective of incoming tidal water settling into deeper waters: average June to July deep salinity was 15.4 ppt, while average August to September salinity was 17.8 ppt. These 2019 concentrations were 6.4 ppt and 4.6 ppt less, respectively, than 2018 concentrations.

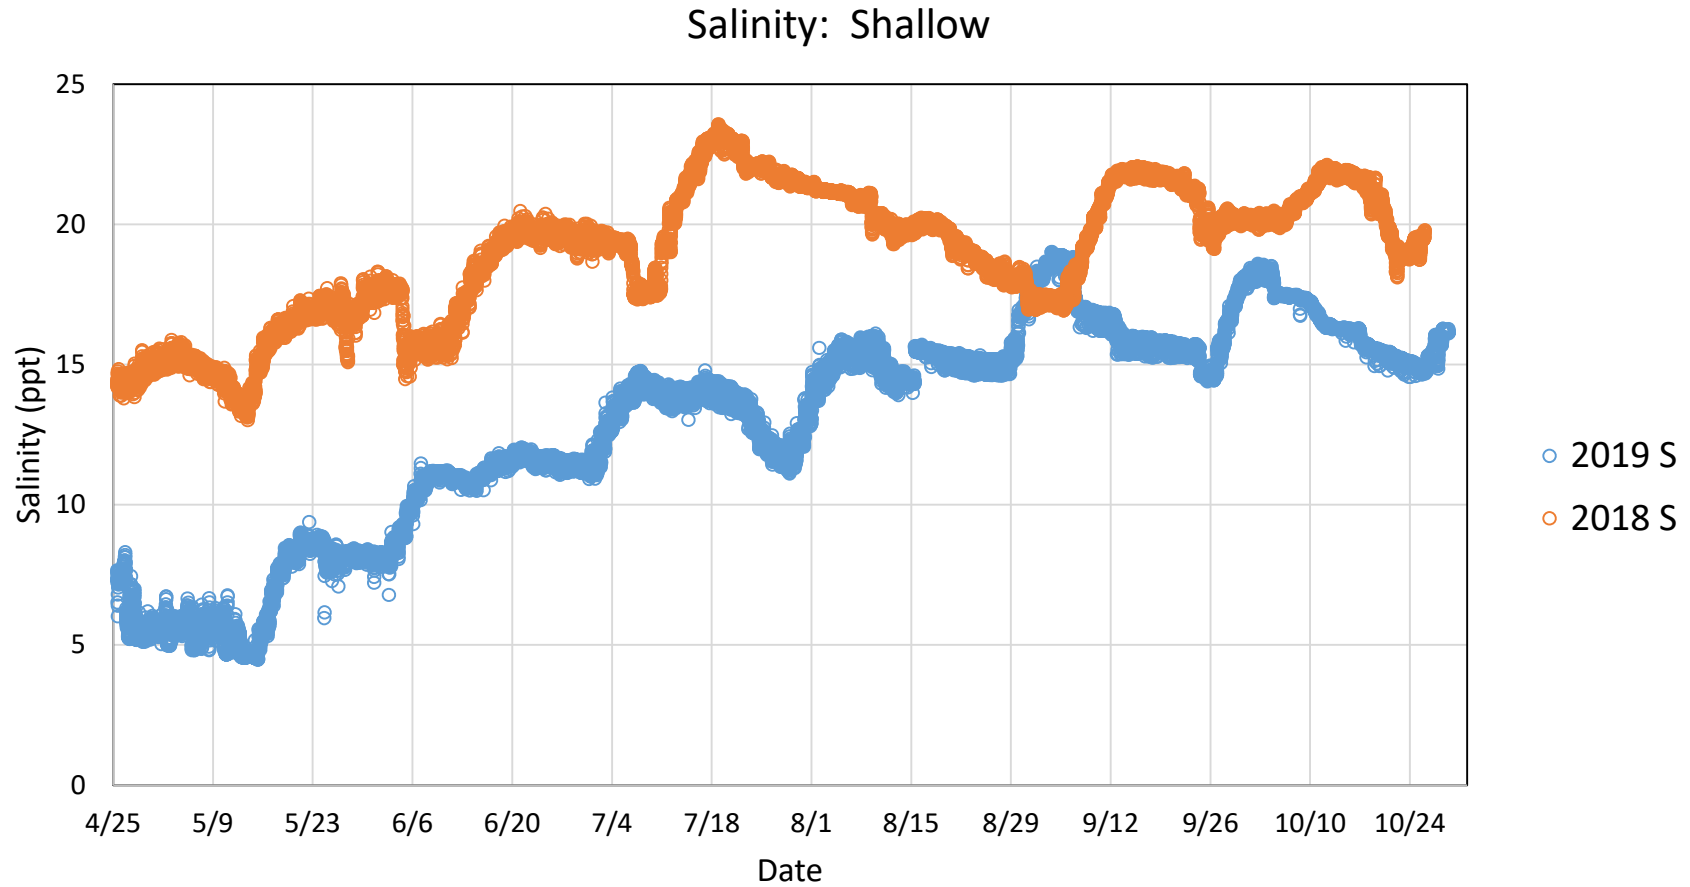
Figure 7. Cedar Pond 2018 and 2019 Continuous Shallow Salinity Readings. The 2019 device was installed from April 25 to October 29, while the 2018 device was installed from November 3, 2017 to October 26, 2018 (only data from April to October is shown). Both devices were located at a depth of approximately 1.2 m. In April 2018, shallow salinity was approximately 15 ppt, while in April 2019 it was approximately 5 ppt. This difference was likely due to higher outlet board elevation during the 2018/2019 winter. Both 2018 and 2019 shallow salinities increased between April and July at the same rate (0.086 ppt per day) suggesting similar tidal inflows, but 2018 concentrations reached an equilibrium concentration in July (20.4 ppt), while the increase continued until early September during 2019 and reached an equilibrium concentration of 16.2 ppt.

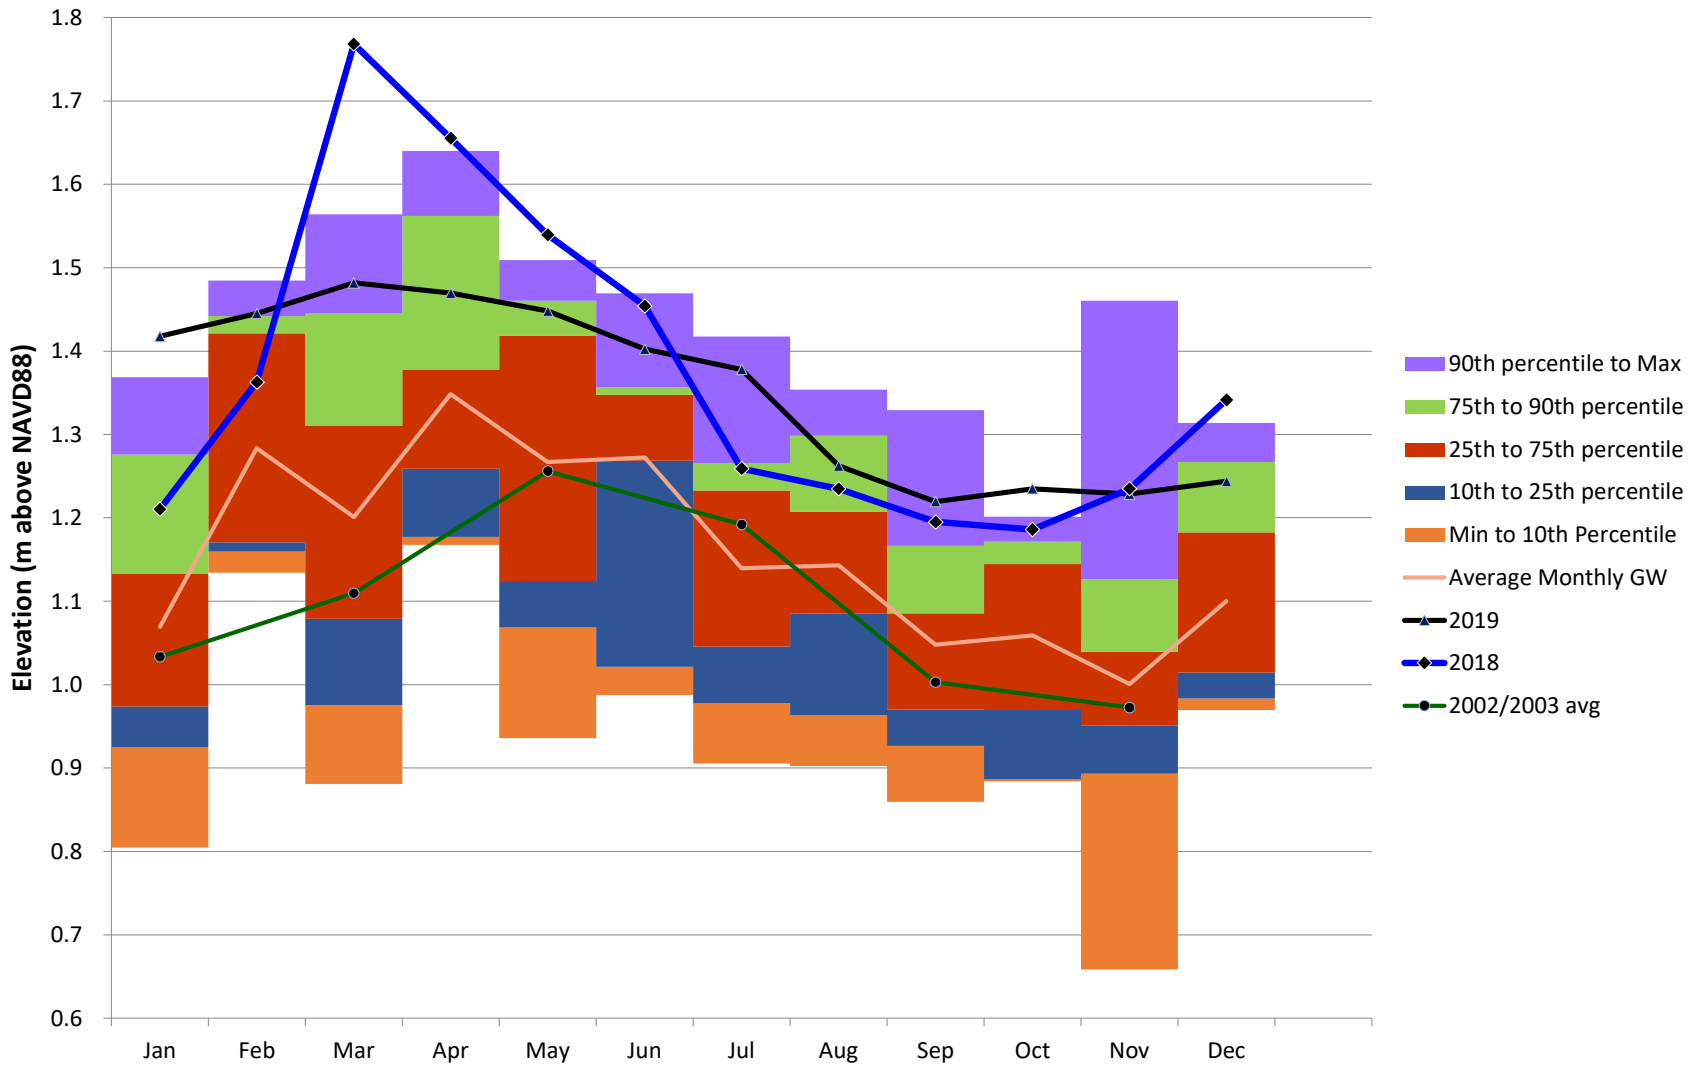
Figure 8. Orleans Groundwater Elevations (OSW-22). Groundwater elevations in Orleans during 2018 were exceptionally high with March, April, May, and December recording new high monthly levels. 2019 levels remained high, but were lower during the winter and about the same as 2018 during the summer, so groundwater inflow differences cannot explain the lower salinities in 2019 vs 2018. Lower levels would reduce groundwater discharge rates into Cedar Pond. Average levels during 2002/2003, when MEP stream outflow readings were recorded, were less than the long-term average groundwater elevations.

The lower 2019 salinities seem to be related to the boards being installed at a higher elevation throughout the 2018/2019 winter with the result that April 2019 salinity was lower than in April 2018. Since the rate of salinity rise in both years was similar, almost the entire reason for the lower salinity at the end of 2019 was due to the lower salinity at the start of the sampling season. The higher boards in the winter reduced the salt inputs from tidal inflows and allowed fresh groundwater inputs to become a larger portion of the fresh and salt water flowing into the pond. Groundwater levels in 2019 were above average, but they were lower than 2018 levels, also reinforcing the role of the higher boards (Figure 8).

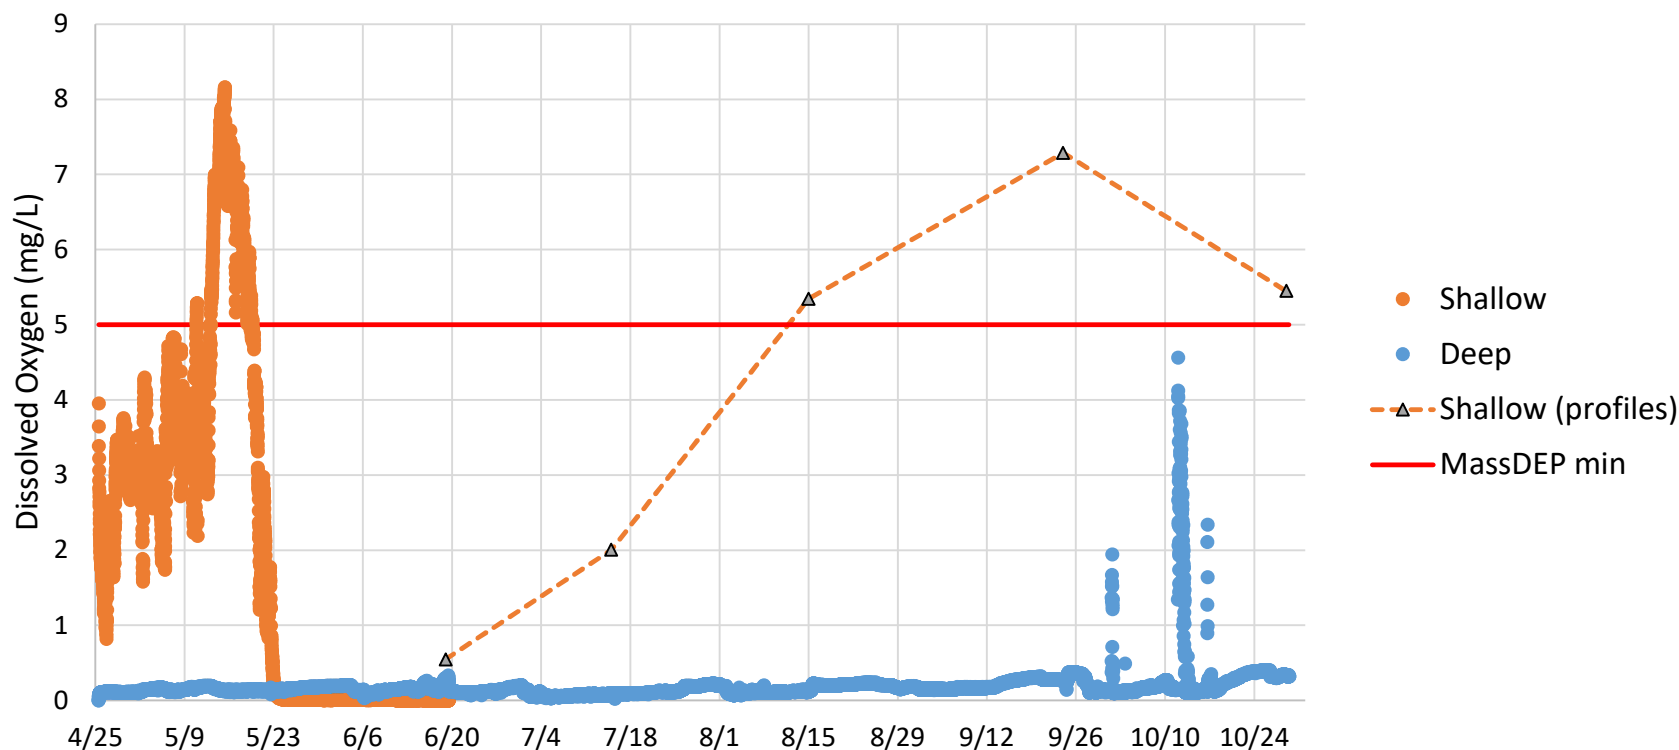
Figure 9. Cedar Pond 2019 Continuous Dissolved Oxygen Readings (April 25 to October 29). In 2019, shallow and deep devices were deployed between April 25 to October 29, programmed to record dissolved oxygen readings every 15 minutes, and were located in the main basin at averages depths of 1.2 m and 3.6 m. The shallow probe recorded acceptable data until mid-June; recording after that point was compromised by biofouling. Prior to the sensor failure, shallow DO concentrations increased from approximately 3 mg/L to 8 mg/L in mid-May before decreasing to near 0 mg/L during the third week of May. Profile DO recordings at the shallow sensor depth showed that sensor concentrations should have increased from mid-June to late September. From mid-August to the last profile in late October, shallow DO concentrations were greater than the MassDEP minimum concentration (5 mg/L). Deep DO readings were near 0 mg/L throughout most of the deployment period except for some short-lived increases in September and October likely due to large tidal inputs.

Comparison of 2018 and 2019 continuous DO readings was compromised because of the intense biofouling of the shallow sensor after the middle of June 2019, which produced unreliable sensor readings. When the probe was working, shallow readings gradually increased from the initial deployment on April 25, peaked on May 15 (8.16 mg/L), and then decreased to near 0 mg/L in mid-June (Figure 9). Deep concentrations were less than 0.5 mg/L DO throughout the deployment except for some October peaks between 2 and 4 mg/L, which were likely inputs of high oxygen, tidal water that did not mix extensively and rapidly sunk to the sensor depth. In general, continuous DO readings and profile readings had acceptable congruence.

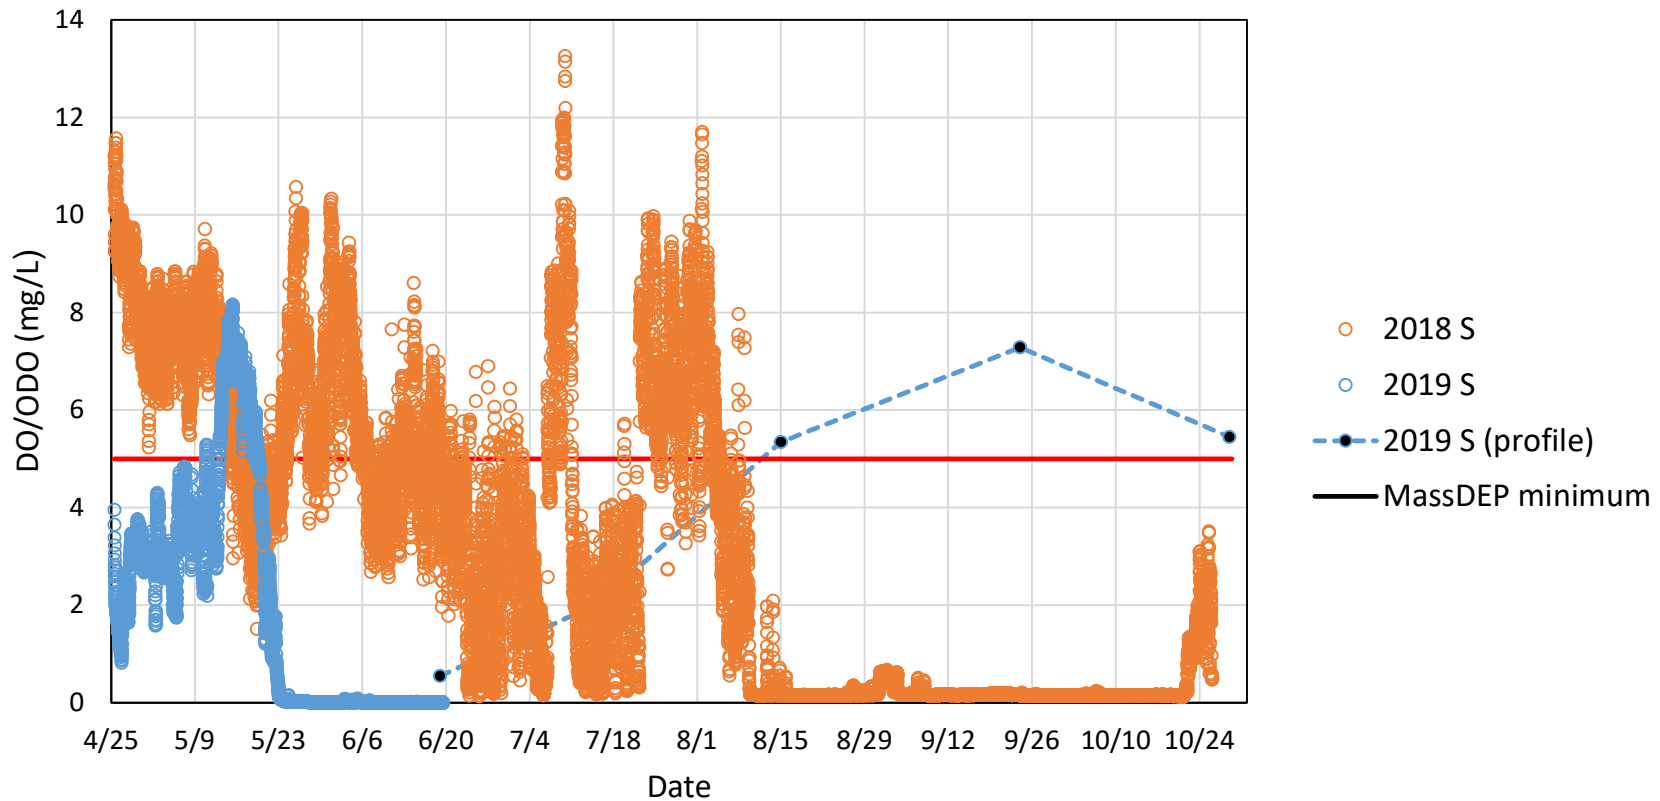
Figure 10. Cedar Pond 2018 and 2019 Continuous Shallow Dissolved Oxygen Readings. Continuous recording devices were installed in Cedar Pond during the same periods and depth during both 2018 and 2019. Both devices were located at a shallow depth of approximately 1.2 m and recorded DO concentrations every 15 minutes. During the 2019 deployment, the device stopped recording in mid-June due to biofouling, so the equivalent profile concentrations are shown. Concentrations in 2018 gradually decreased from April to June, then became extremely variable before decreasing to virtual zero from early August to mid-October. In contrast, 2019 concentration increased from ~1 mg/L in late April to ~8 mg/L in mid-May 2019, then decreased to near 0 mg/L (anoxia), and then began to increase from mid-June to late-September. Profile concentrations at 1.2 m in August, September, and October all were greater than the MassDEP minimum concentration, a notable improvement over 2018. This improvement in shallow DO concentrations was likely due to a decrease in cormorant roosting over the pond caused by the relocation of power lines that used to span the northern half of the pond.

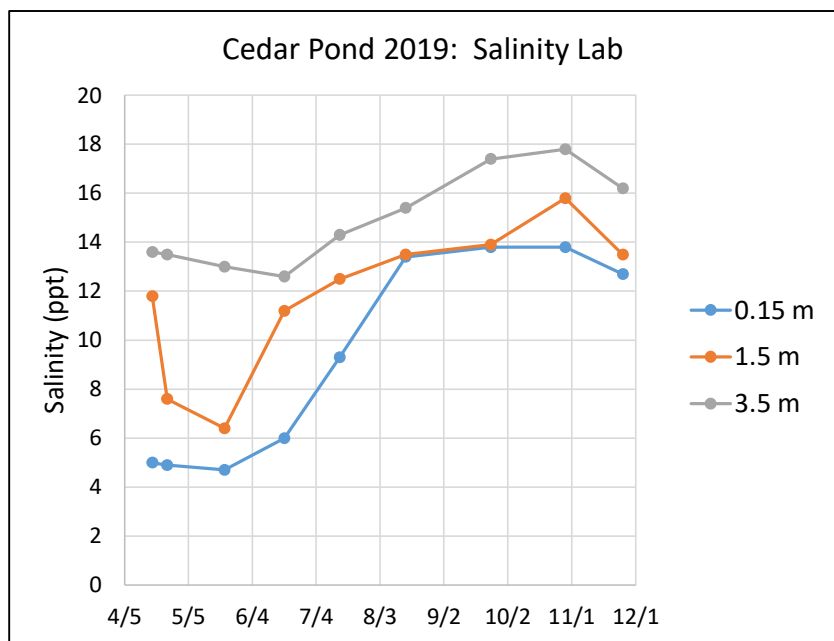
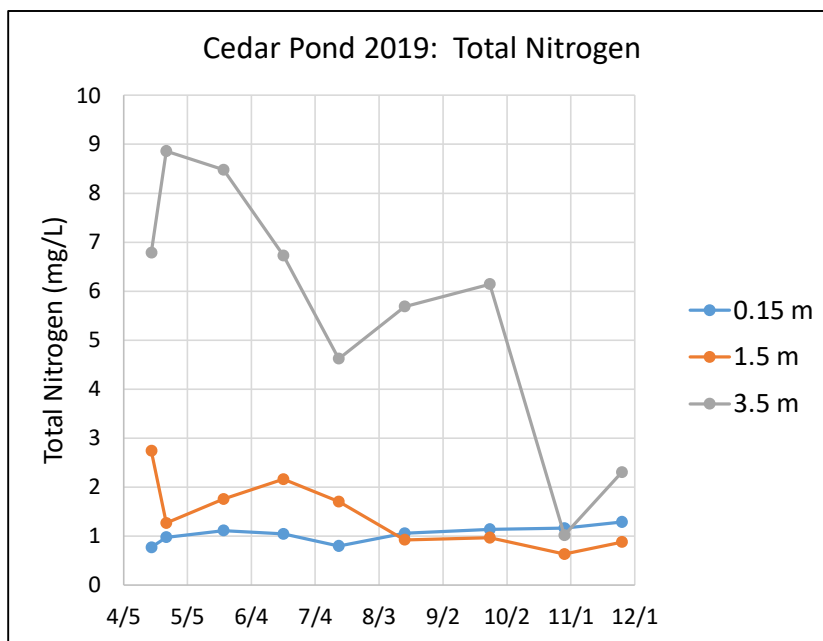
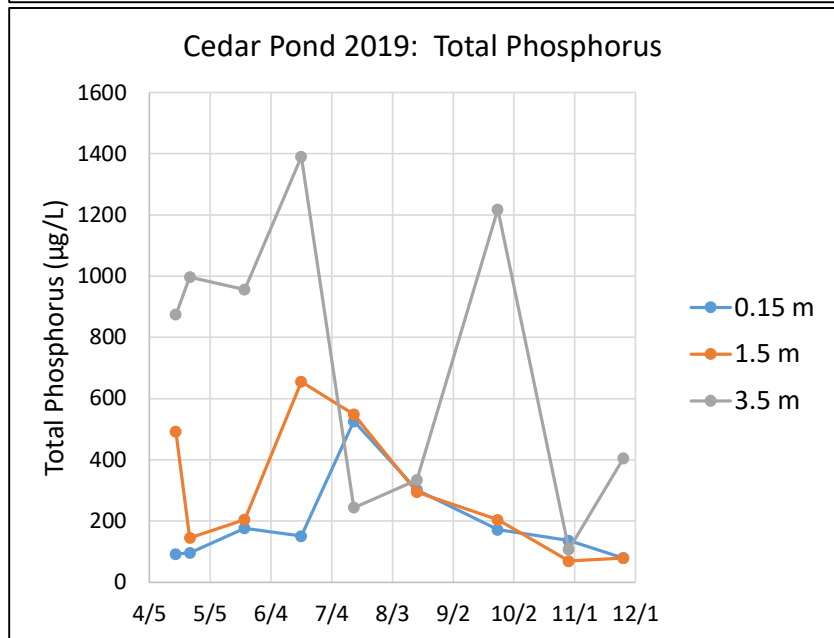
Figure 11. Cedar Pond 2019 Water Column Salinity, Total Phosphorus, and Total Nitrogen. Salinity readings increased as boards were lowered, but initial readings in April and May were only slightly higher than the Pond Management Plan target range of 1-4 ppt, largely due to boards installed at a higher elevation during the 2018/2019 winter. TN concentrations at 0.15 m and 1.5 m were generally within the same range during 2019, while deep (3.5 m) concentrations decreased from around 9 mg/L to ~1 mg/L during the year. TP concentrations at 0.15 m and 1.5 m peaked in June and July, respectively, then decreased during the rest of the year. Deep TP concentrations began April around 1 mg/L, but decreased significantly in July and August before increasing again in September.

TP concentrations in 2019 have a more complex pattern than TN and suggest phytoplankton played a role in increasing TP retention in the upper water column in June and July followed by settling to deeper waters in August and September. Deep 2019 TP concentrations were ~1,000 µg/L in April and May, decreased by ~1200 µg/L from June to July, remained low in August, and increased to ~1200 µg/L (~4X increase) between August and September (see Figure 11). Chlorophyll readings at 1.5 m increased between May and June ~20X, increased again in July by ~25%, and then decreased back to a concentration similar to the 0.15 m concentration (35 µg/L) in August (Figure 12). This pattern suggest phytoplankton having conditions favorable to grow faster at 1.5 m in June 2019, retaining TP (and TN) at that depth while they were growing, and then beginning to die off and the phytoplankton particles slowly settling to lower portions of the water column after the peak in mid-July. The die-off coincides with a significant decrease in DO at 1.5 m between July and August profiles, an increase in clarity, and a decrease in chlorophyll.
