Cedar Pond
Adaptive Management Monitoring Program:
Annual Technical Report
January 2019 to December 2019

FINAL REPORT

September 2020

Town of Orleans

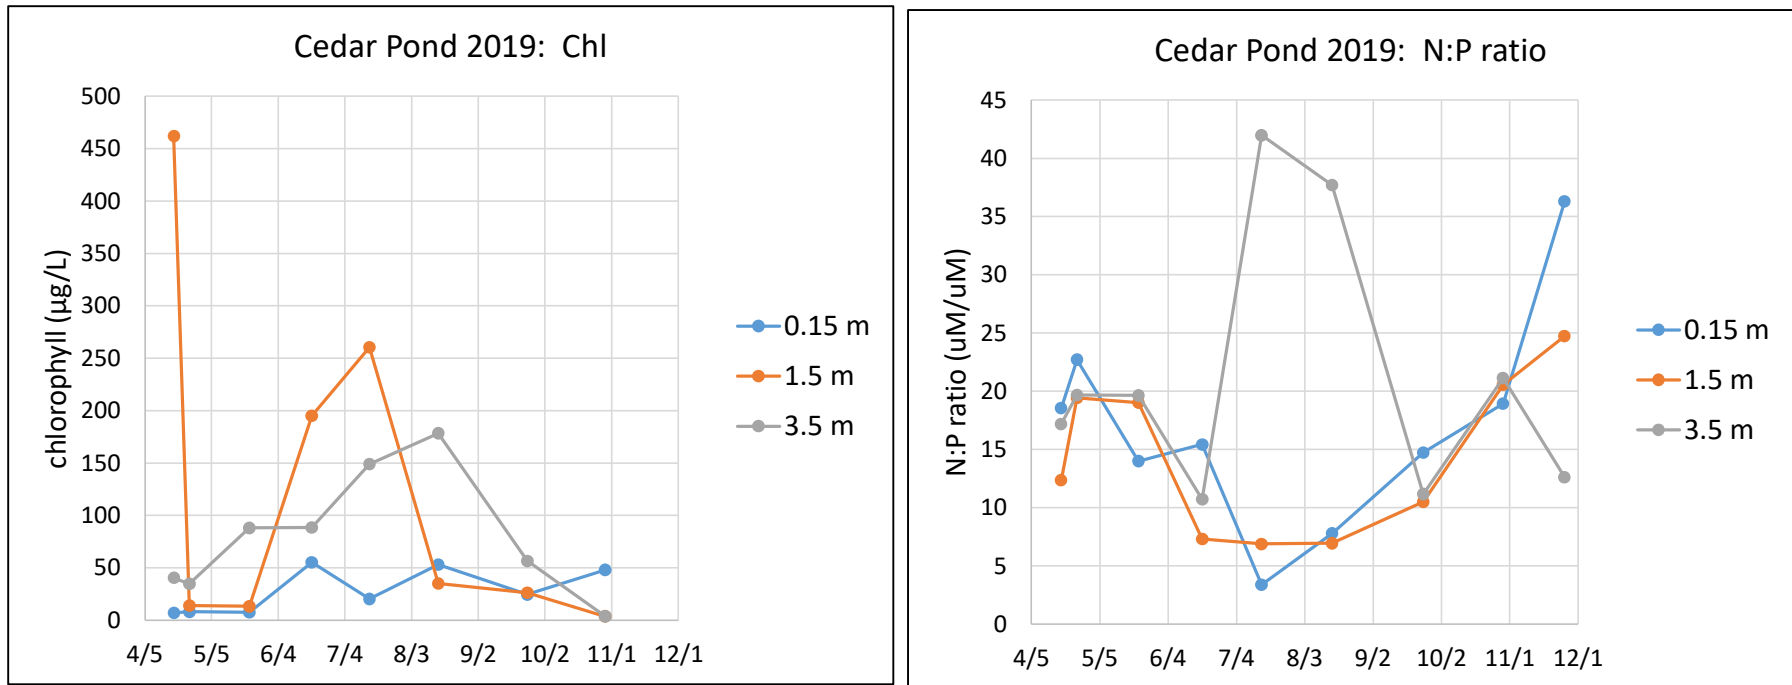
Figure 12. Cedar Pond 2019 Water Column Chlorophyll and N:P ratios. Chlorophyll readings at 0.15 m were high (20 to 50 $\mu\text{g/L}$), but relatively consistent throughout 2019. Readings at 1.5 m increased significantly between May and June, peaked at $\sim 250 \mu\text{g/L}$ in July, then decreased in the remaining samplings as salinity reached peak 2019 levels. Readings at 3.5 m followed a similar pattern to 1.5 m readings, but a 1-month delay, consistent with dead phytoplankton chlorophyll settling within the water column. N:P ratio began April generally in the 15 to 20 range at all three depths, then decreased through July into the 5 to 10 range. During this same period, deep (3.5 m) ratios increased to above 40, while the other two depths continued to decrease. The 0.15 m and 1.5 m ratios increased during September until November at approximately the same rate as they decreased between April and July, while the 3.5 m ratio decreased slightly in August and then generally matched the same range as the 0.15 and 1 m ratios between September and October. The July/August peak in the 3.5 m N:P ratio was due to the greater reduction in TP than TN (both concentrations were decreasing) being released from the sediments or perhaps relatively more TN entering the pond during this period from tidal inputs.

Review of 2019 N:P ratios showed that nitrogen availability generally determined phytoplankton growth especially between June and September, but deep in the pond phosphorus and nitrogen were so high that neither would be limiting and growth would be likely more limited by light penetration (see Figure 12). In April 2019, N:P ratios were generally between 15 and 20, which brackets the Redfield ratio of 16. Phytoplankton growth in surface waters with N:P ratios above 16 are generally determined by available phosphorus, while waters less than 16 are generally determined by nitrogen, although ratios close to the Redfield limit are more often N controlled or balanced in their nutrient needs.²⁸ N:P ratios at 0.15 m and 1.5 m decreased from April to June to the 5 to 10 range (more available P than N), were relatively consistently within this range until August, and then began to slowly increase through October. This pattern showed that N controlled phytoplankton growth more than P during the summer. During the early spring and late fall, phytoplankton growth was determined more by an equal balance of N and P. Deep N:P ratios increased notably during the decrease in shallower readings, largely due to more TN being released from the sediments than TP. This peak was also likely related to available TP being retained in phytoplankton in the shallower parts of the water column during the high growth period of June/July. It is also likely that species within the phytoplankton community was quite variable throughout the summer due to changing nutrient availability. Deep TP and TN concentrations were notably higher in 2019 than 2018 due to the stronger stratification, but neither had a big increase experienced in November 2018 likely due to the near removal of TP and TN inputs from the cormorants.
