School for
Marine Science
and Technology

University of
Massachusetts
Dartmouth

Technical Memorandum

RE: Cedar Pond Adaptive Management Monitoring Program: 2021 Semi-Annual Report
(Activities between January 2021 and August 2021)

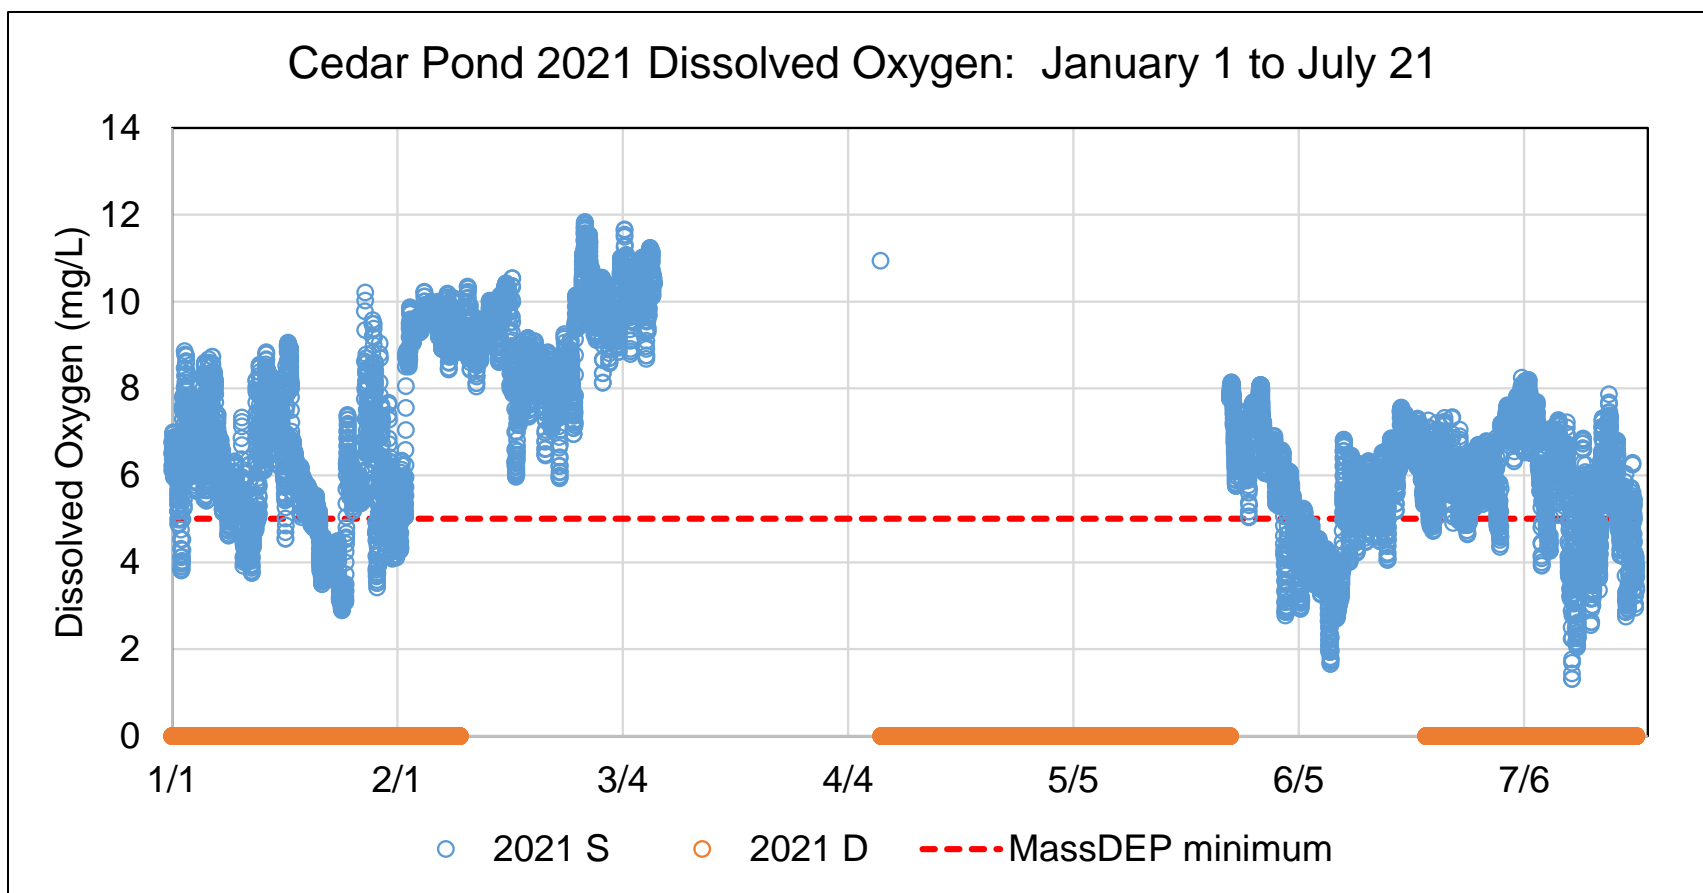
Figure 3. Cedar Pond 2021 Shallow and Deep Continuous Dissolved Oxygen (January 1 to July 21). Shallow DO readings during the recording period averaged 6.7 mg/L (*i.e.*, greater than the MassDEP 5 mg/L minimum), while Deep DO readings were consistently 0 mg/L. Continuous monthly DO readings are somewhat limited in the January to July time period, but among these May 2020 was the only previous monthly average above 5 mg/L. Average shallow DO concentrations in June and July 2020 and April, May, June and July 2019 were less than the MassDEP minimum. All monthly averages of 2021 shallow DO readings were greater than the MassDEP minimum.

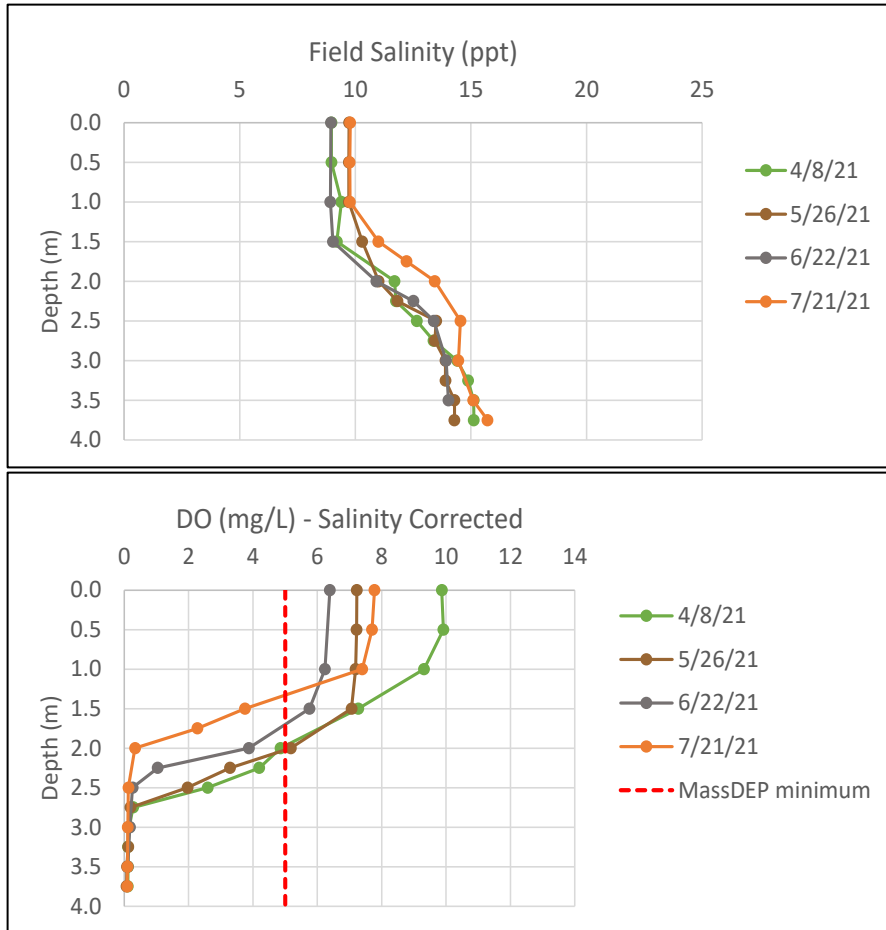
Figure 5. 2021 Cedar Pond Water Column Profiles: Salinity, Temperature, and Dissolved Oxygen. 2021 water column profile readings to date show the pond was slightly warmer, slightly saltier, and had greater shallow DO than in the spring/early summer of 2020. These findings are generally consistent with continuous readings except for temperature, which generally had cooler temperatures in 2021. 2021 monthly salinity profiles readings tended to be slightly greater (+1 ppt) than the same months in 2020. DO profiles showed that shallow readings in April 2020 and 2021 were similar including DO concentrations deeper than 2.25 m below the MassDEP minimum (5 mg/L). In May and June 2021, more of the shallow water column had acceptable DO than in 2020, consistent with the continuous readings. July 2020 and 2021 DO profiles had similar concentrations.

Water column profile readings from 2021 to date (Figure 5) generally agree with the continuous readings for salinity (slightly higher) and shallow DO (higher) than spring/early summer 2020, but 2021 temperature profiles were slightly warmer than 2020, while continuous monthly reading averages were cooler. While April and May 2021 shallow temperature profile readings were 2 to 3°C greater than corresponding profiles in 2020, monthly averages from the continuous record at 1.2 m depth showed that April and May 2021 had lower temperatures than the same months in 2020. This difference reinforces the benefits provided by continuous readings, although profiles continue to provide more complete measurement throughout the whole water column. Review of salinity showed that 2021 monthly profiles readings tended to be slightly greater (+1 ppt) than the same months in 2020. DO profiles showed that shallow readings in April 2020 and 2021 were similar with both having DO concentrations in waters deeper than 2.25 m below the MassDEP minimum (5 mg/L). In May and June 2021, there was a clear improvement compared to prior years with a greater proportion of the upper water column having acceptable DO. July 2020 and 2021 DO profiles had similar concentrations. Preliminary review of assay results from water column samples suggest that higher phytoplankton populations (*i.e.*, higher pigment concentrations) may play a significant role in increased 2021 shallow DO concentrations especially considering the warmer 2021 temperatures. Further review of the integrated data from profiles, lab results, and continuous readings will occur in the 2021 Annual Report.
